BLAST VIBRATION DAMAGE ASSESSMENT STUDY AND REPORT

**PREPARED FOR:
THE MIAMI-DADE COUNTY BLASTING TASK FORCE**

FINAL REPORT

ASSESSMENT OF BLAST VIBRATION IMPACTS FROM QUARRY BLASTING IN DADE COUNTY

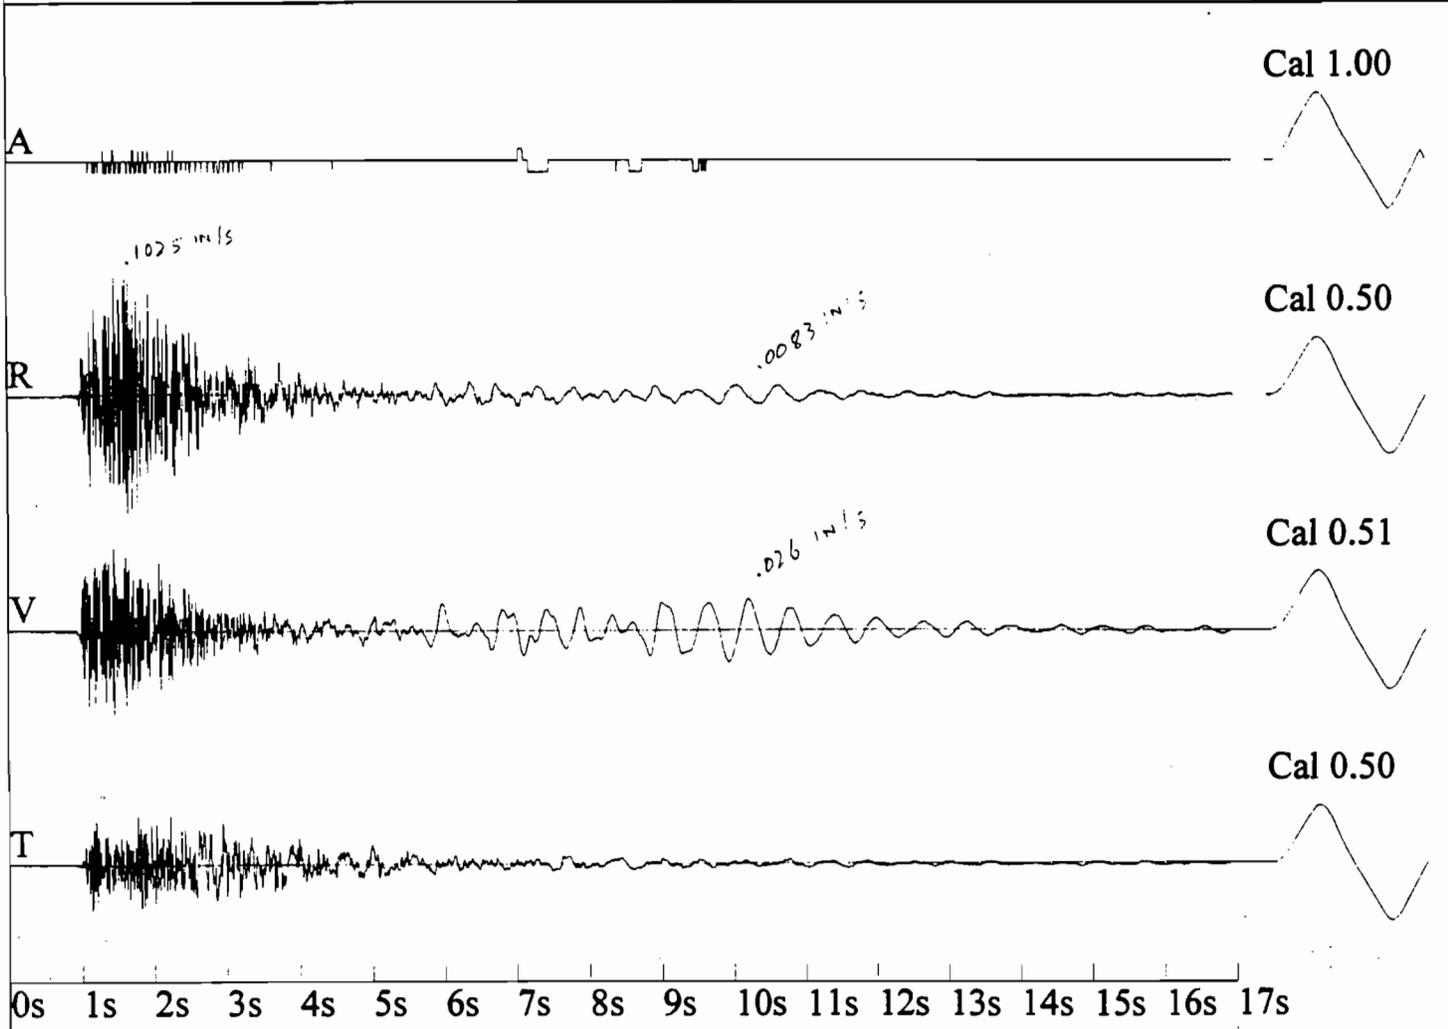
Figure 13.- Highest vibration record from monitoring at House 42. This is a Miami crushed Rock blast at 8,100 ft.

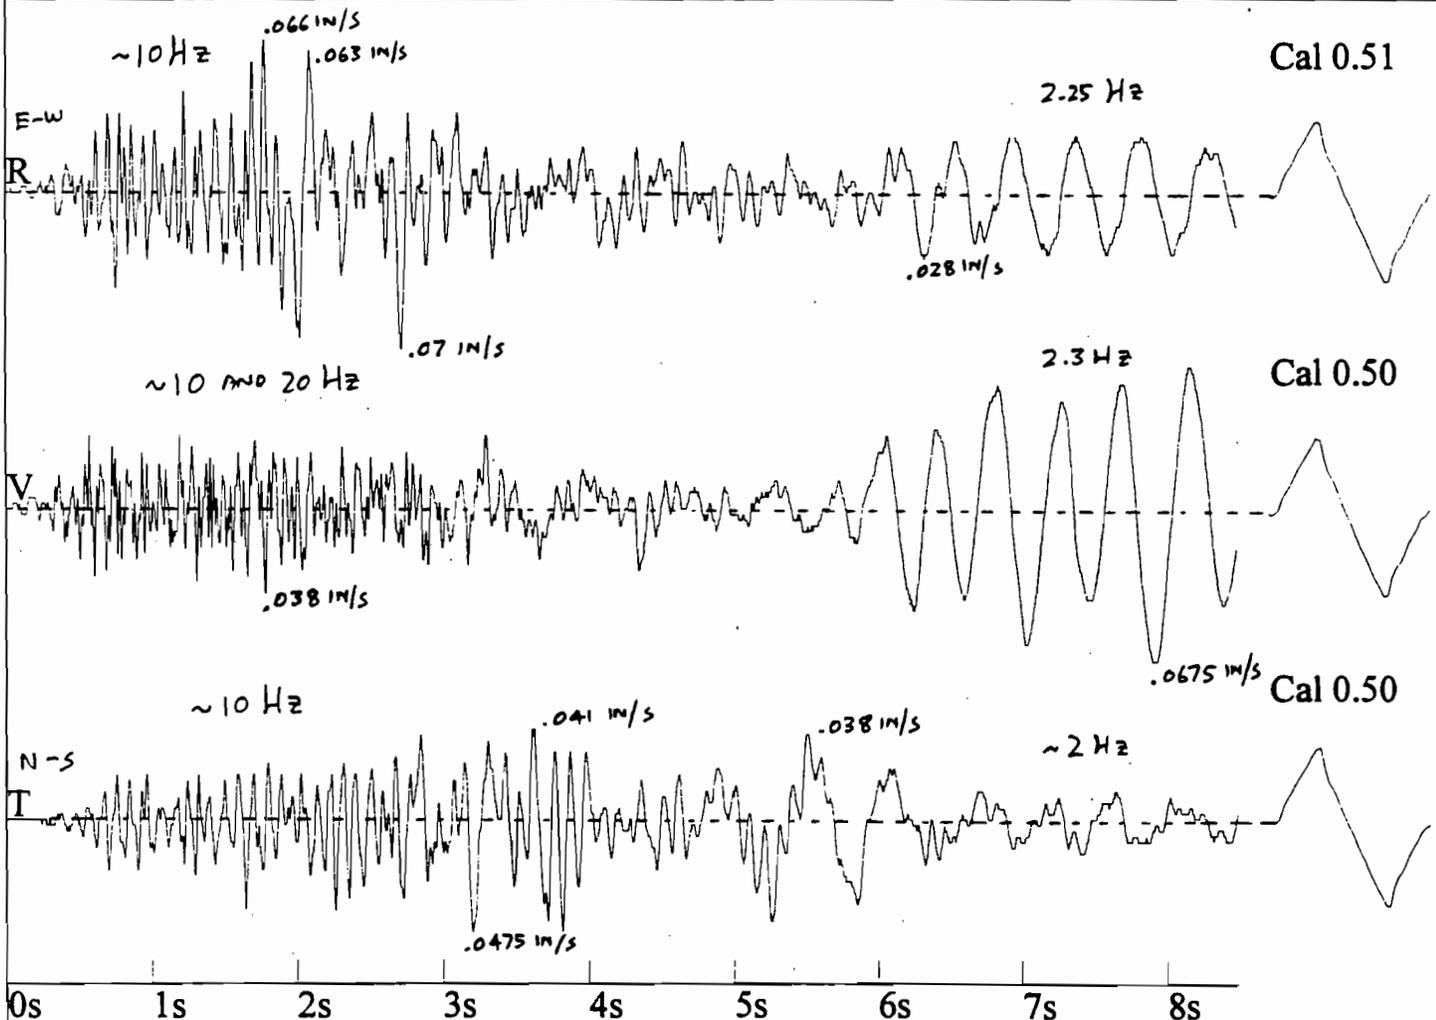
Figure 14.- Highest vibration record from monitoring at House 6. WRQ
Section 7 blast at about 12,600 ft.

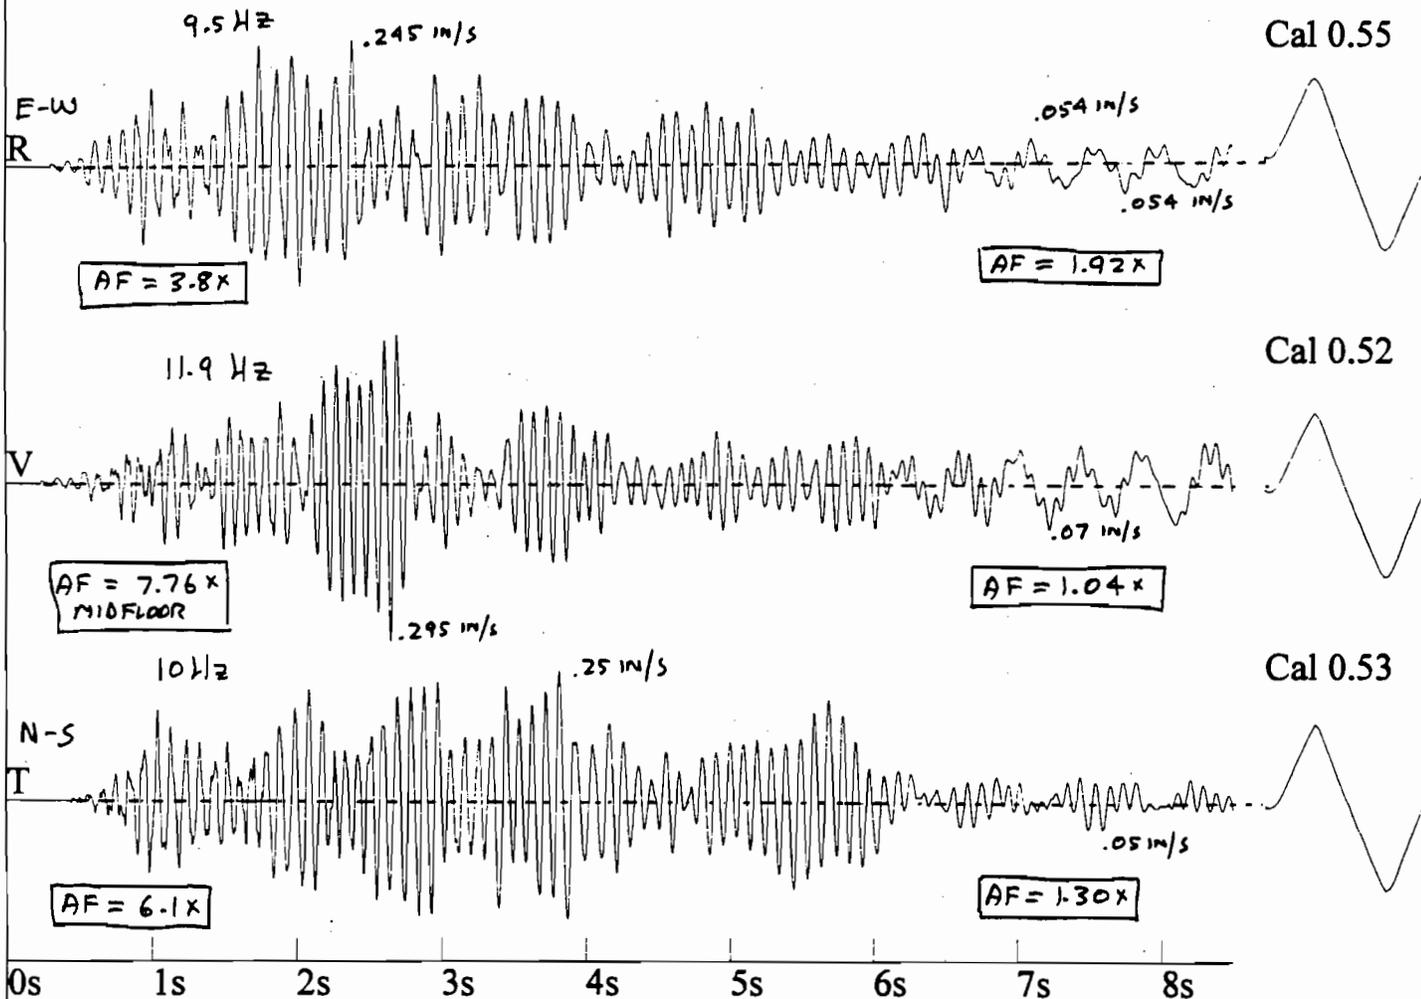
Figure 15.- Structure response record for House 6 from the same blast shown in Figure 14.

House 6: Most significant for two-story house were the large dynamic amplifications of horizontal vibrations 3.8x (E-W) and 6.1x (N-S) at the "higher" frequencies of 9 to 10 Hz. Previous non-Florida USBM data for amplifications found averages of about 2x and maximums of 4.3x. These responses are high, even without even knowing if the exact resonant frequencies were experienced and if these are the highest responses possible.

Approximating the $\sin\phi\cos\phi$ function as 0.5, the high frequency and low frequency responses are 31 and 42 $\mu\varepsilon$, respectively for House 6. These are sufficiently below the minimum masonry cracking thresholds of 100 $\mu\varepsilon$ to not be a possibility. Higher vibrations and/or higher responses could, however, be a problem. House 13 has lower amplifications, less displacement and hence less strain.

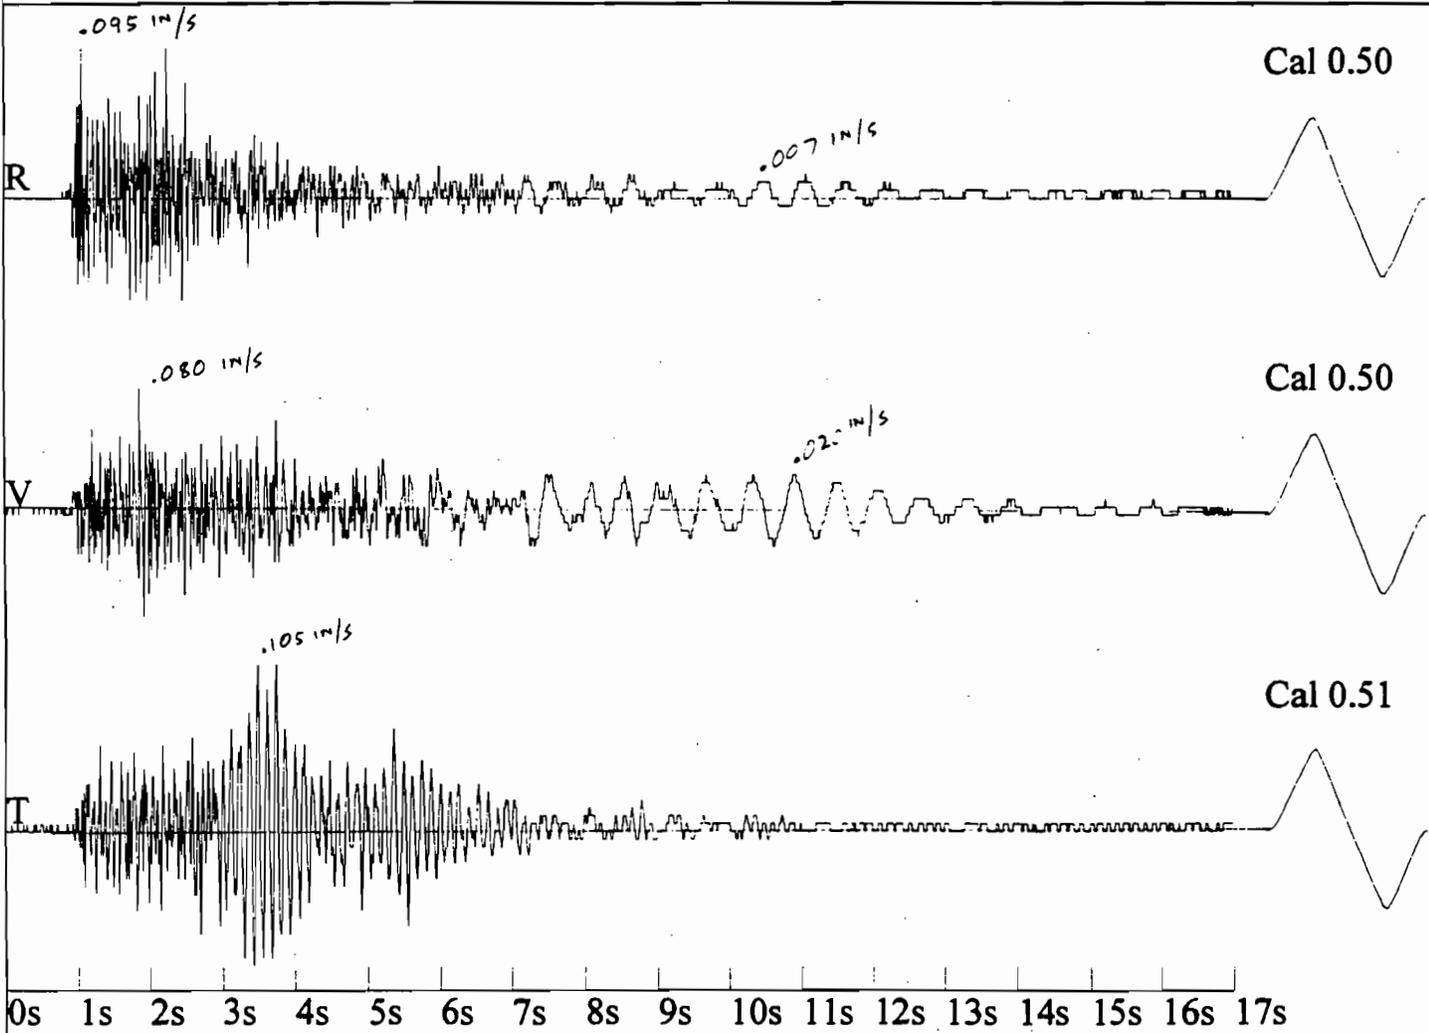
Figure 19.- Structure response waveforms corresponding to the ground vibration in Figure 13.

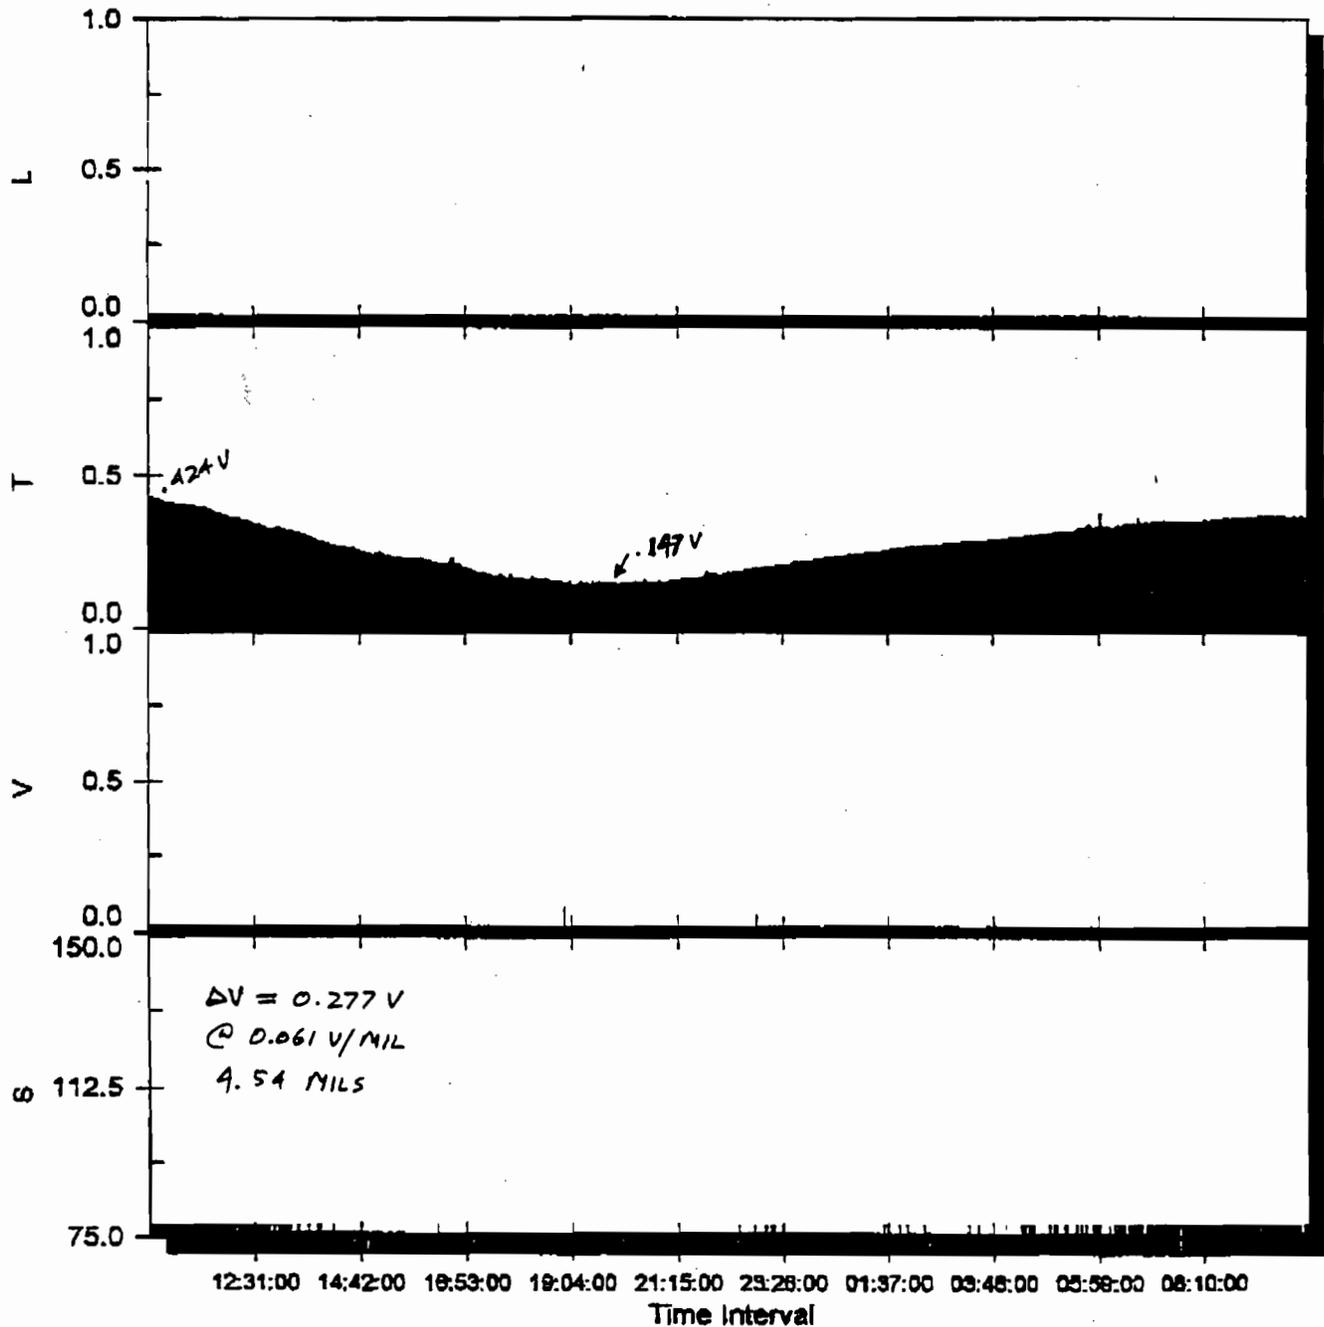
Figure 22.- Thermal response of garage wall crack in House 4. All the long-term measurements had 24-hour cycles. The difference between high and low of 0.277 volts corresponds to a crack width change of 4.54 mils.
