**INVESTIGATION OF DAMAGE TO STRUCTURES  
IN THE McCUTCHANVILLE-DAYLIGHT  
AREA OF SOUTHWESTERN INDIANA**

Vibration Environment and Damage  
Characterization For Houses in  
McCutchanville and Daylight, Indiana.

# VIBRATION ENVIRONMENT AND DAMAGE CHARACTERIZATION FOR HOUSES IN McCUTCHANVILLE AND DAYLIGHT, INDIANA

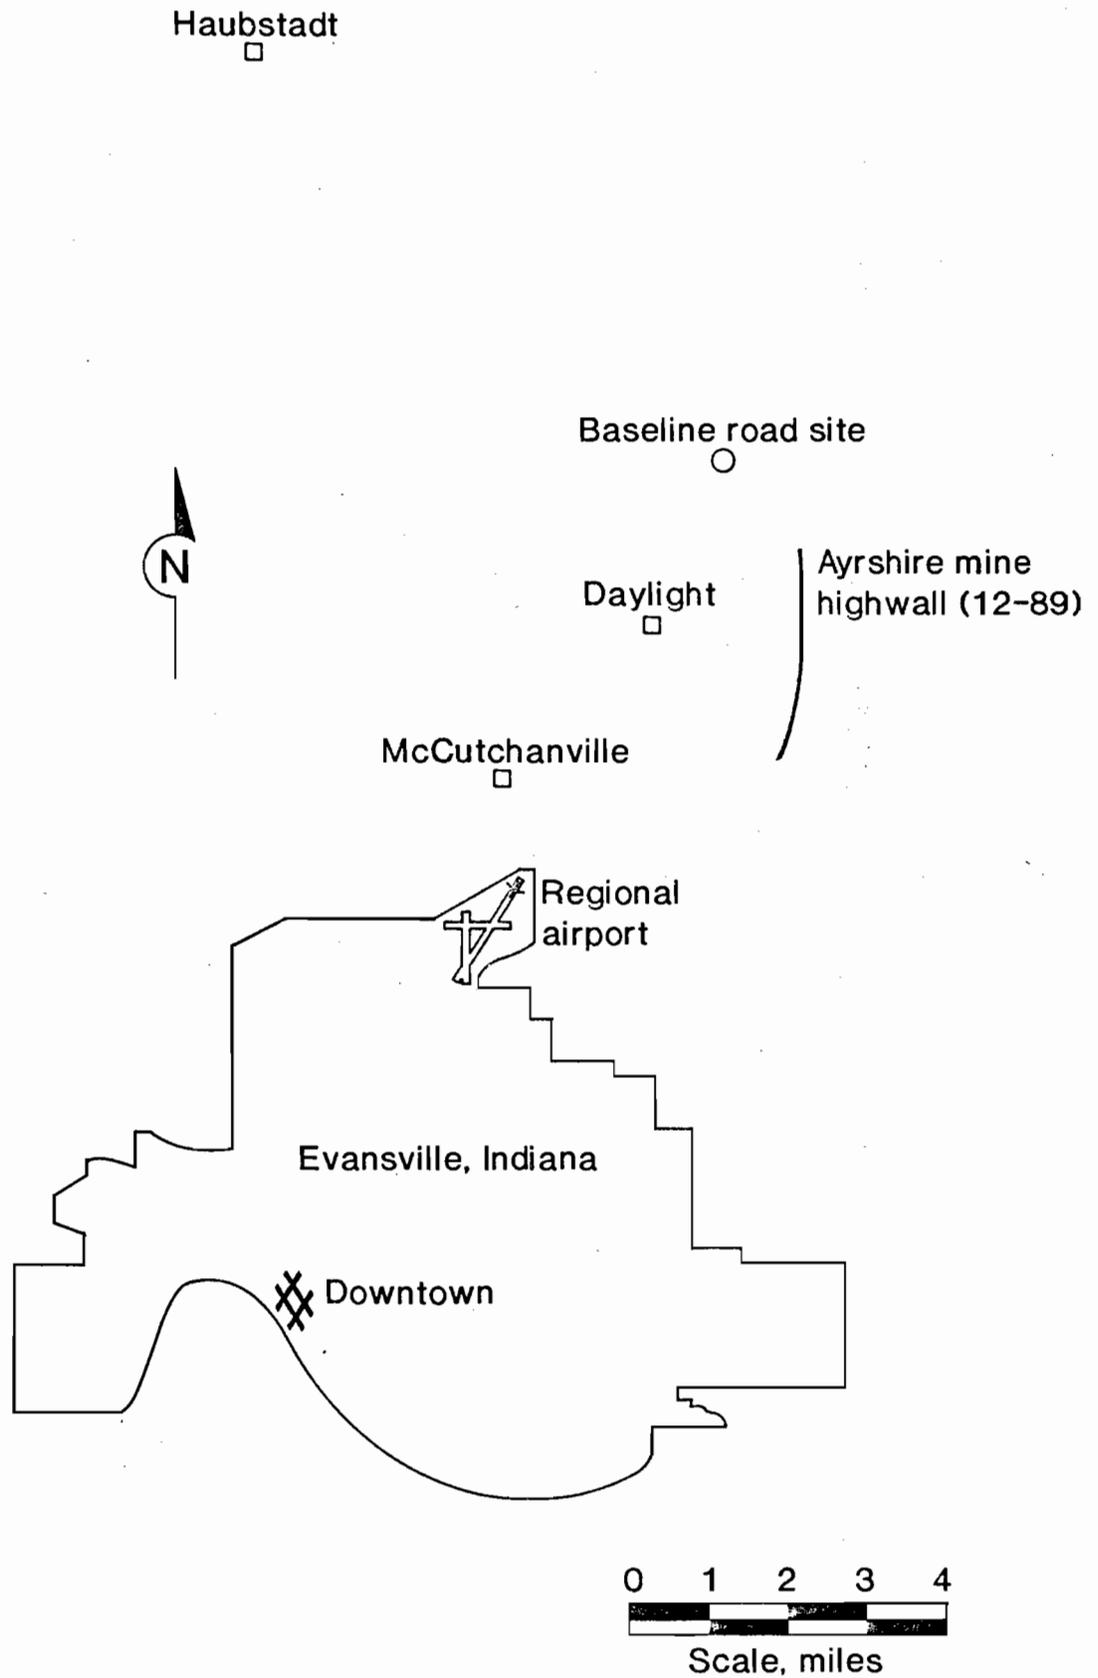
Figure 1. - Mine and monitoring locations west of Ayrshire mine near Evansville, Indiana.

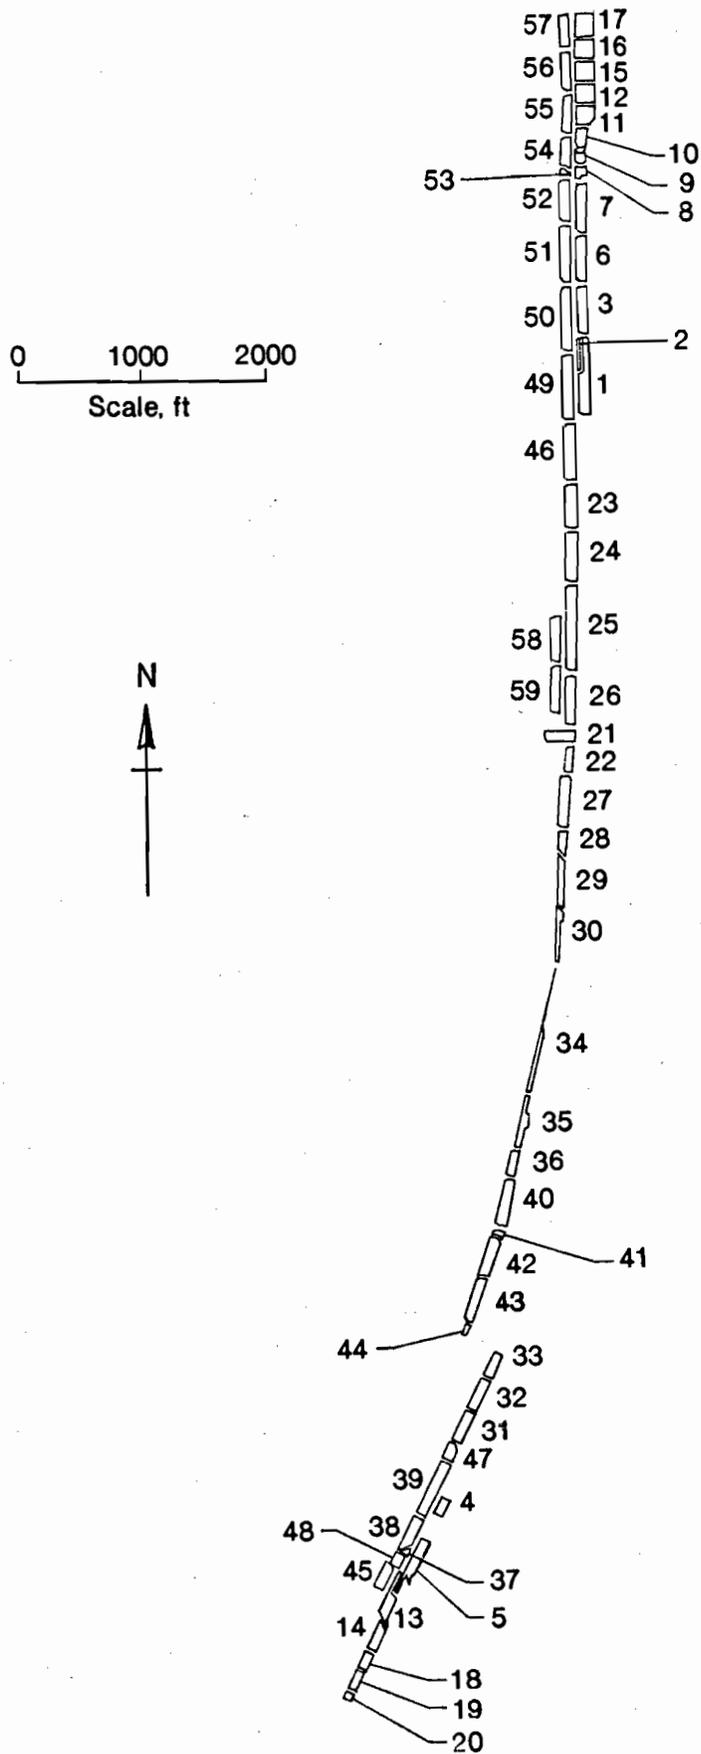
Figure 2. - Ayrshire mine highwall showing blasts during the Bureau of Mines monitoring program, November and December 1989.

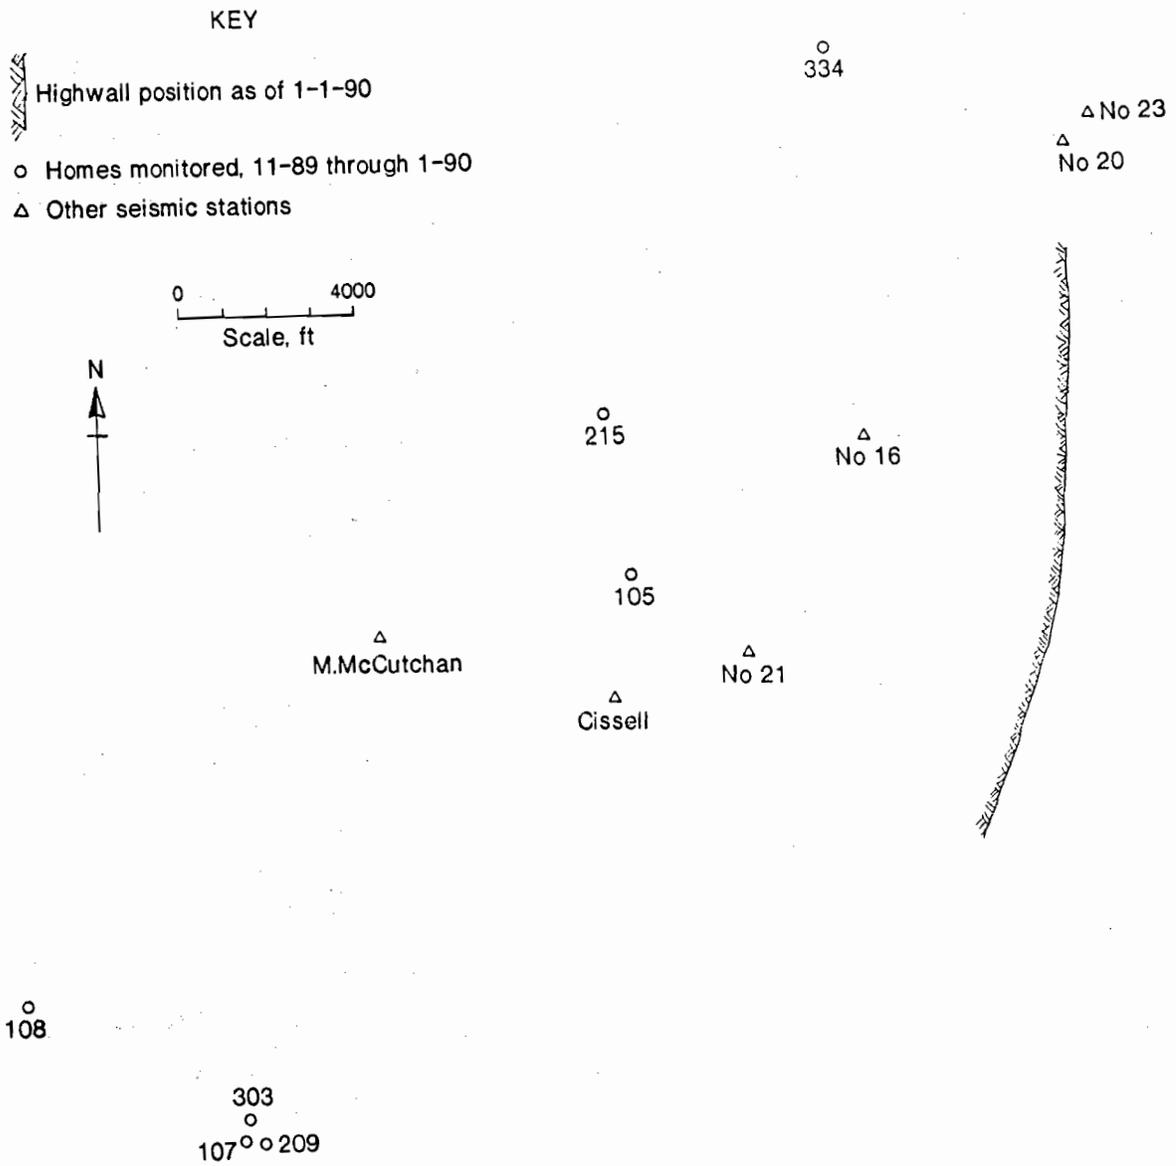
Figure 3. - Monitored homes and additional seismic stations west of the Ayrshire mine highwall.

A review was made of the 115 homes inspected and catalogued by OSM. Of these, 16 were selected as candidates for instrumenting and preliminary level-loop surveying (figure 8). Selection criteria were based on representative samples for both damage condition and location. Regular accessibility was important for both damage inspections and access to instrumentation. In McCutchanville, two homes were located on east-facing slopes (towards the mine) for maximum airblast-induced structure responses. The full two-month inspection and monitoring program was done for 6 homes, 3 of which were in McCutchanville. One additional home had been under constant monitoring by the DNR (#108), and during the study, two additional McCutchanville homes with serious cracking were subjected to walk-through inspections. Table 2 describes nine homes studied. Locations of the homes relative to the highwall were shown previously in figure 3.

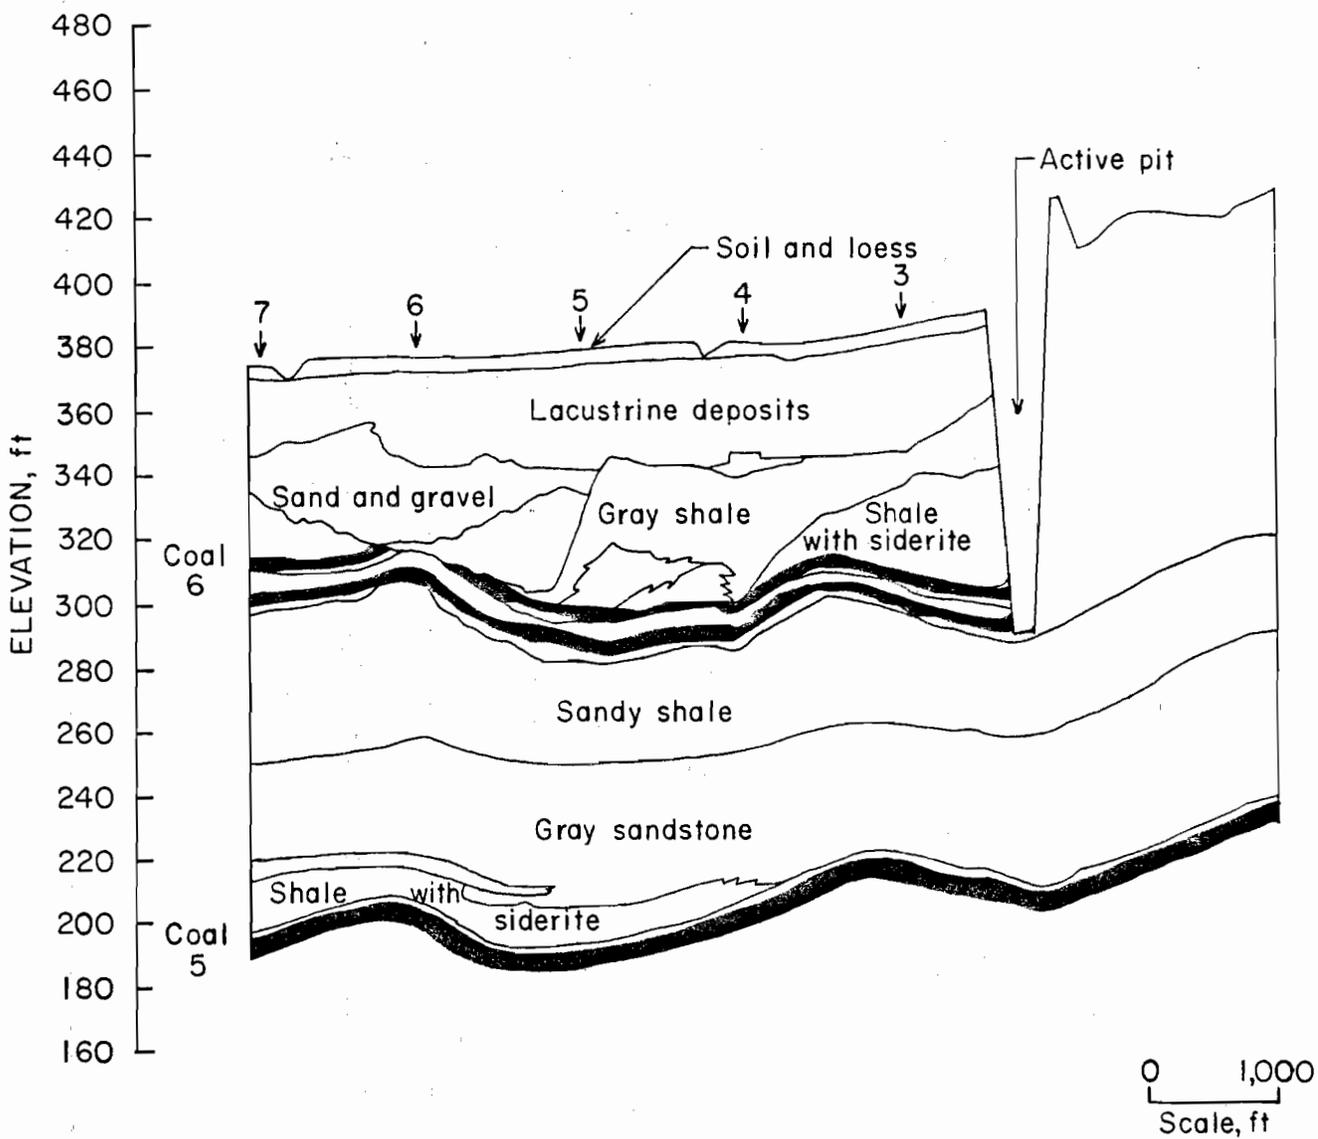
Figure 6. - Generalized sectional view of the Ayrshire mine trending west (left) to east (right) (Z).

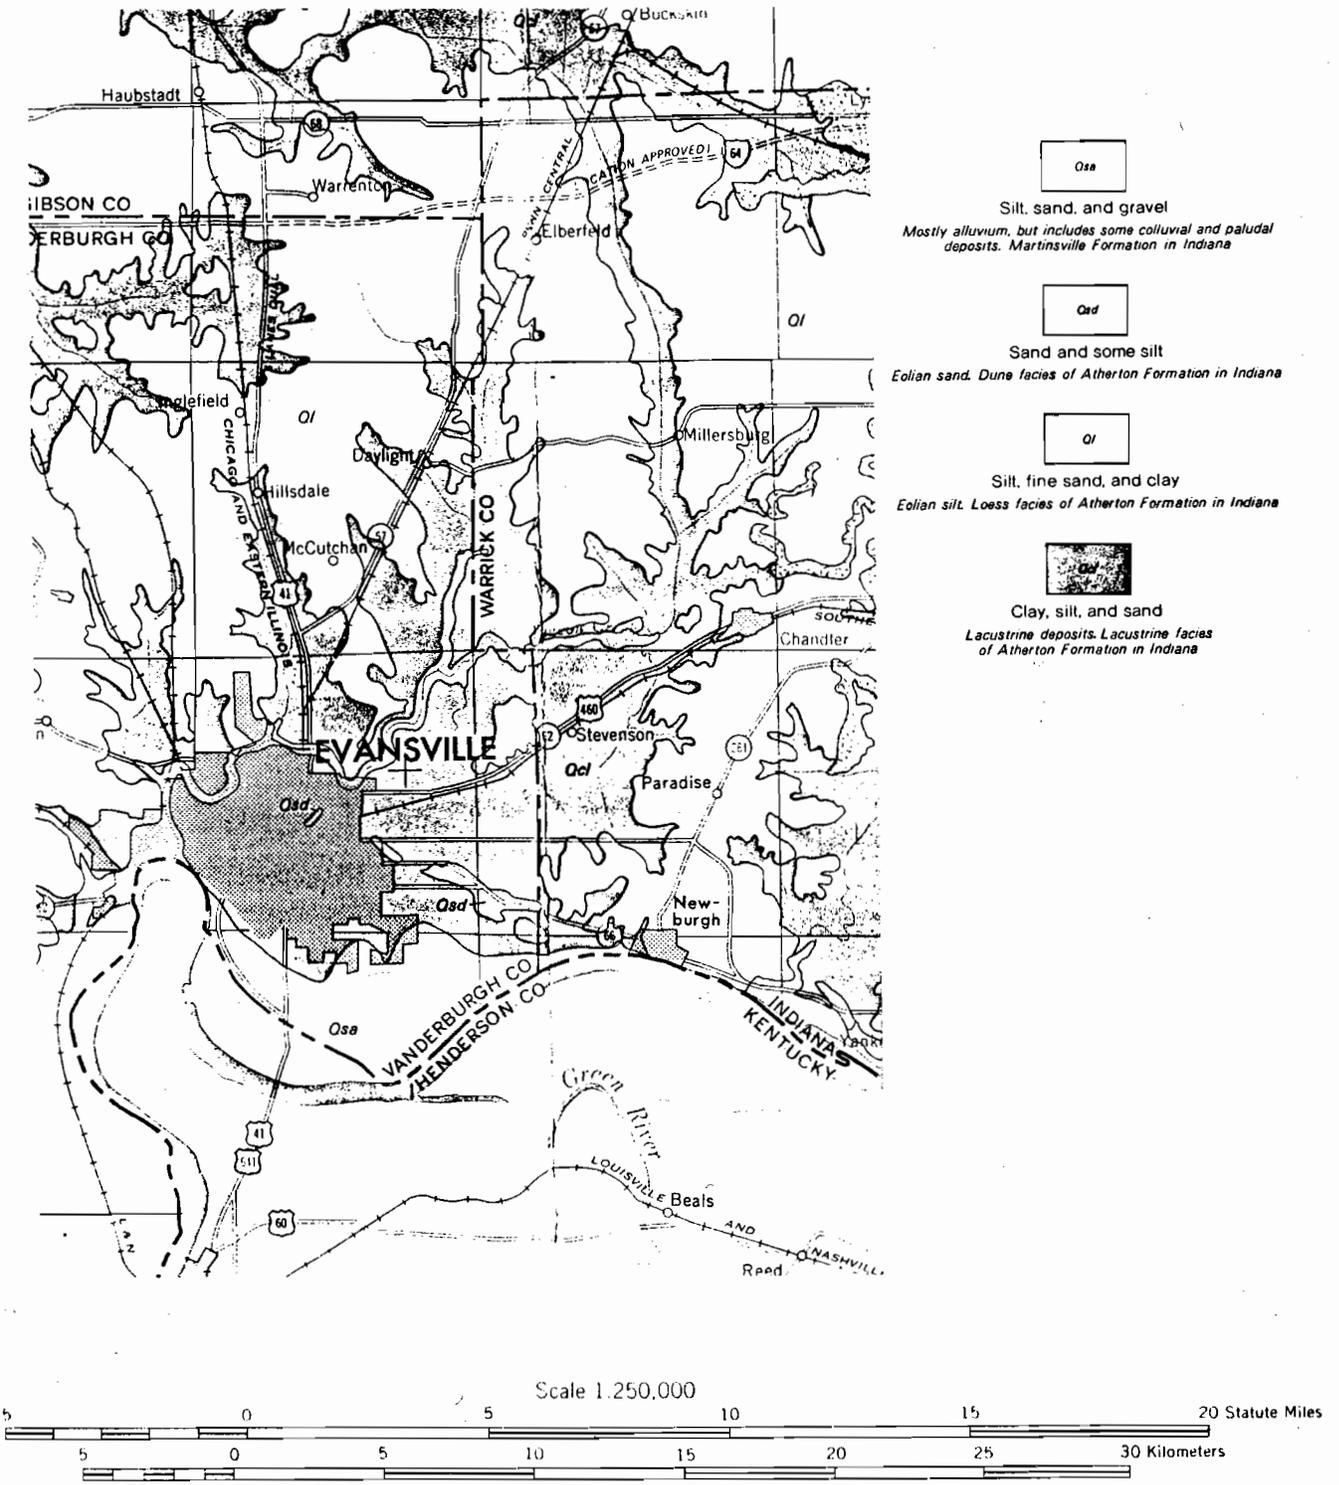
Figure 5. - Generalized map illustrating the surface geology in the Daylight and McCutchanville study area (9).

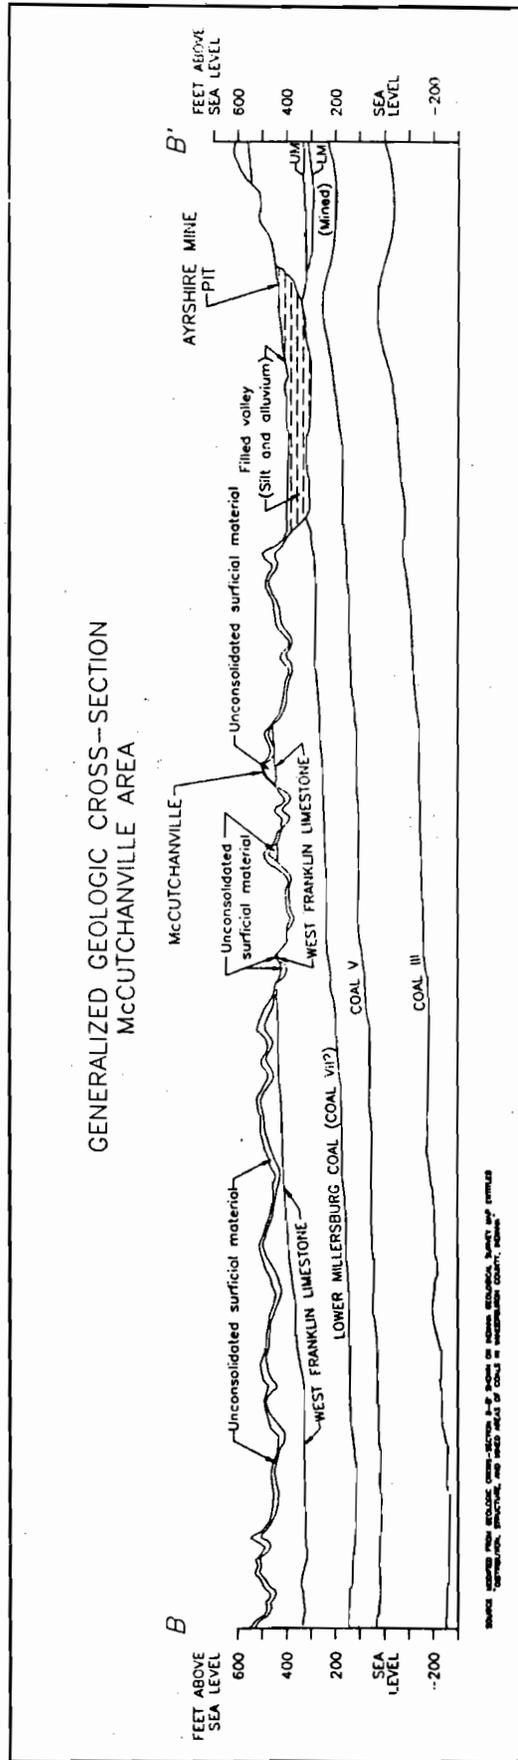
GENERALIZED GEOLOGIC CROSS-SECTION  
MCCUTCCHANVILLE AREA

Figure 7. - Generalized sectional view of the McCutchanville area (1).

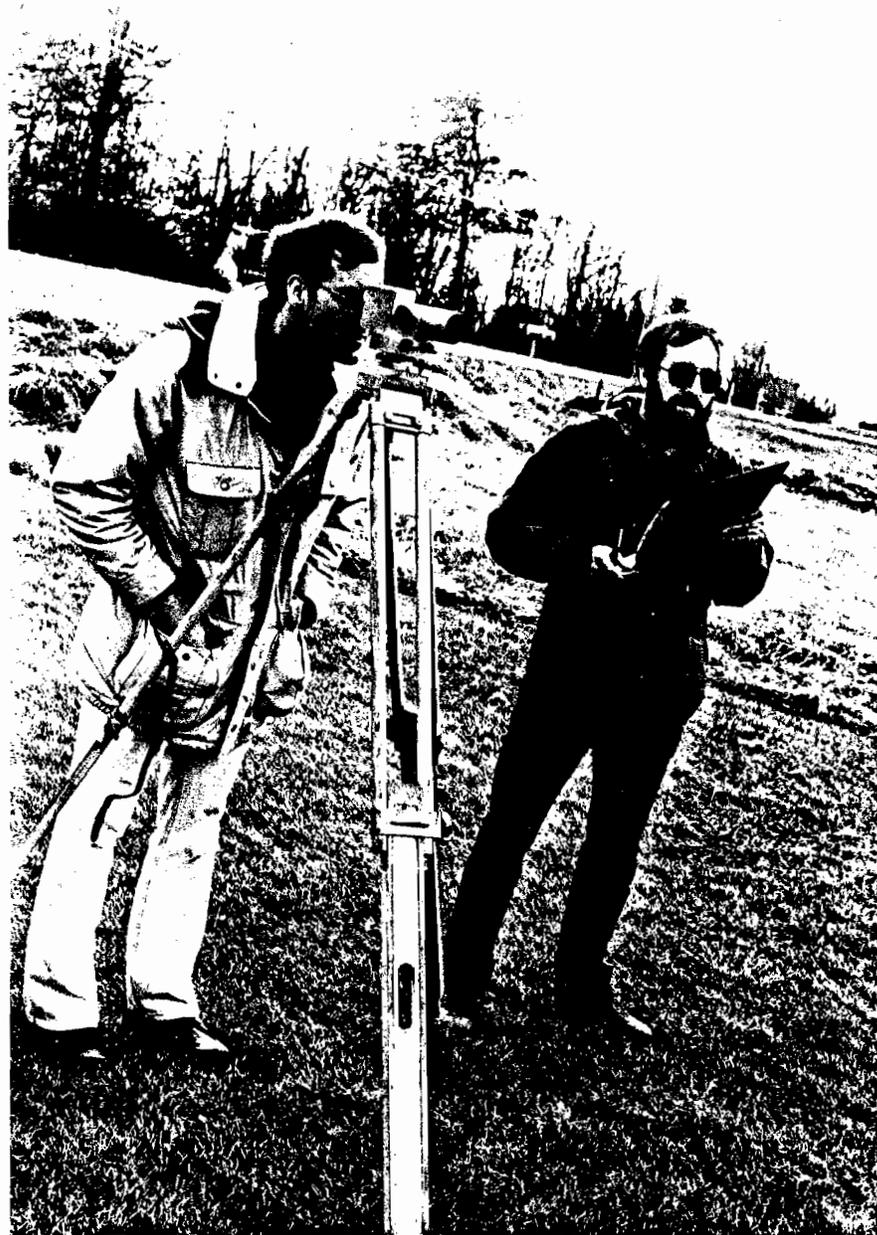
Figure 8. - Survey crew performing level-loop with an automatic level.

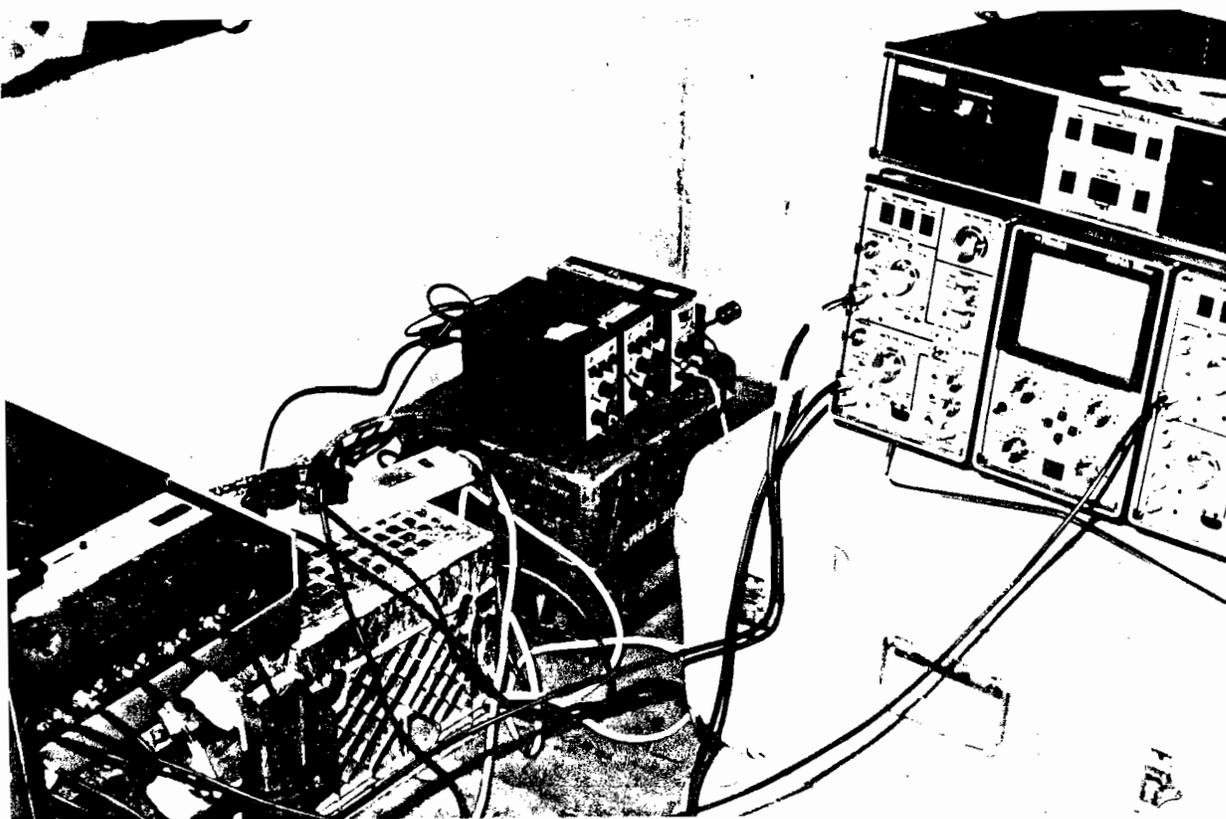
Figure 9. - Vibration monitoring system in house 209 including digital oscilloscope for data retrieval (R) and seven-channel FM recorder (L).

Figures 9 through 12 show the vibration sensors, high-gain integrating signal conditioning amplifiers and 7-channel FM tape recorders in place, plus seismographs and a digital oscilloscope for data retrieval. Ground vibration transducers were either mounted on the inside of the foundation at ground level or buried next to the foundation, depending on outside accessibility. Bureau studies of vibration monitoring procedures found that exact locations were not critical for low levels (8). Airblast microphones were mounted high up on the house walls facing the mine and under the eaves (figure 13). Although not ideal because of possible reflection-enhancement of the airblast, it was done to reduce weather exposure. A more ideal but impractical placement would be high up in an open field.

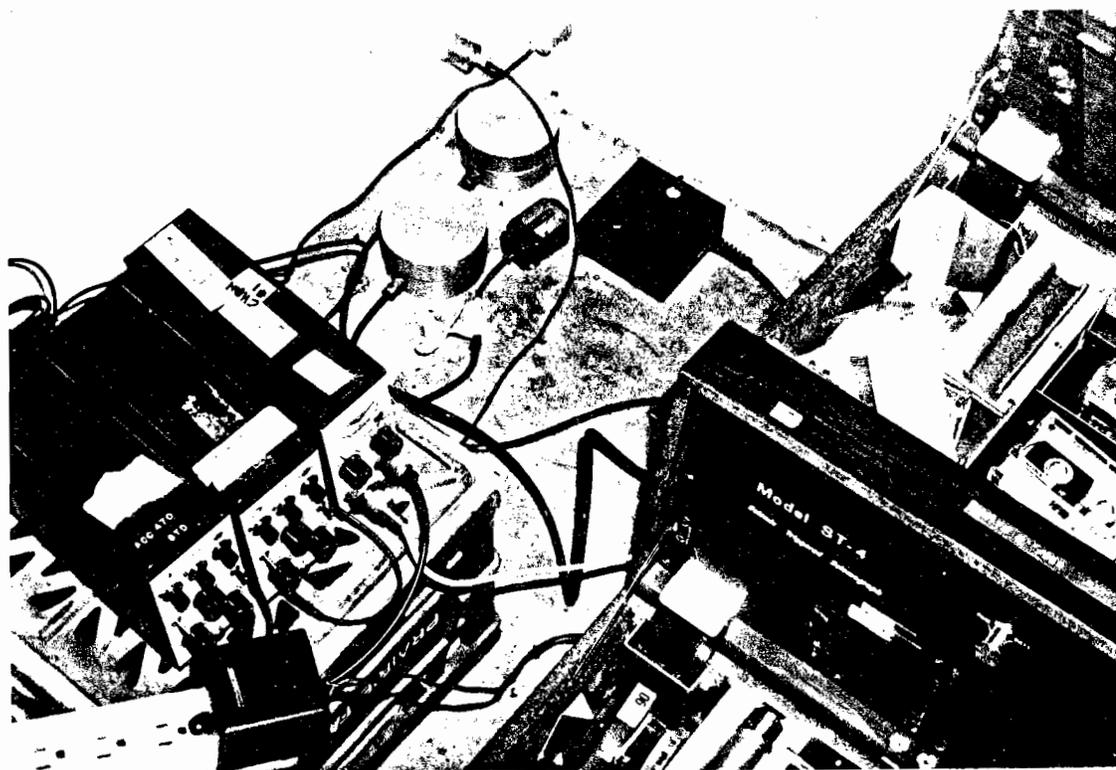
Figure 10. - Vibration transducers in basement corner of 209 ground level. The larger cylindrical and square seismograph transducer contain three geophones each.

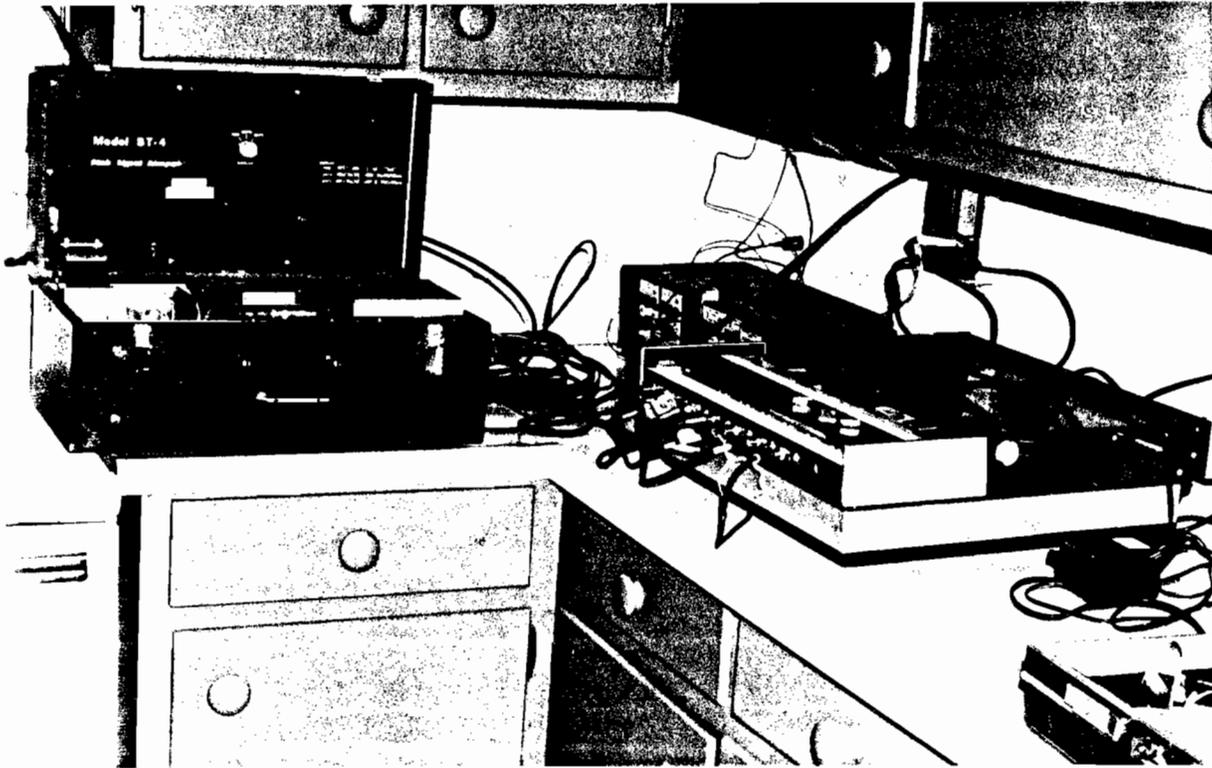
Figure 11. - Seismograph and recorder in house 105.

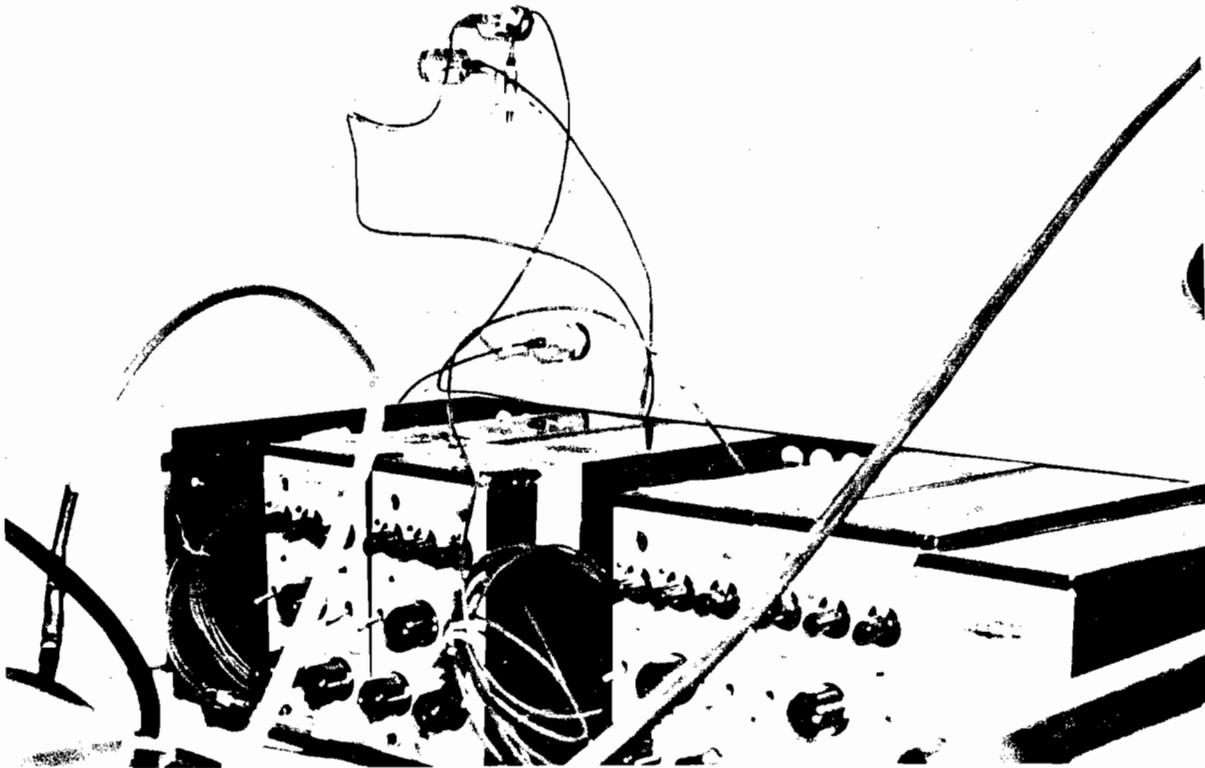
Figure 12. - Close up of accelerometers and integrating amplifiers giving wide-band velocity measurements in house 105.

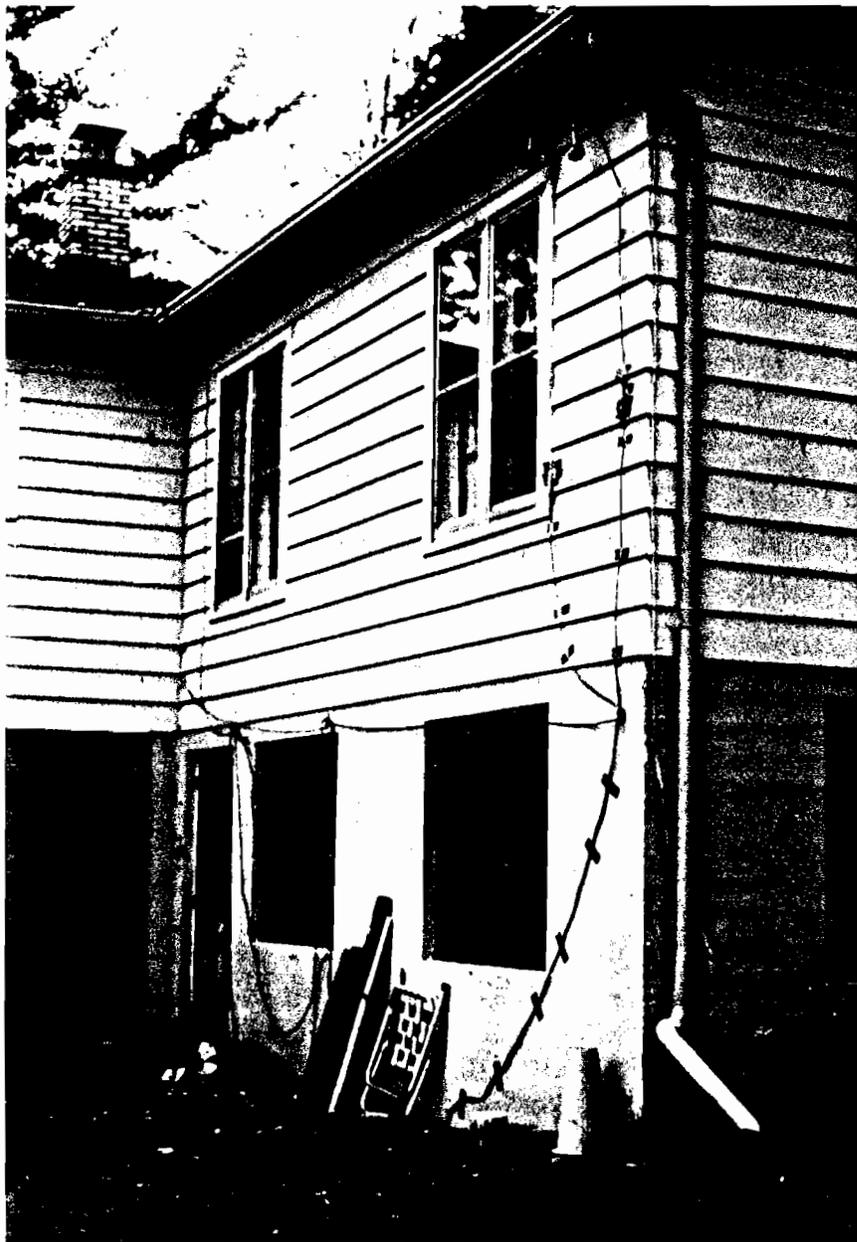
Figure 13. - Rear view of house 209 showing height and microphone placement.

House 209 has a "walk-out" basement on this side of the structure so the sensors were located essentially two stories above ground-level, directly over and in the same directions as the horizontal ground motion transducers (figure 13). The second-story corner response of house 209, as seen in figure 15, is again very similar to the ground motion except for structure amplification of the particle velocity. In addition, some high frequency "bumps" are observed on the time history which are probably modifications induced by specific characteristics the structures such as by the materials and methods used in construction.

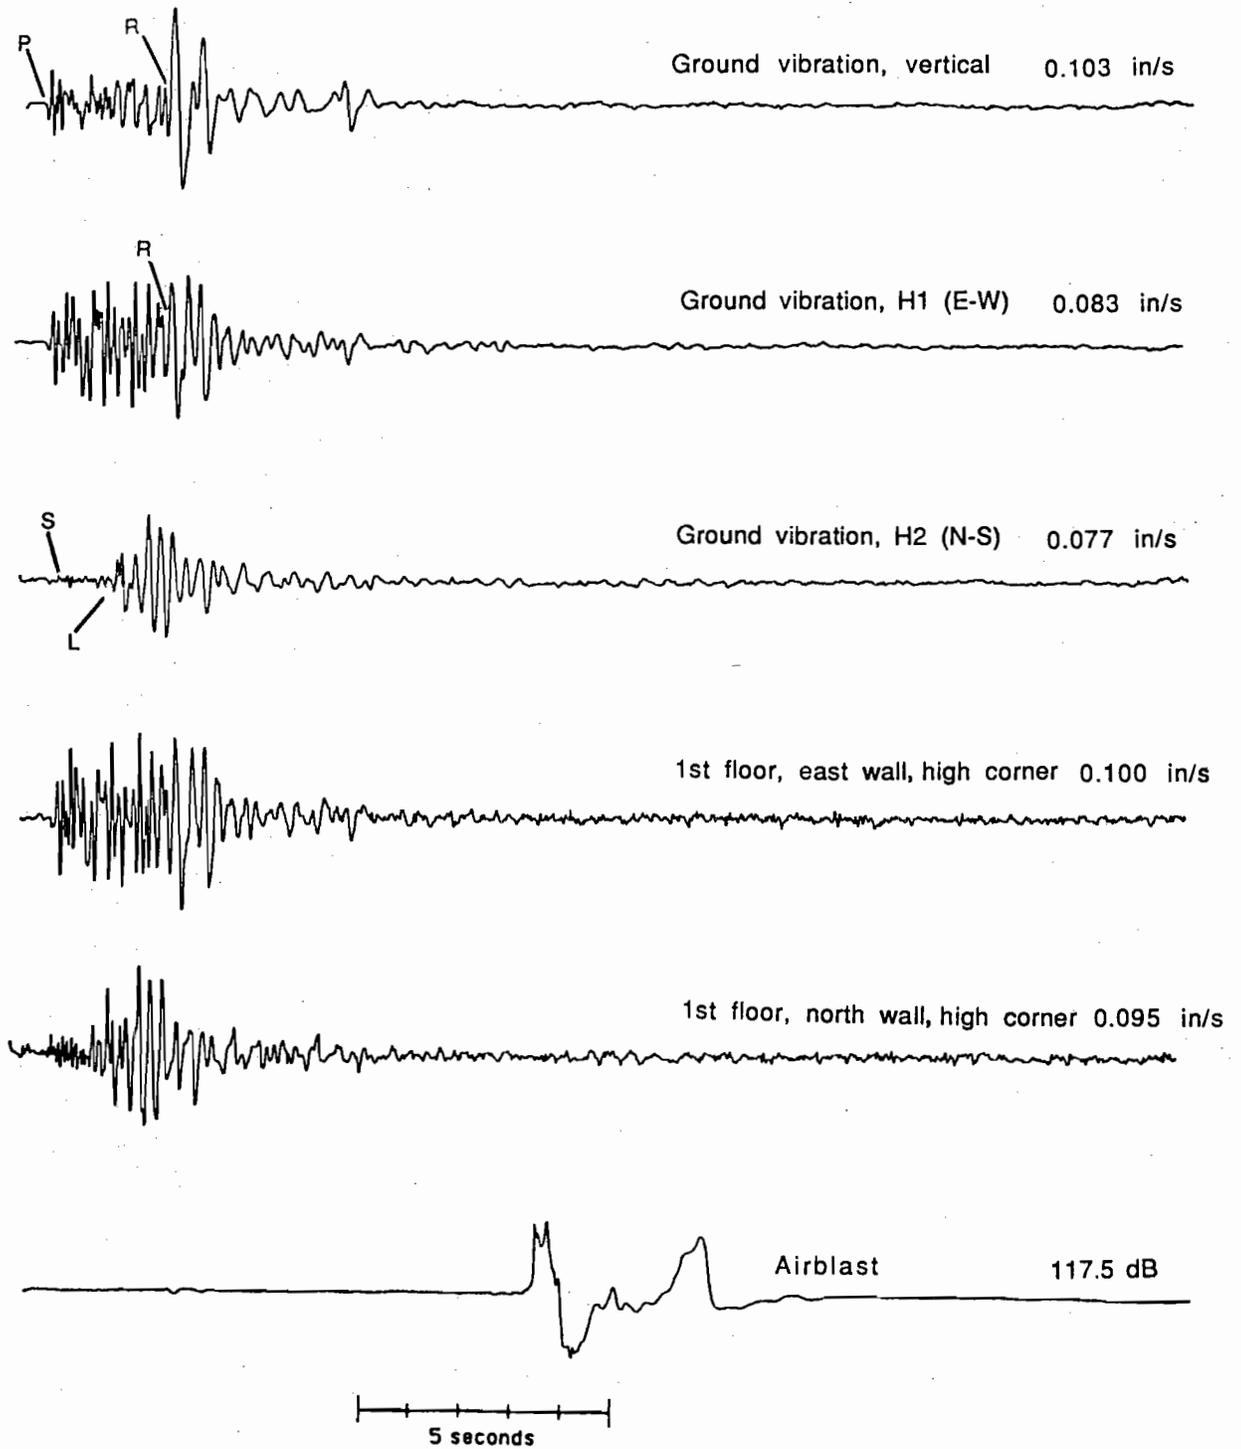
Bureau of Mines Monitoring, House 105  
 Shot #25, 11/22/89 at 11:16 am  
 Distance from shot = 10,254 ft  
 Reported charge weight per delay period = 6,225 lbs

Figure 14. - Ground vibrations, structure response and airblast overpressure time-histories at house 105 for shot #25. For the ground motion time-histories, "P" = P-wave arrival, "S" = S-wave arrival, "R" = Rayleigh wave arrival and "L" = Love wave arrival.

22, 1989 at 1116. House 105 was 10,254 ft (1.9 miles) from the blast and house 209 was at a distance of 24,306 ft (4.6 miles). This blast produced one of the largest ground vibrations recorded during the Bureau's monitoring period and is representative of a "worst case" vibration with respect to this study. These waveforms presented in figures 14 and 15 were recorded on the 7-channel FM recording systems described earlier in the text. Values listed to the right of the waveforms are peak amplitudes. The first floor vibrations are discussed in the structural vibrations' section later in this report.

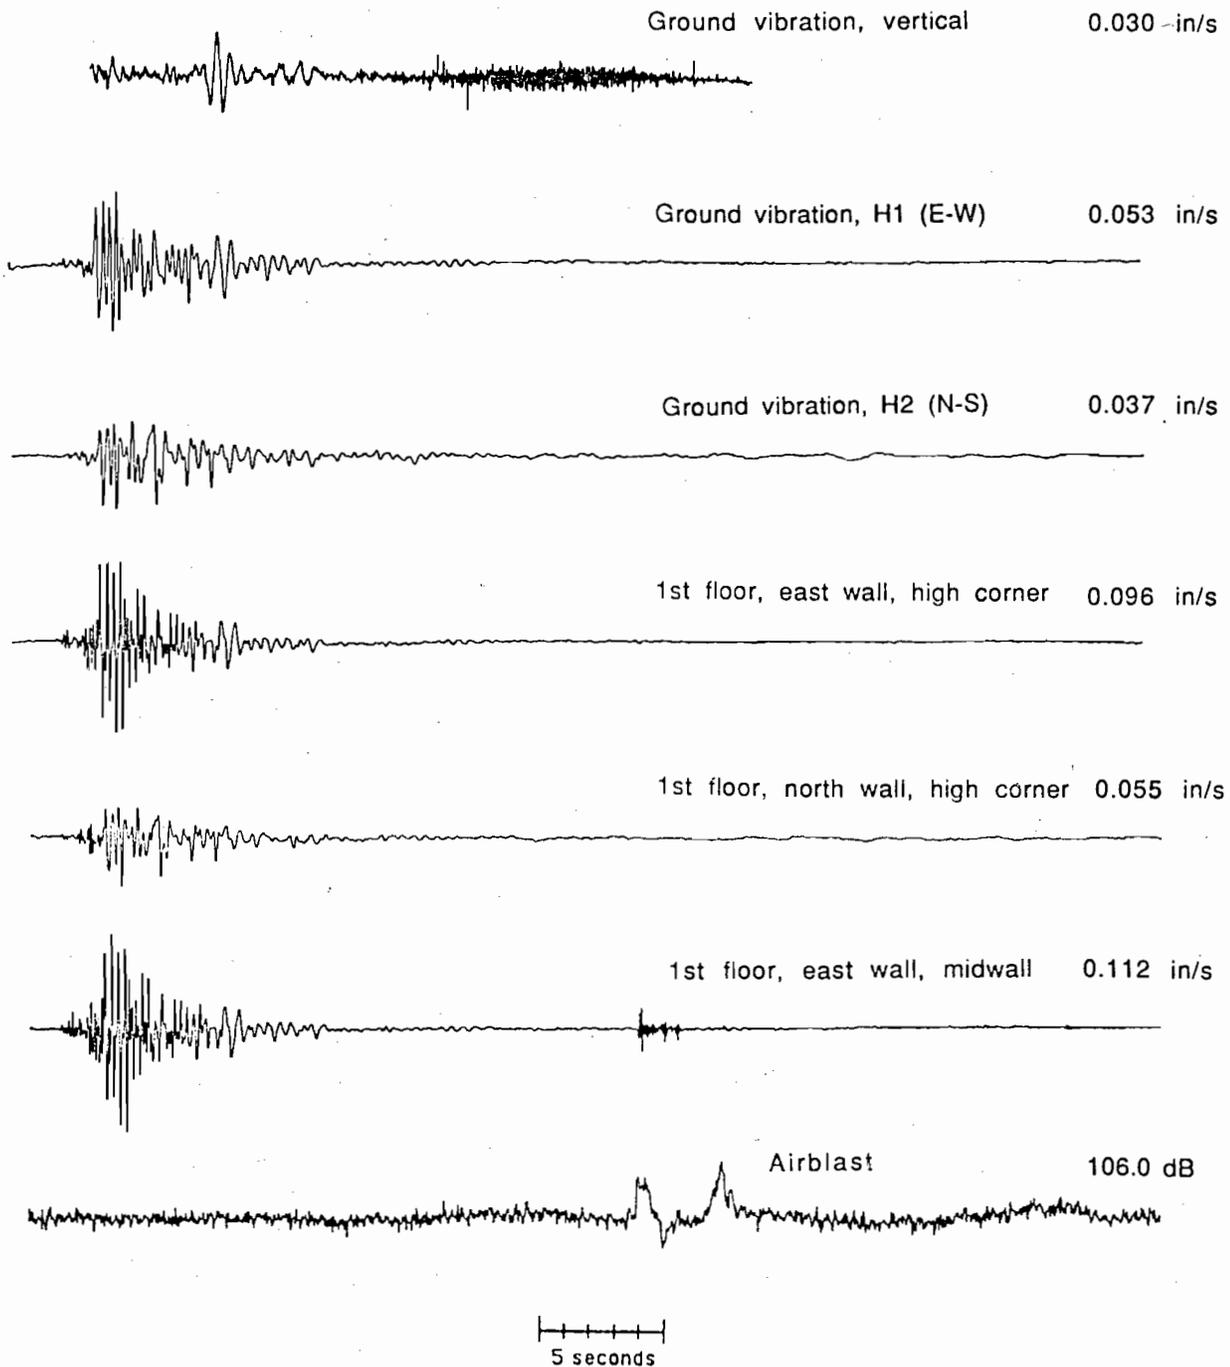
Bureau of Mines Monitoring, House 209  
Shot #25, 11/22/89 at 11:16 am  
Distance from shot = 24,306 ft  
Reported charge weight per delay period = 6.225 lbs

Figure 15. - Ground vibrations, structure response and airblast overpressure time-histories at house 209 for shot #25.

The ground vibrations at house 209 (figure 15), located in McCutchanville at a distance of 4.6 miles from the blast, last perhaps twice as long, or more, than those observed at house 105 in Daylight, about 2 miles from the blast. Peak amplitudes are about half at house 209 compared to house 105, but dominant ground motion is now located on the horizontal components (H1 and H2) and not associated with the Rayleigh-wave phase as before. The peak vertical ground motion at house 209, which is mimicked in the H1 component, is probably Rayleigh-wave vibration. Also, the character of the early portion of the H1 component at house 209 is very similar to the Love-wave phase identified on the H2 component at house 105. Perhaps the Love wave travels more efficiently than the Rayleigh wave and its motion is being recorded more on the H1 than the H2 component because of the large orientation angle of 39 degrees between the H1 direction and the shot. Additional studies, designed to specifically look at surface wave generation and propagation are needed in order to better understand these observations from a seismological standpoint.

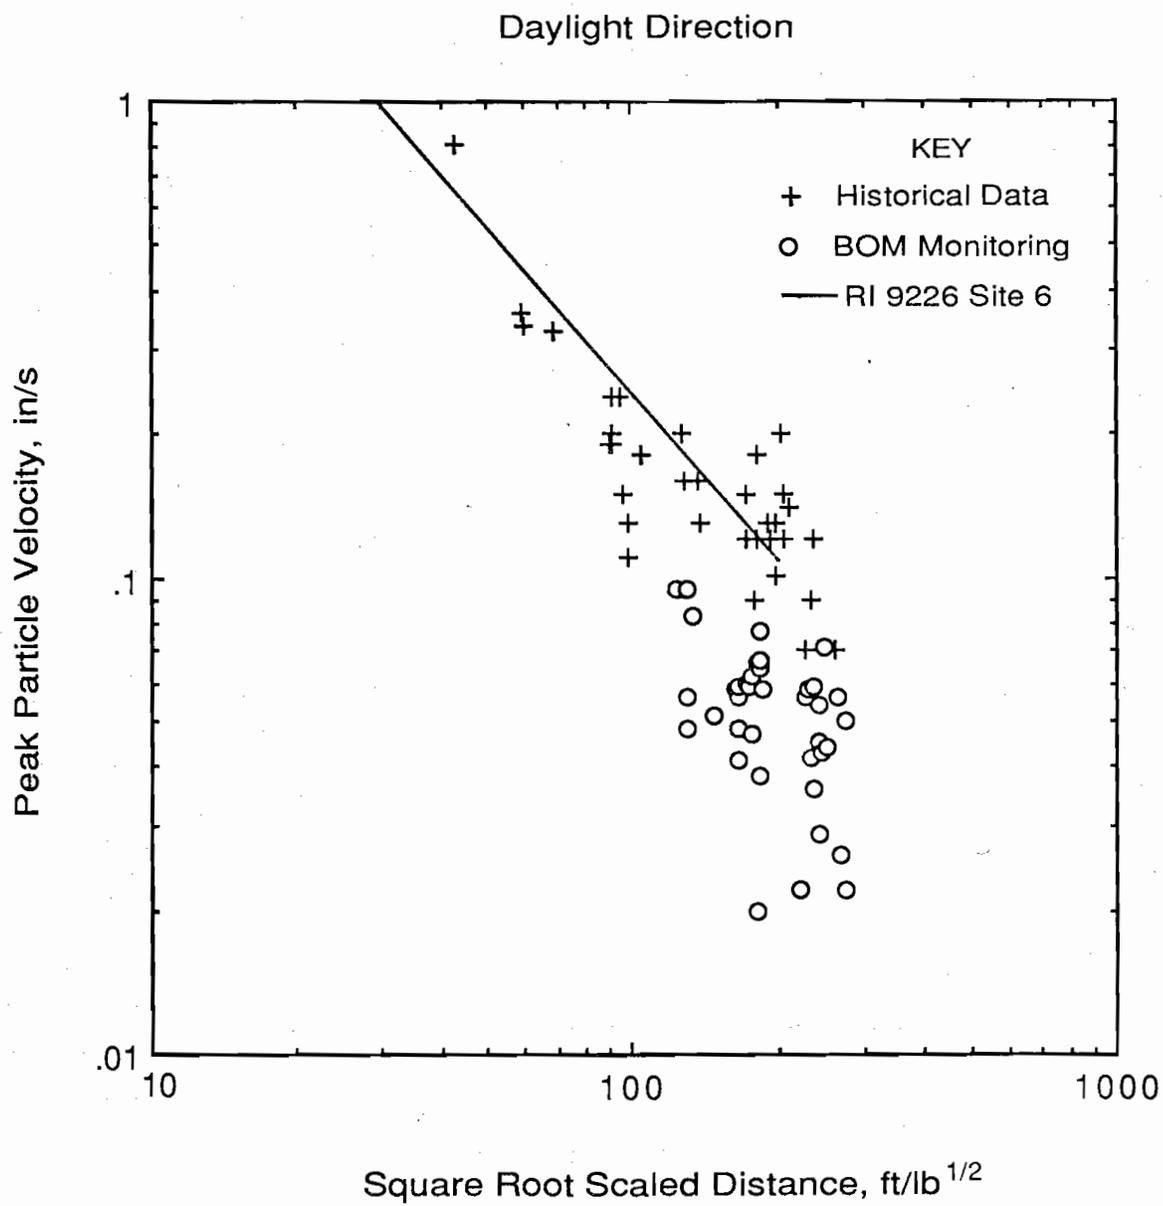
Figure 17. - Historical and recent Bureau of Mines (BOM) peak particle velocity data in the Daylight (west) direction.

Figures 16 through 18 show the relation between square-root scaled distance and peak ground vibration particle velocity. This scaled distance is used so that the data presented can be easily compared to previously published Bureau of Mines research. The position of the recording stations are fixed so changes in the scaled distance arise from differing shot locations along the highwall and changes in the charge weight per delay used in the blast design. A peak value represents the highest amplitude particle velocity for all three components so that only one peak value is used from a station for a particular blast. Peak amplitudes were usually, but not always, horizontal components.
