**INVESTIGATION OF DAMAGE TO STRUCTURES  
IN THE McCUTCHANVILLE-DAYLIGHT  
AREA OF SOUTHWESTERN INDIANA**

Vibration Environment and Damage  
Characterization For Houses in  
McCutchanville and Daylight, Indiana.

# VIBRATION ENVIRONMENT AND DAMAGE CHARACTERIZATION FOR HOUSES IN McCUTCHANVILLE AND DAYLIGHT, INDIANA

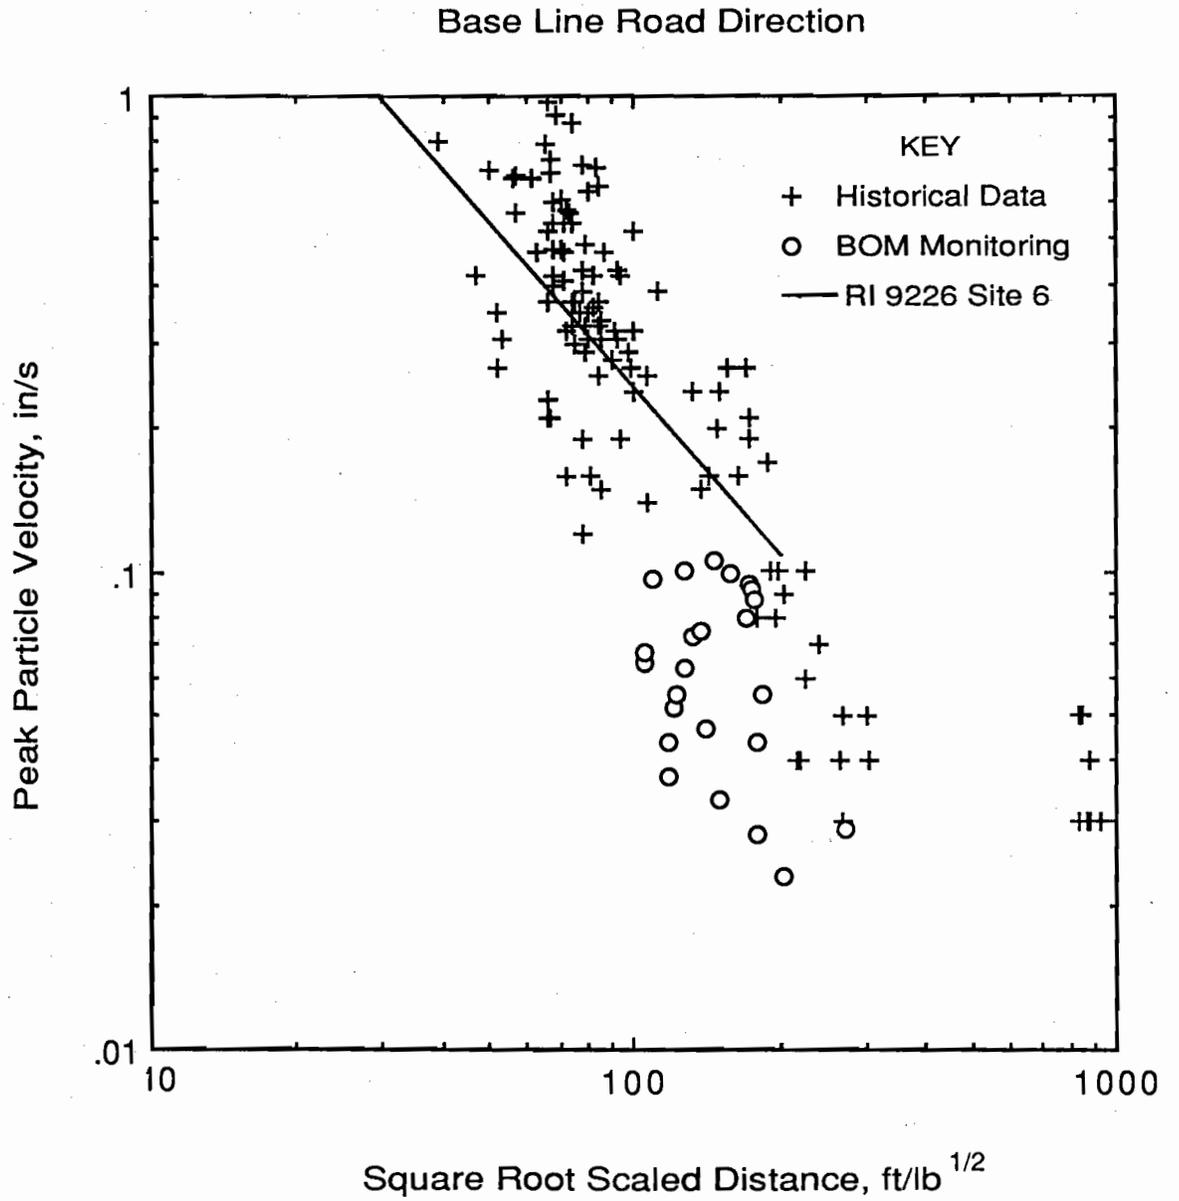
Figure 18. - Historical and recent Bureau of Mines (BOM) peak particle velocity data in the Base Line Road (northwest) direction.

The propagation plot for the Base Line Road direction, figure 18, indicates particle velocities that are somewhat higher than expected for the historical data as compared to the other two directions. Peak levels were observed from about 1 in/s at a scaled distance of approximately 65 ft/lb<sup>1/2</sup> to 0.03 in/s at a scaled distance of about 1000 ft/lb<sup>1/2</sup>. The series of crosses to the far right of the graph represent the Haubstadt School, about 10 miles away from the blasts. Peak particle velocities of 0.02 to .05 in/s recorded at this site are unusually high for such a large distance. Ground resonance near the characteristic frequency of the earth in this area may explain this unexpected occurrence.

The plot of the historical data in the Base Line Road direction suggests a different type of seismic propagation, relative to the Daylight and McCutchanville area, because of the higher peak levels observed at common scaled distances and because of the vibrations recorded at the Haubstadt School. The Base Line Road and McCutchanville plots have many of the same blasts in common or have a basically similar design, so differences in blast design do not appear responsible for the amplitude differences. In-depth blast design analysis was not part of the project so this conclusion is speculative. Again, the Bureau's recent measurements in the Base Line Road direction (house 334 only) are comparatively lower than the historical peaks, but contrary to the historical observations, are very similar to the peak values obtained in the McCutchanville area. Researchers do not believe that

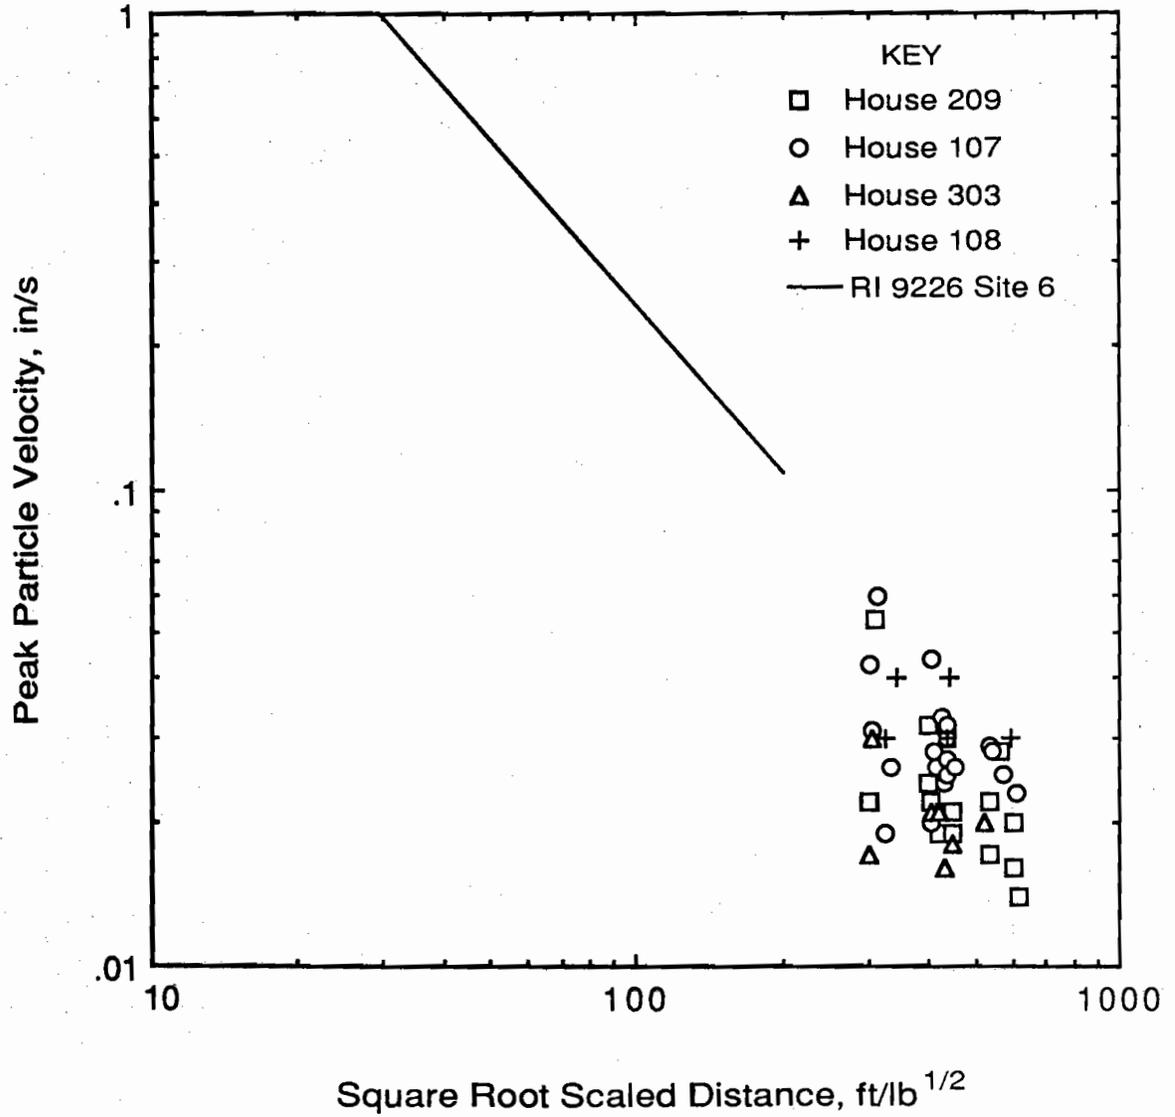
Bureau of Mines Monitoring, McCutchanville

Figure 19. - Recent Bureau of Mines peak particle velocity data for homes monitored in McCutchanville.

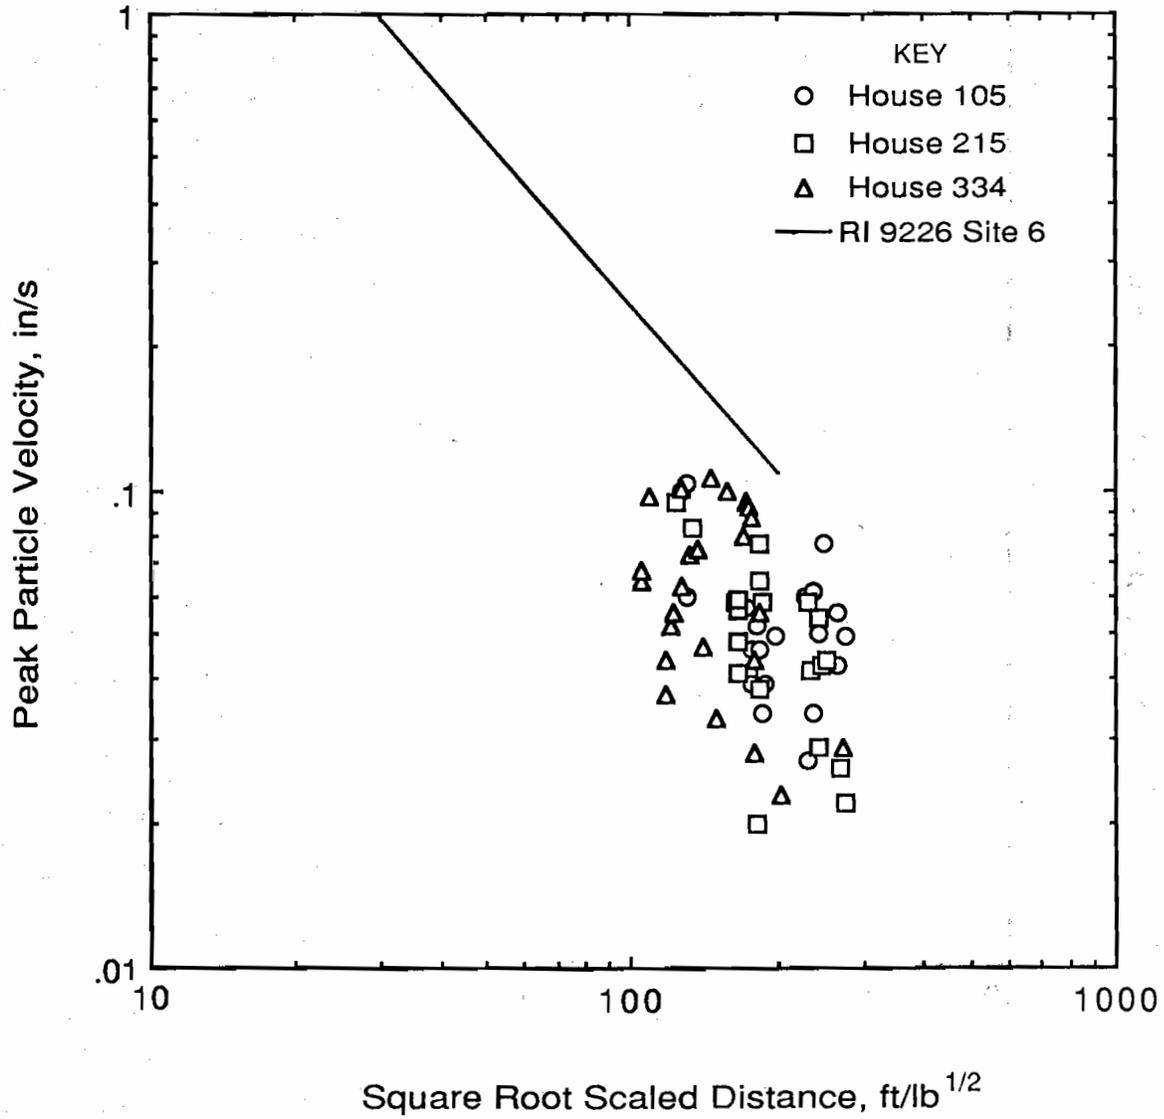
Bureau of Mines Monitoring, Daylight

Figure 20. - Recent Bureau of Mines peak particle velocity data for homes monitored in Daylight.

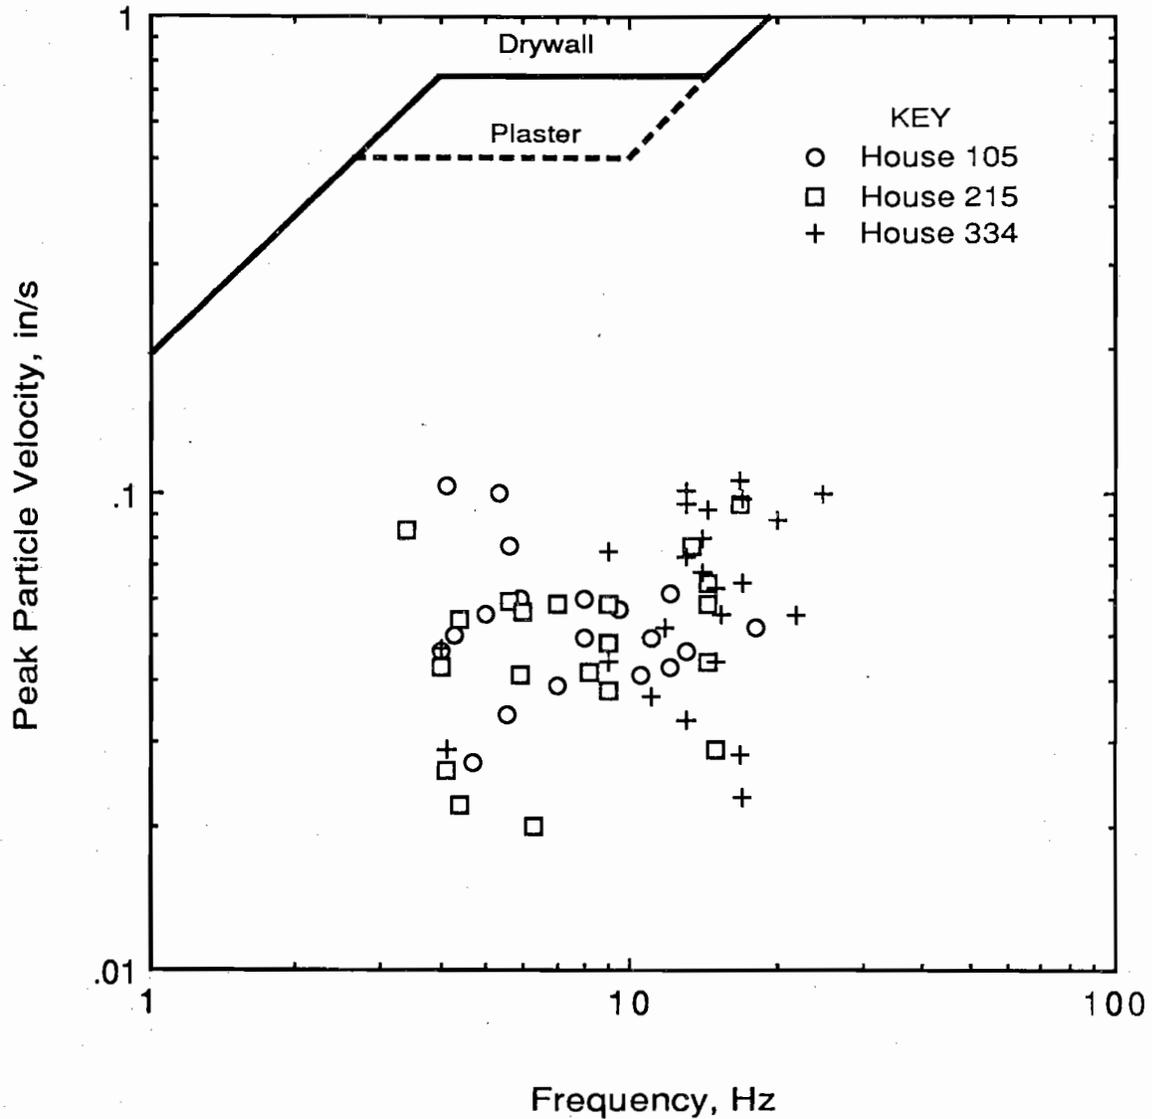
Bureau of Mines Monitoring, Daylight

Figure 22. - Peak particle velocity and associated frequency relations for recent Bureau of Mines monitoring in Daylight. The curve in the upper-right corner is from Appendix B of RI 8507 and represents the safe limits recommended by the Bureau of Mines (3).

Figures 21 and 22 depict frequency versus peak ground vibration particle velocity levels in McCutchanville and Daylight, respectively. The frequencies were obtained from the ground vibration time-histories and calculated as the inverse of the period (in seconds) of the corresponding peak velocity wavelet. The curve in the upper left-hand corner of each plot is the recommended Bureau of Mines limits from Appendix B in RI 8507 which relates threshold damage levels to frequency and peak ground vibration particle velocity (3). The ST 4 seismographs have a flat response from about 2 to 200 Hz and the tape recording systems from 1 to 5000 Hz for ground (and structure) vibration. No frequency data were available for house 108.

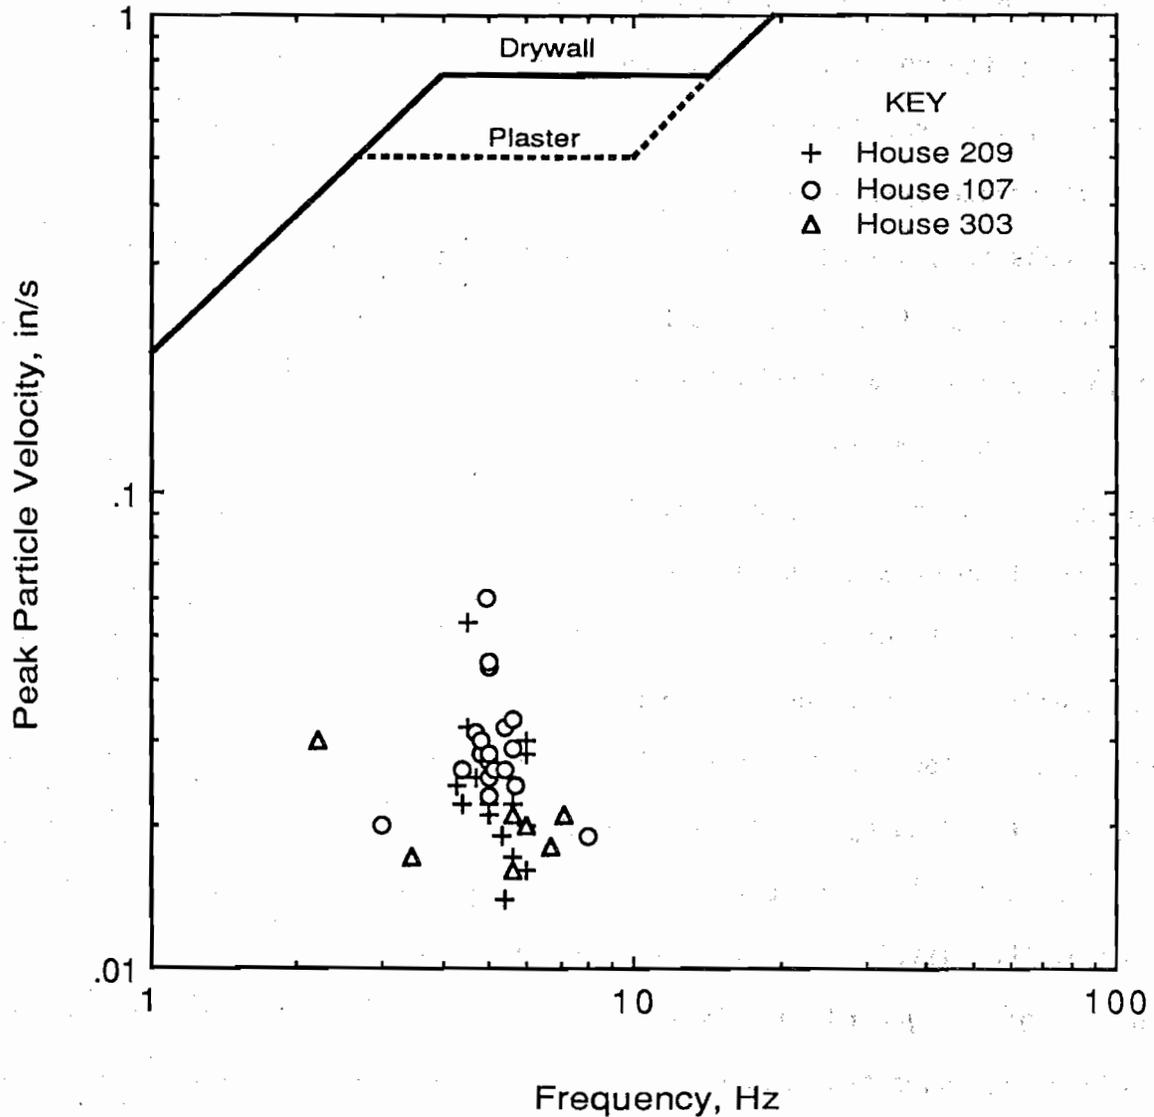
Bureau of Mines Monitoring, McCutchanville

Figure 21. - Peak particle velocity and associated frequency relations for recent Bureau of Mines monitoring in McCutchanville. The curve in the upper-right corner is from Appendix B of RI 8507 and represents the safe limits recommended by the Bureau of Mines (3).

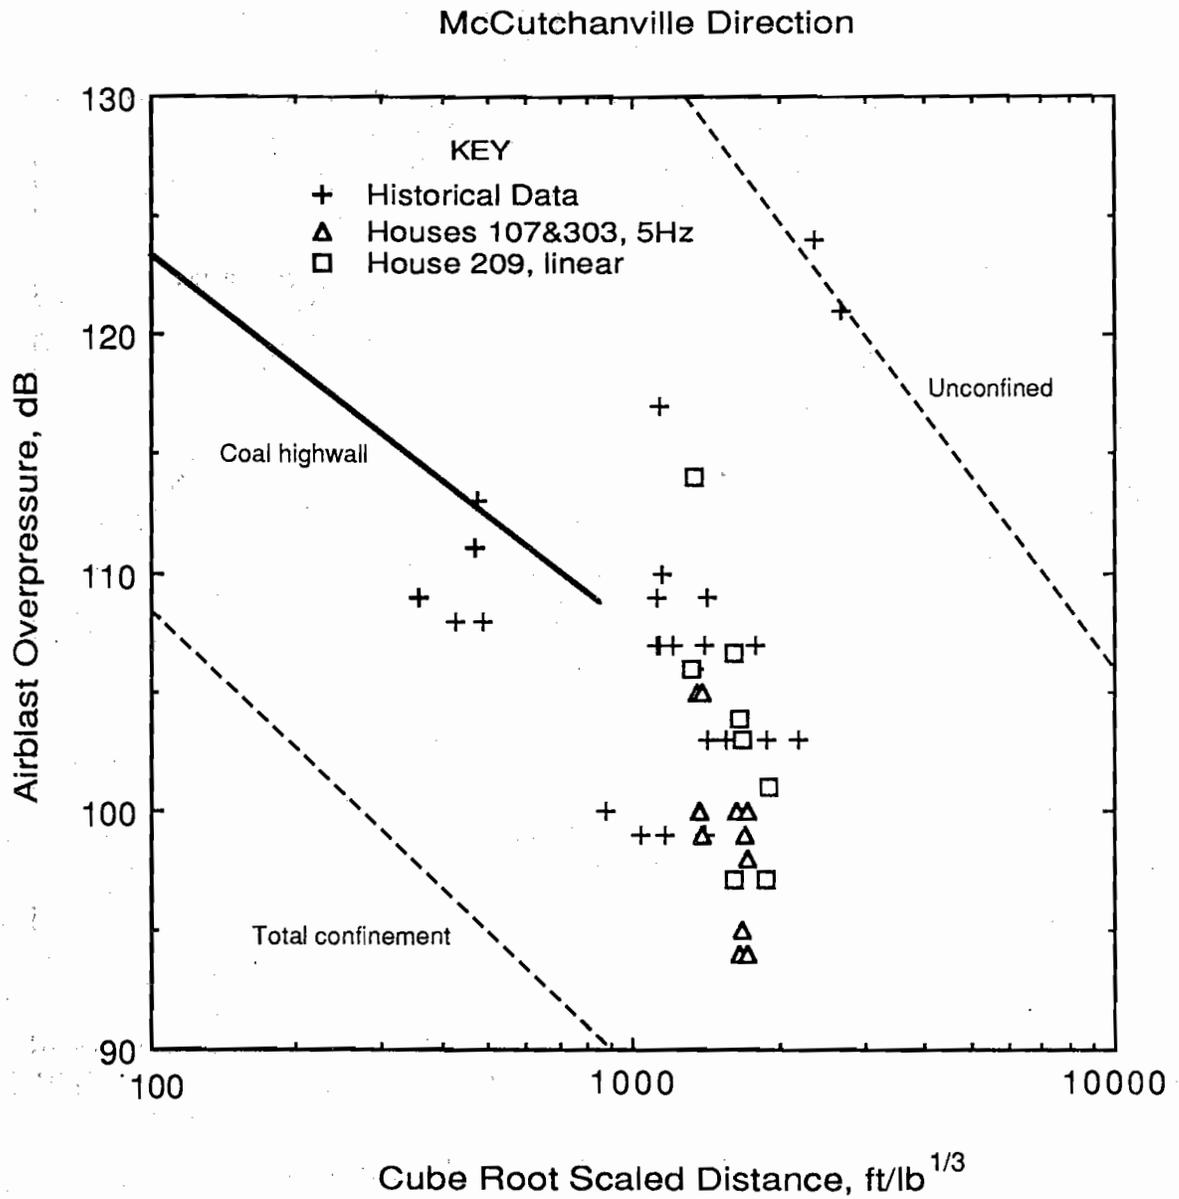
Figure 23. - Historical and recent Bureau of Mines airblast overpressures for the McCutchanville (southwest) direction. Reference lines and explanations about the plot key are discussed in the text.

Historical data and Bureau of Mines monitoring of airblast overpressure recorded in the McCutchanville direction are given in figure 23 and in the Daylight direction in figure 24. Airblast data correspond to the same group of blasts used in the previous ground-vibrations analysis (see figures 33 and 34 and discussion thereof), with house 334 included in the Daylight group

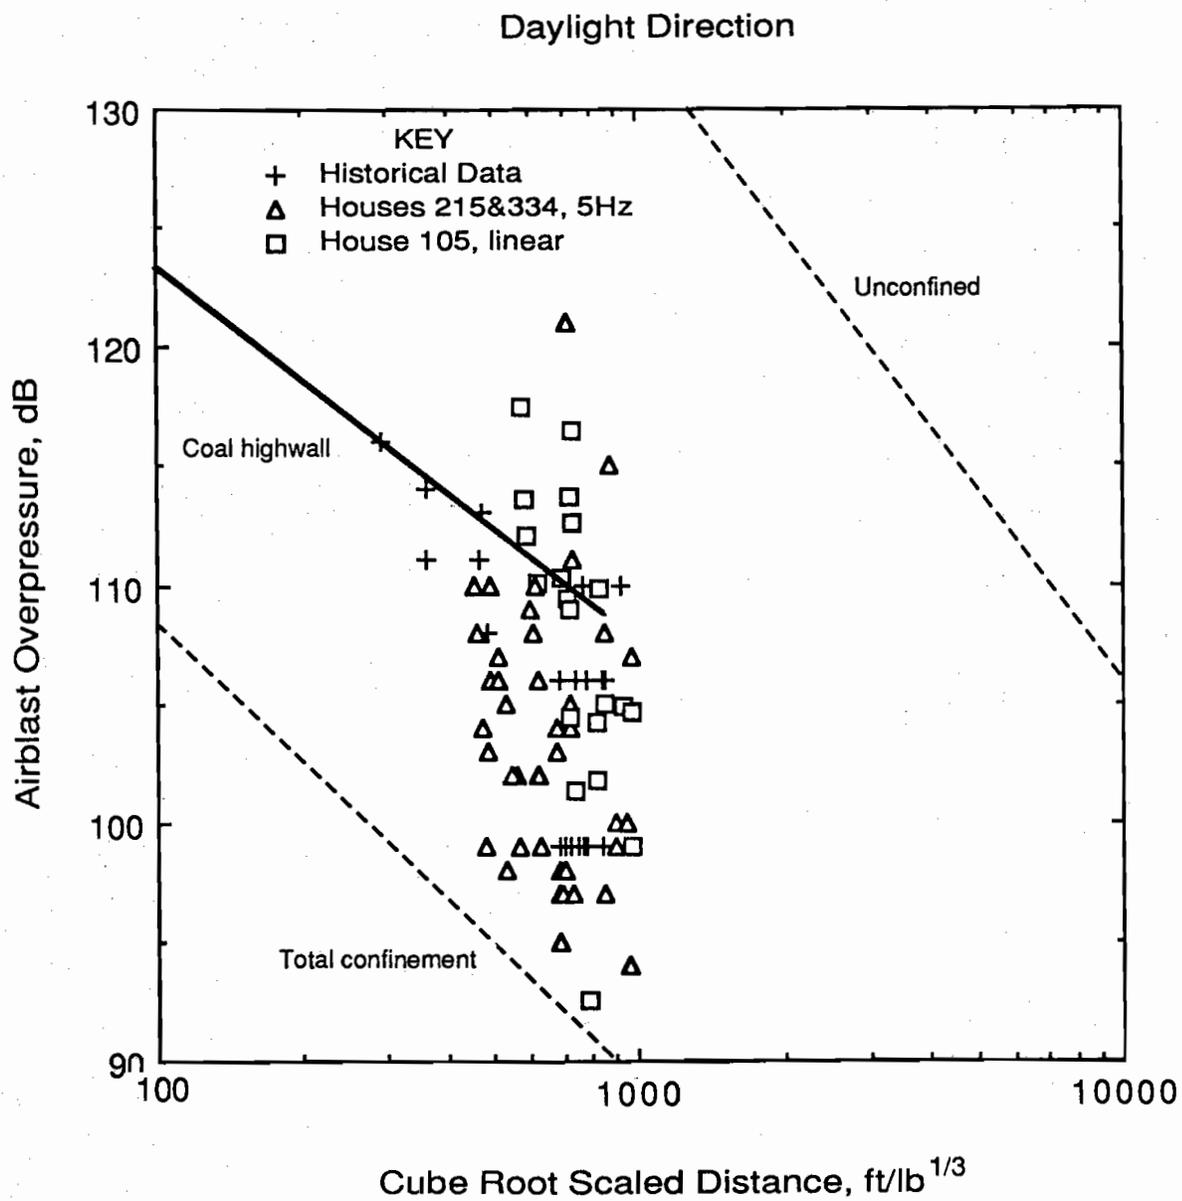
Figure 24. - Historical and recent Bureau of Mines airblast overpressures for the Daylight (west) direction. Reference lines and explanations about the plot key are discussed in the text.

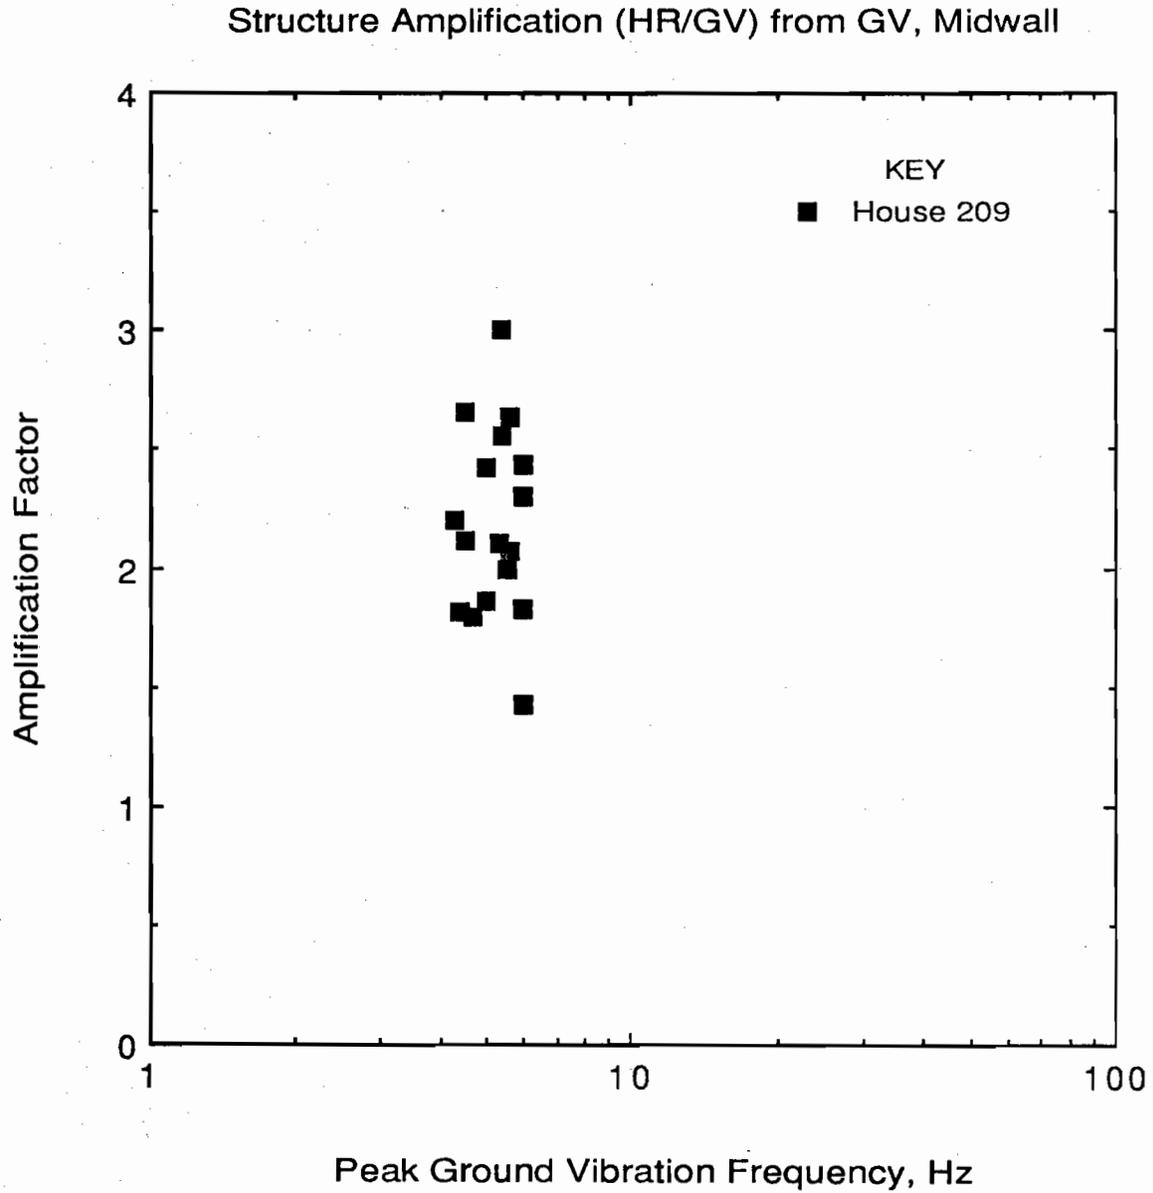
Figure 26. - Amplification factors for blast-produced midwall response for house 209.

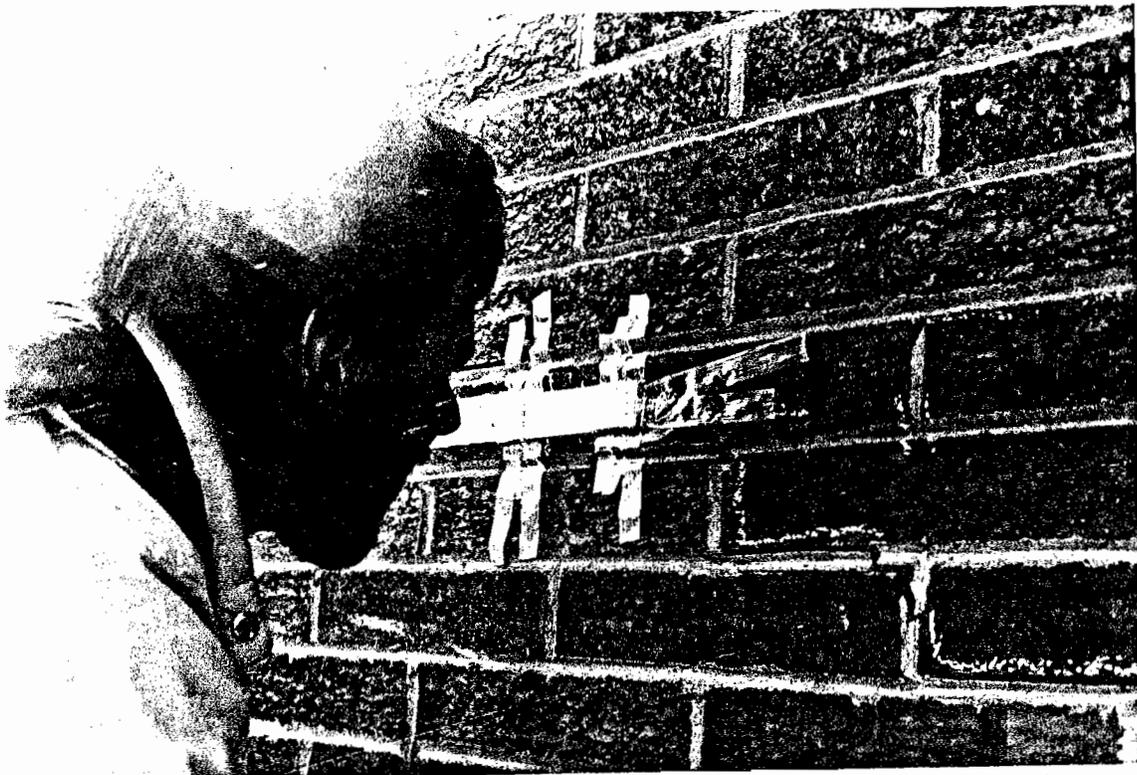
Figure 27. - Displacement gauge placed across a residential crack in house 108 prior to the Bureau's study.

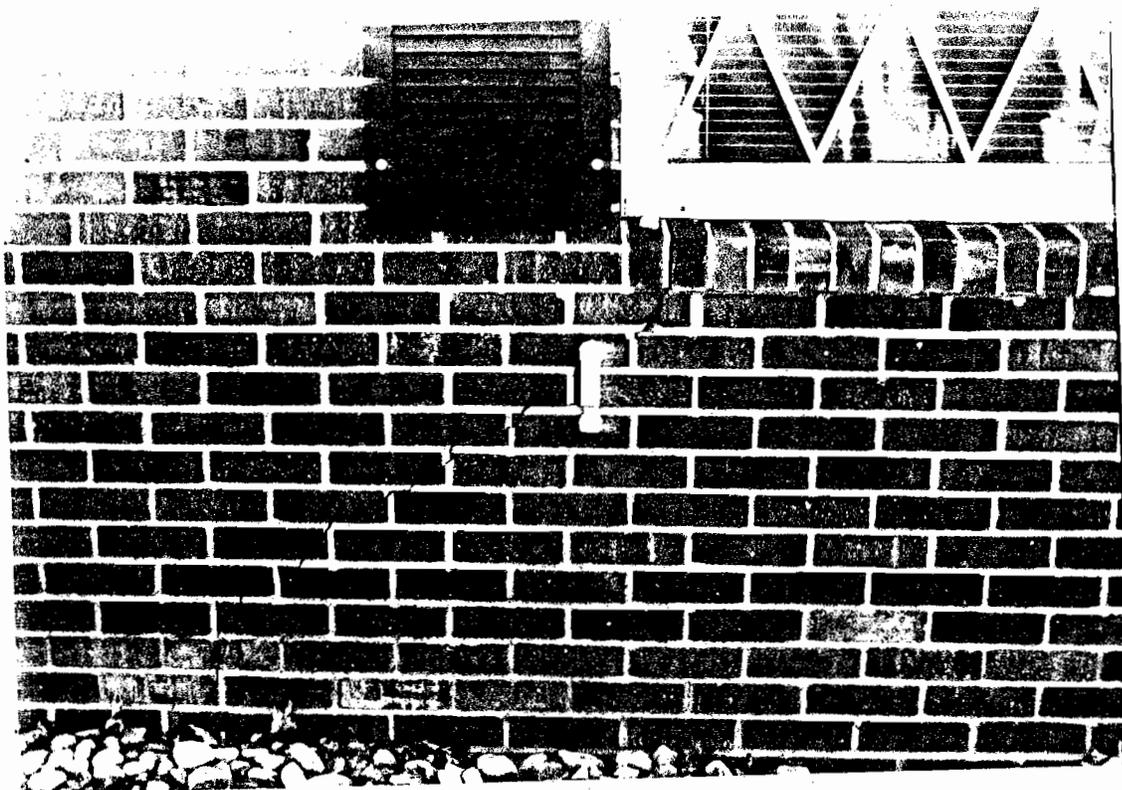
Figure 28. - Displacement gauge across a crack beneath a window of house 201.

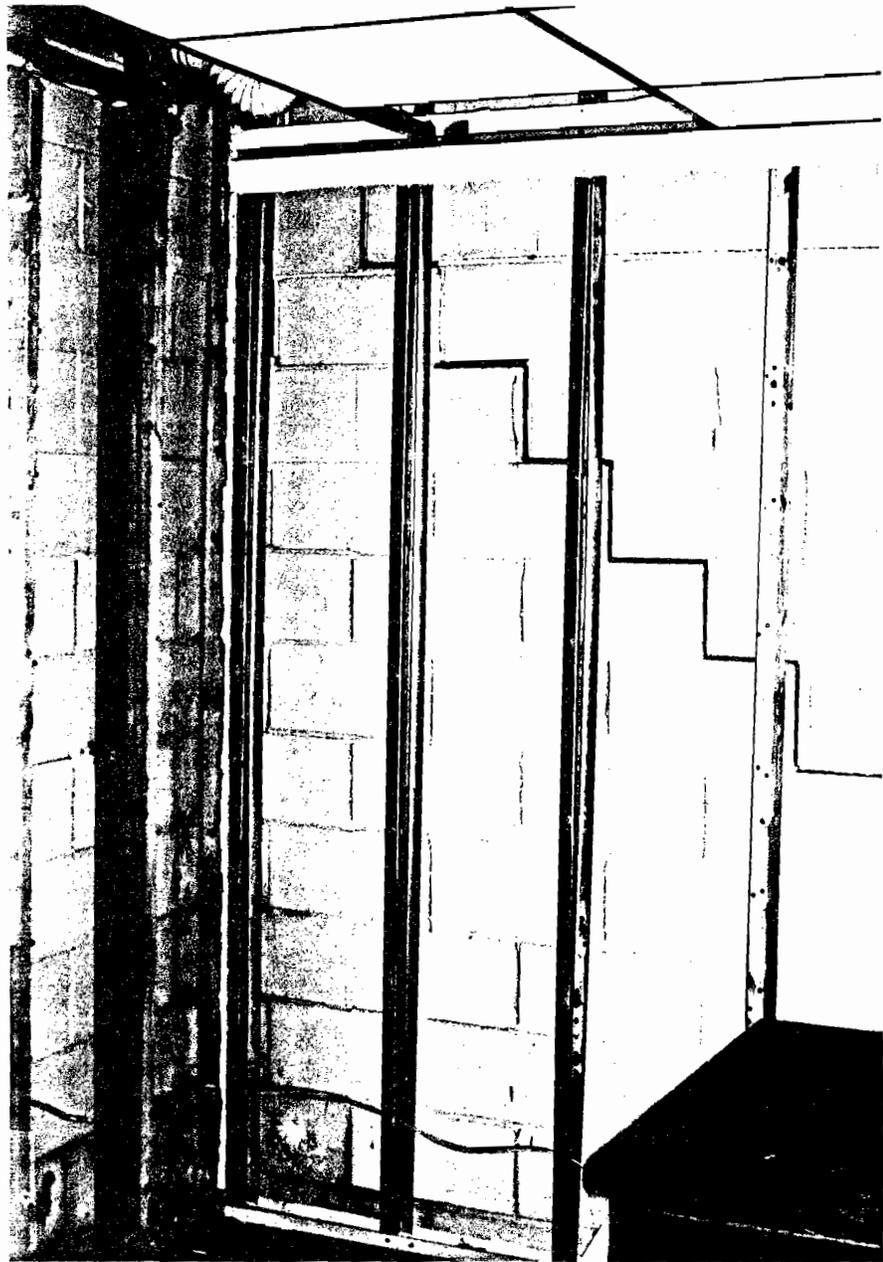
Figure 29. - Basement block wall crack on east wall of house 201.

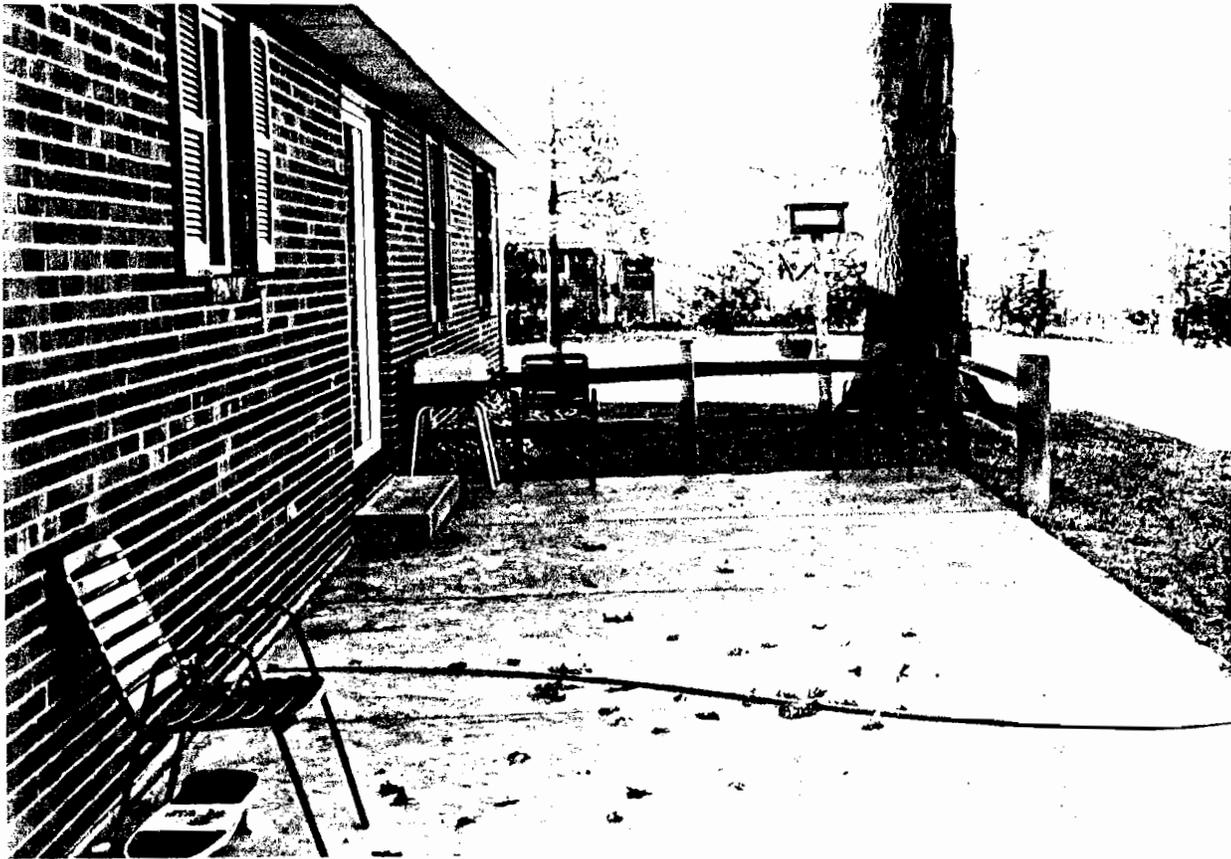
Figure 30. - Uncovered patio at house 201 with perceptible tilt toward house's north wall.

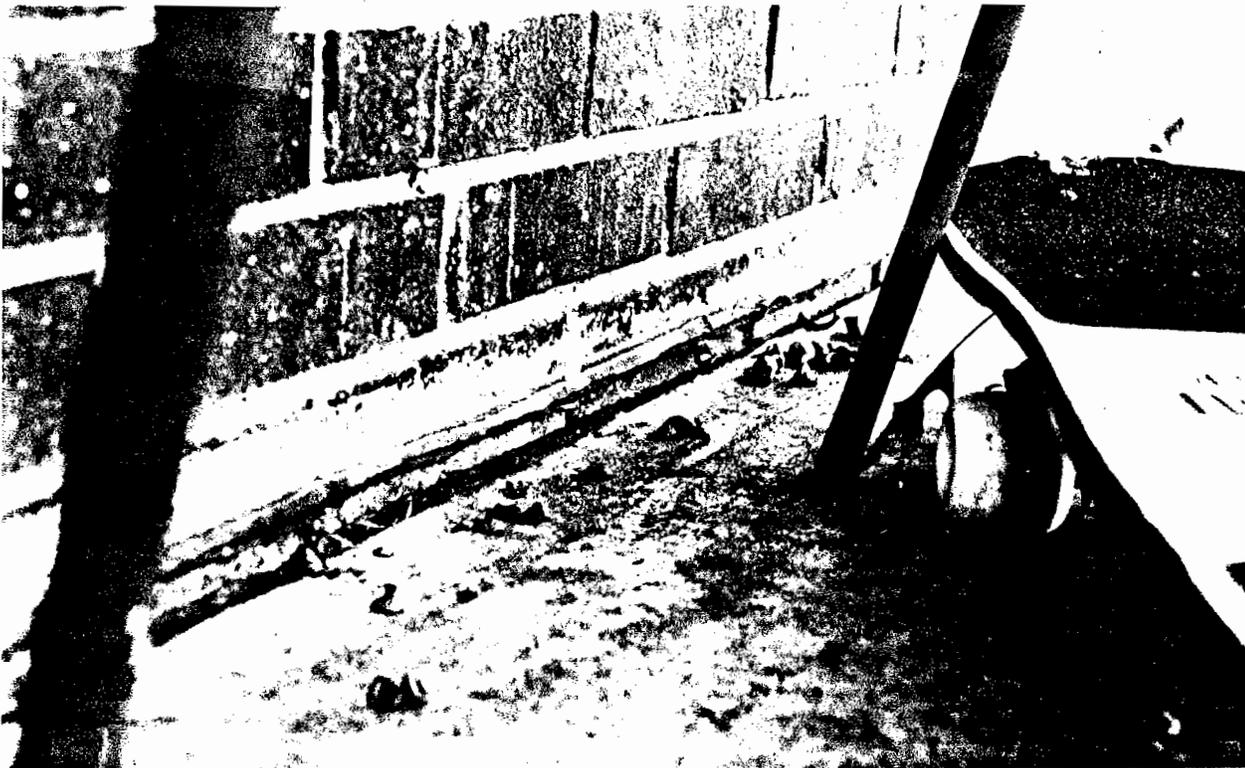
Figure 31. - Junction of north wall and patio of house 201 showing evidence of settlement.

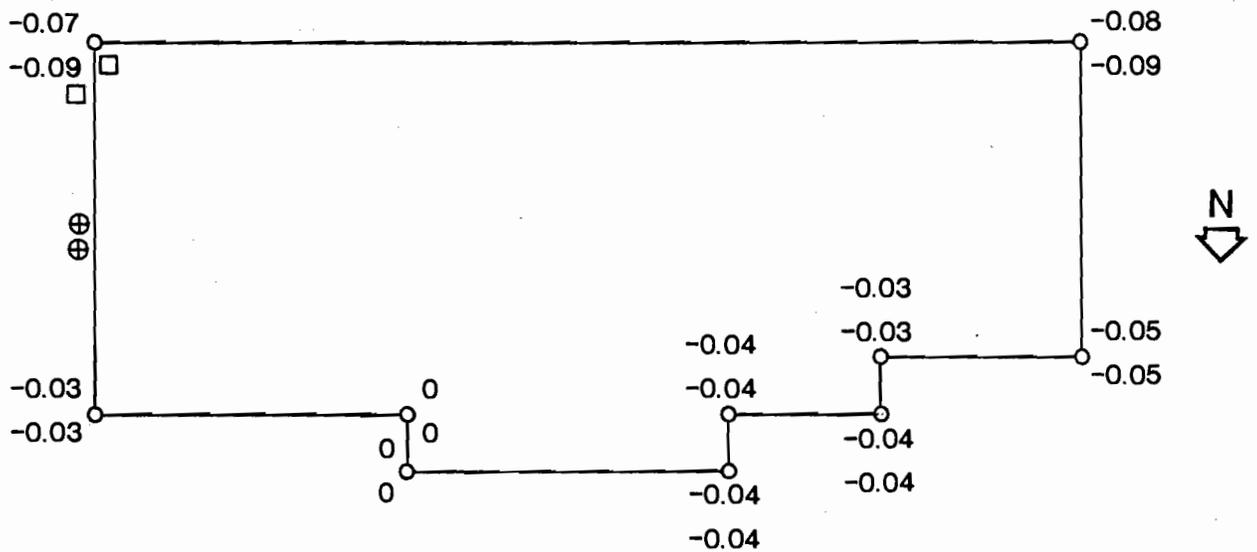
Figure 32. - House 105 and level loop surveys.

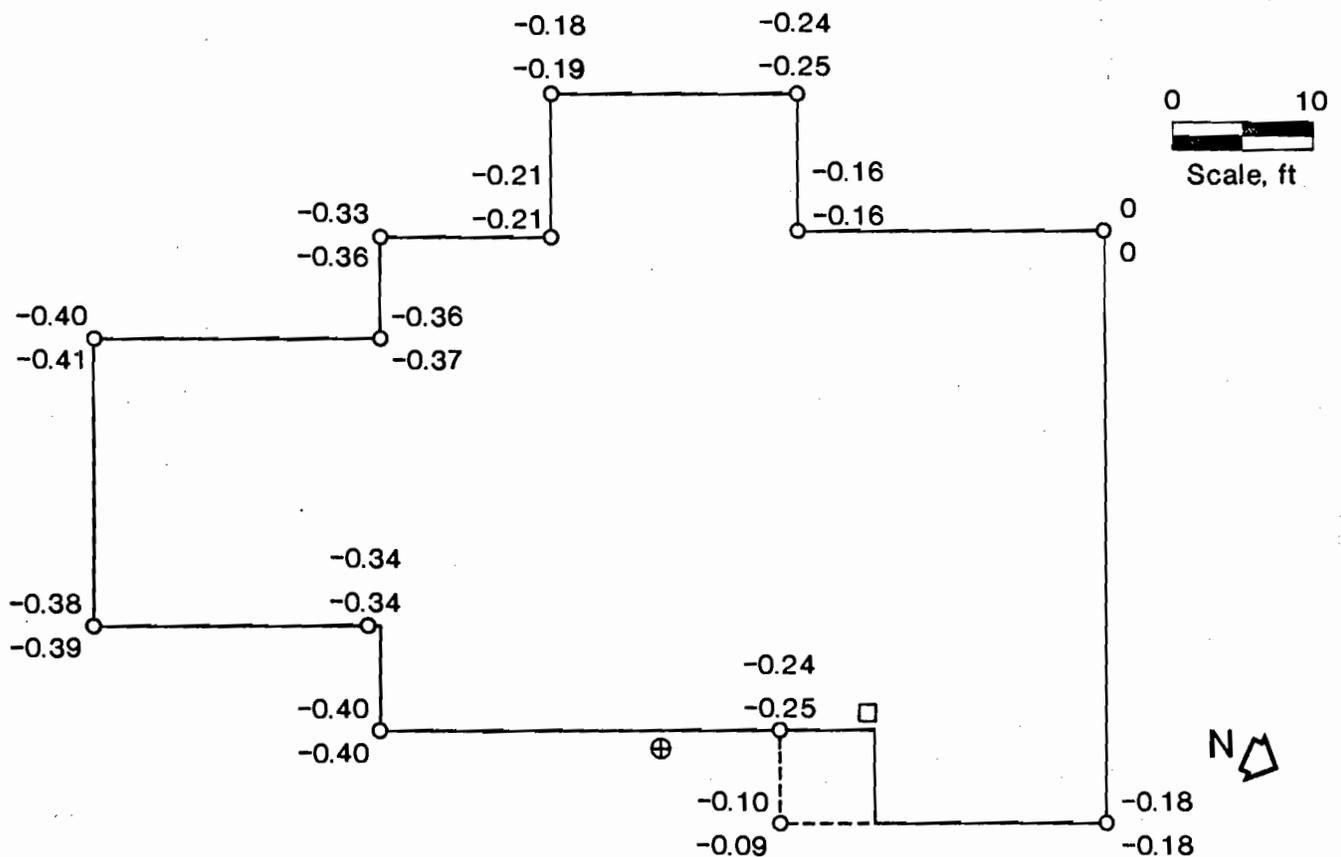
Top number is survey of October 1989  
 Bottom number is survey of January 1990  
 All elevations are in feet  
 Transducer: Vibration □  
 Transducer: Airblast ⊕

Figure 33. - House 107 and level loop surveys.

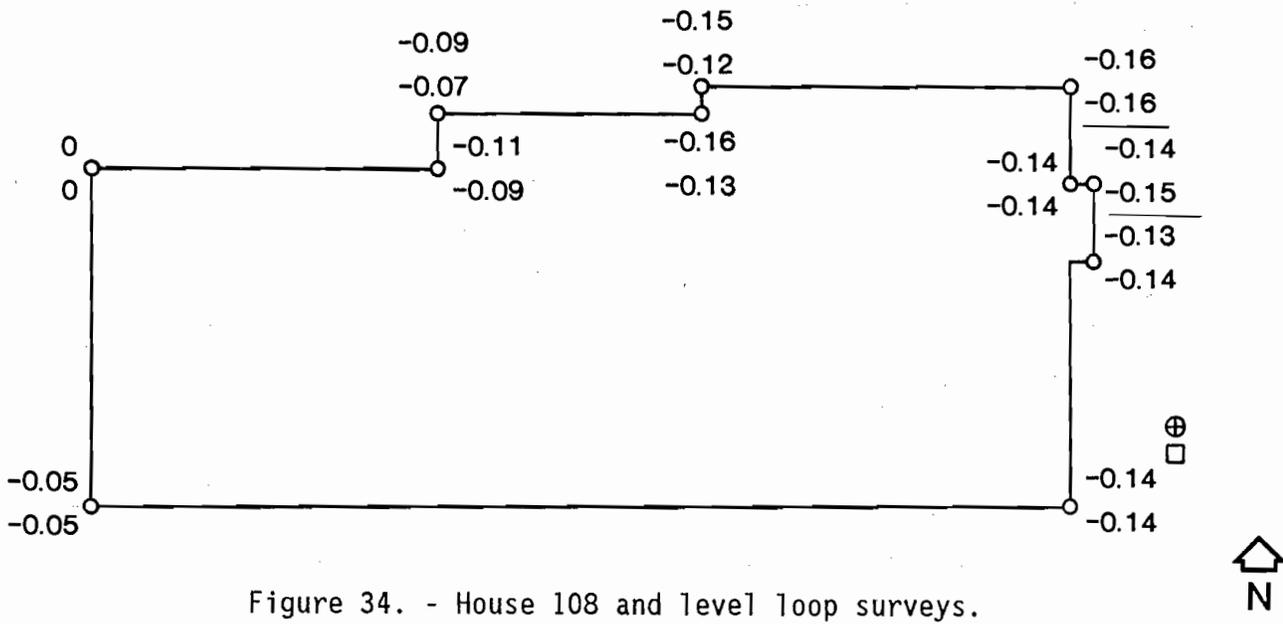
Figure 34. - House 108 and level loop surveys.

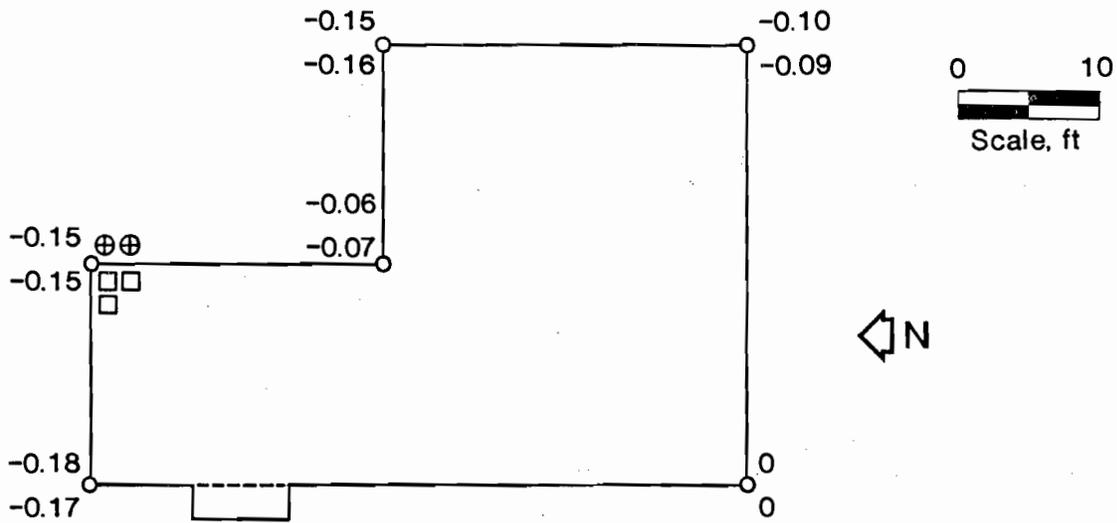
Top number is survey of October 1989  
 Bottom number is survey of January 1990  
 All elevations are in feet  
 Transducer: Vibration □  
 Airblast ⊕

Figure 35. - House 209 and level loop surveys.

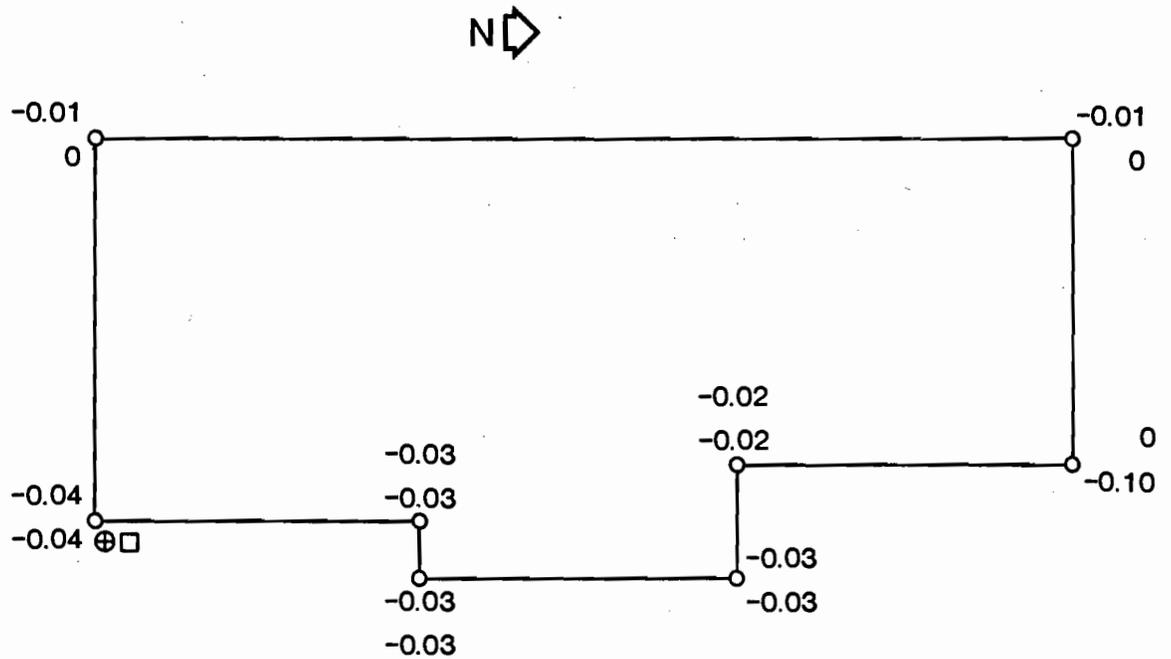
Figure 36. - House 215 and level loop surveys.

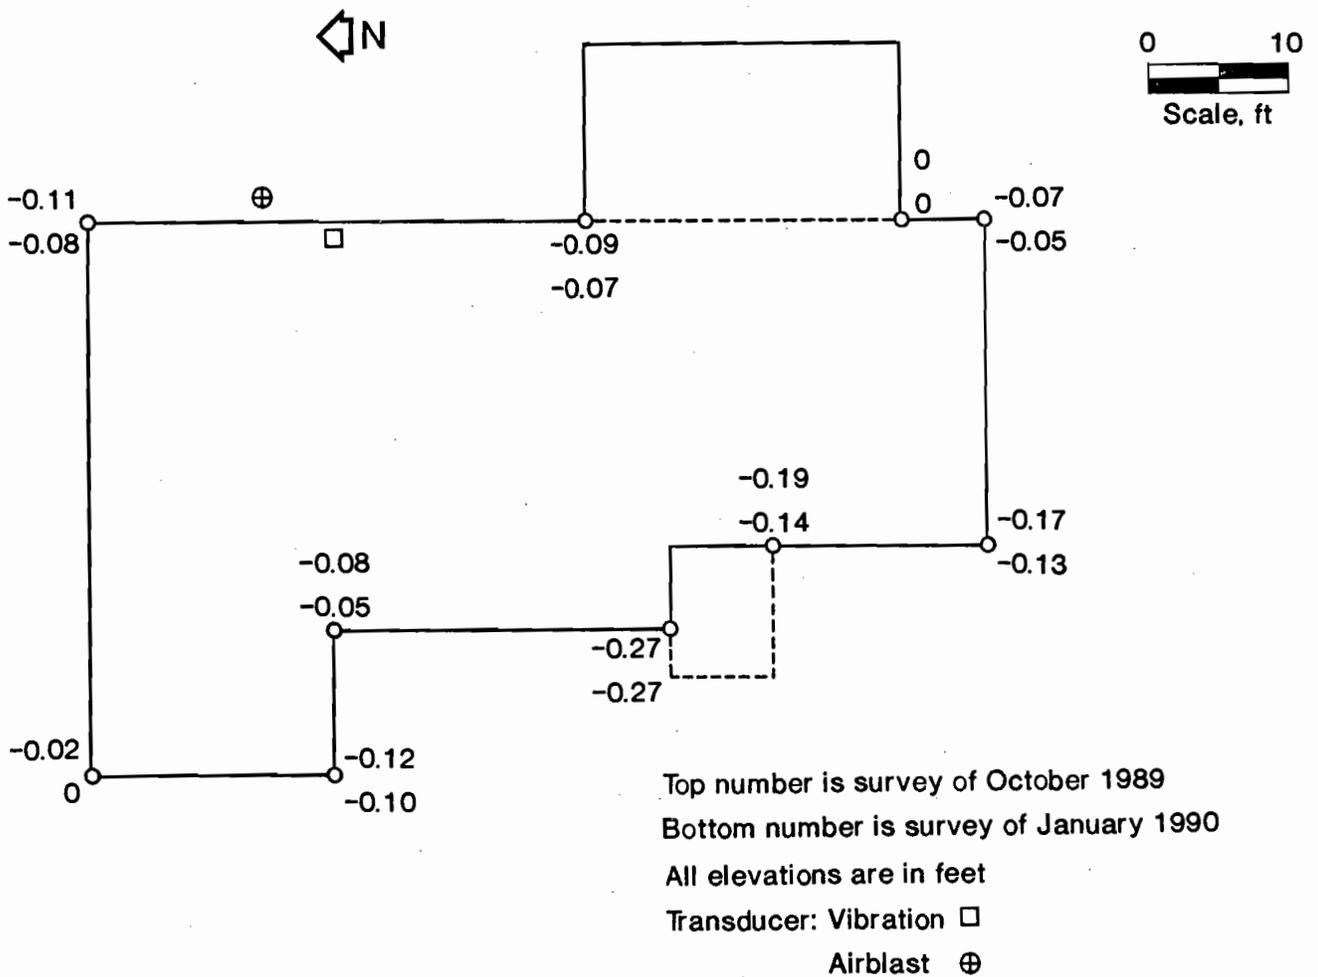
Figure 37. - House 303 and level loop surveys.
