**INVESTIGATION OF DAMAGE TO STRUCTURES  
IN THE McCUTCHANVILLE-DAYLIGHT  
AREA OF SOUTHWESTERN INDIANA**

Vibration Environment and Damage  
Characterization For Houses in  
McCutchanville and Daylight, Indiana.

# VIBRATION ENVIRONMENT AND DAMAGE CHARACTERIZATION FOR HOUSES IN McCUTCHANVILLE AND DAYLIGHT, INDIANA

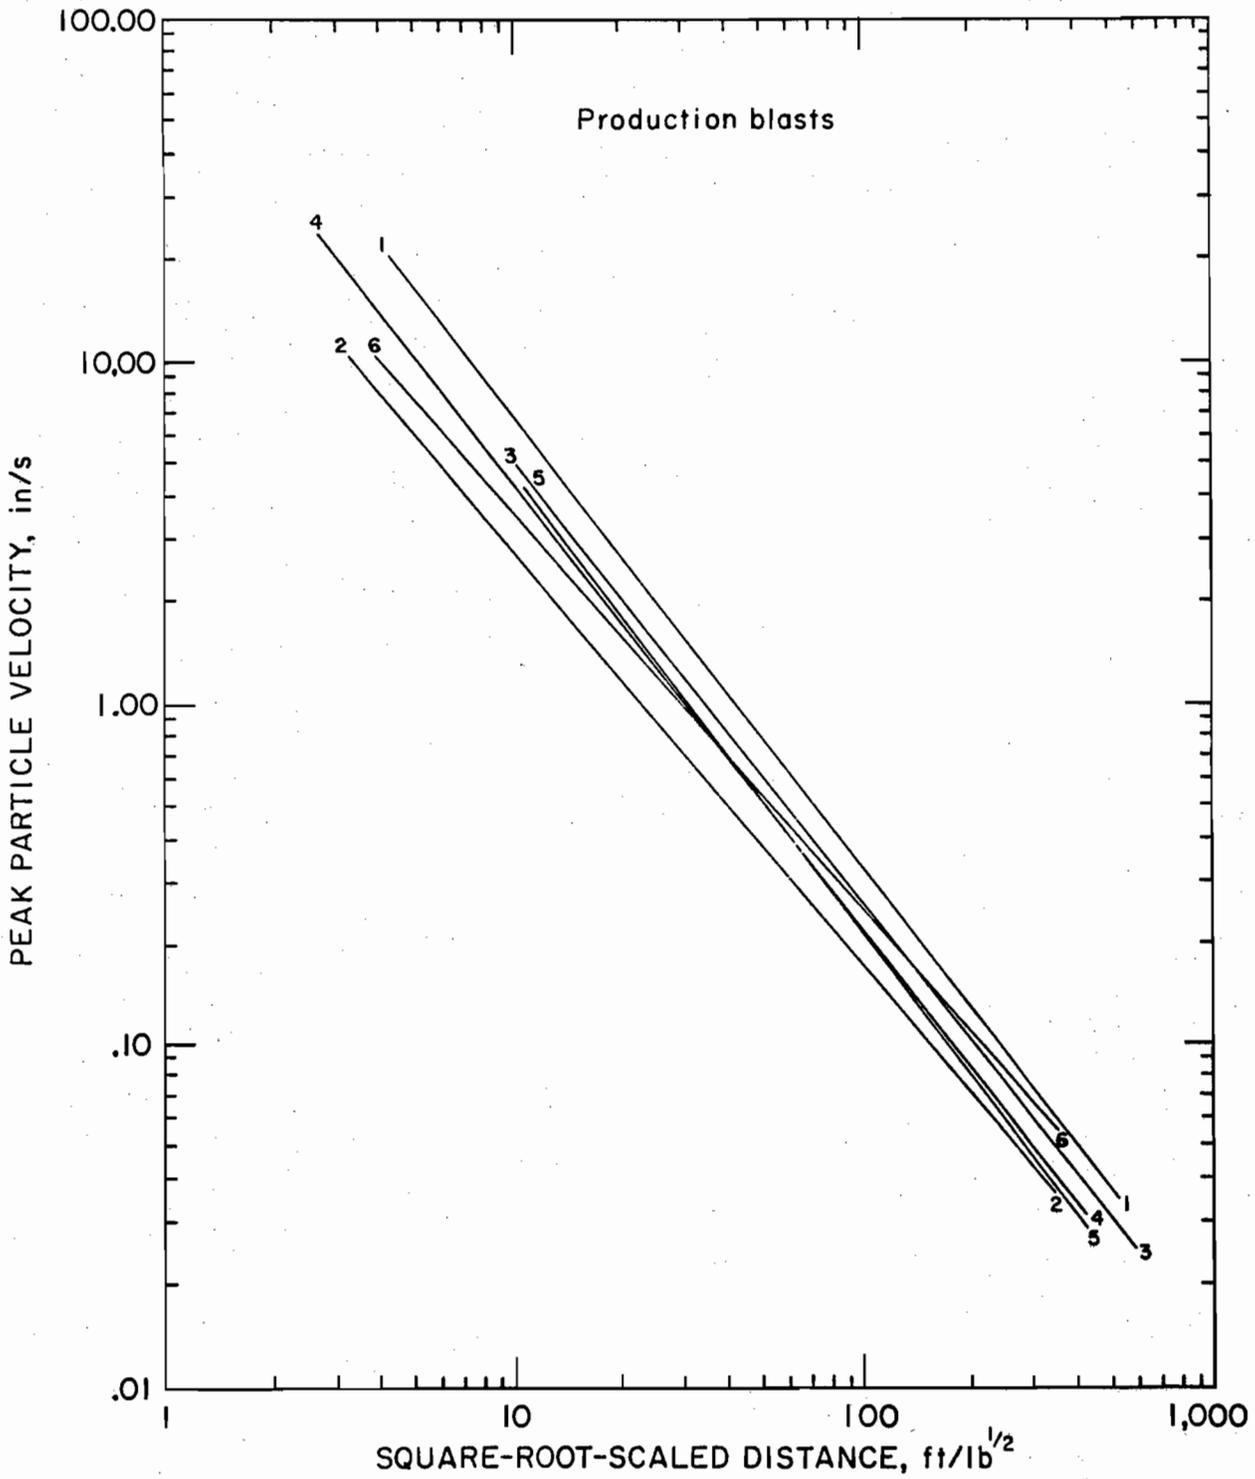
Figure A-1. - Propagation plot regressions for production blasts for six Indiana coal mines monitored by the Bureau of Mines, from Bureau of Mines RI 9226 (7).

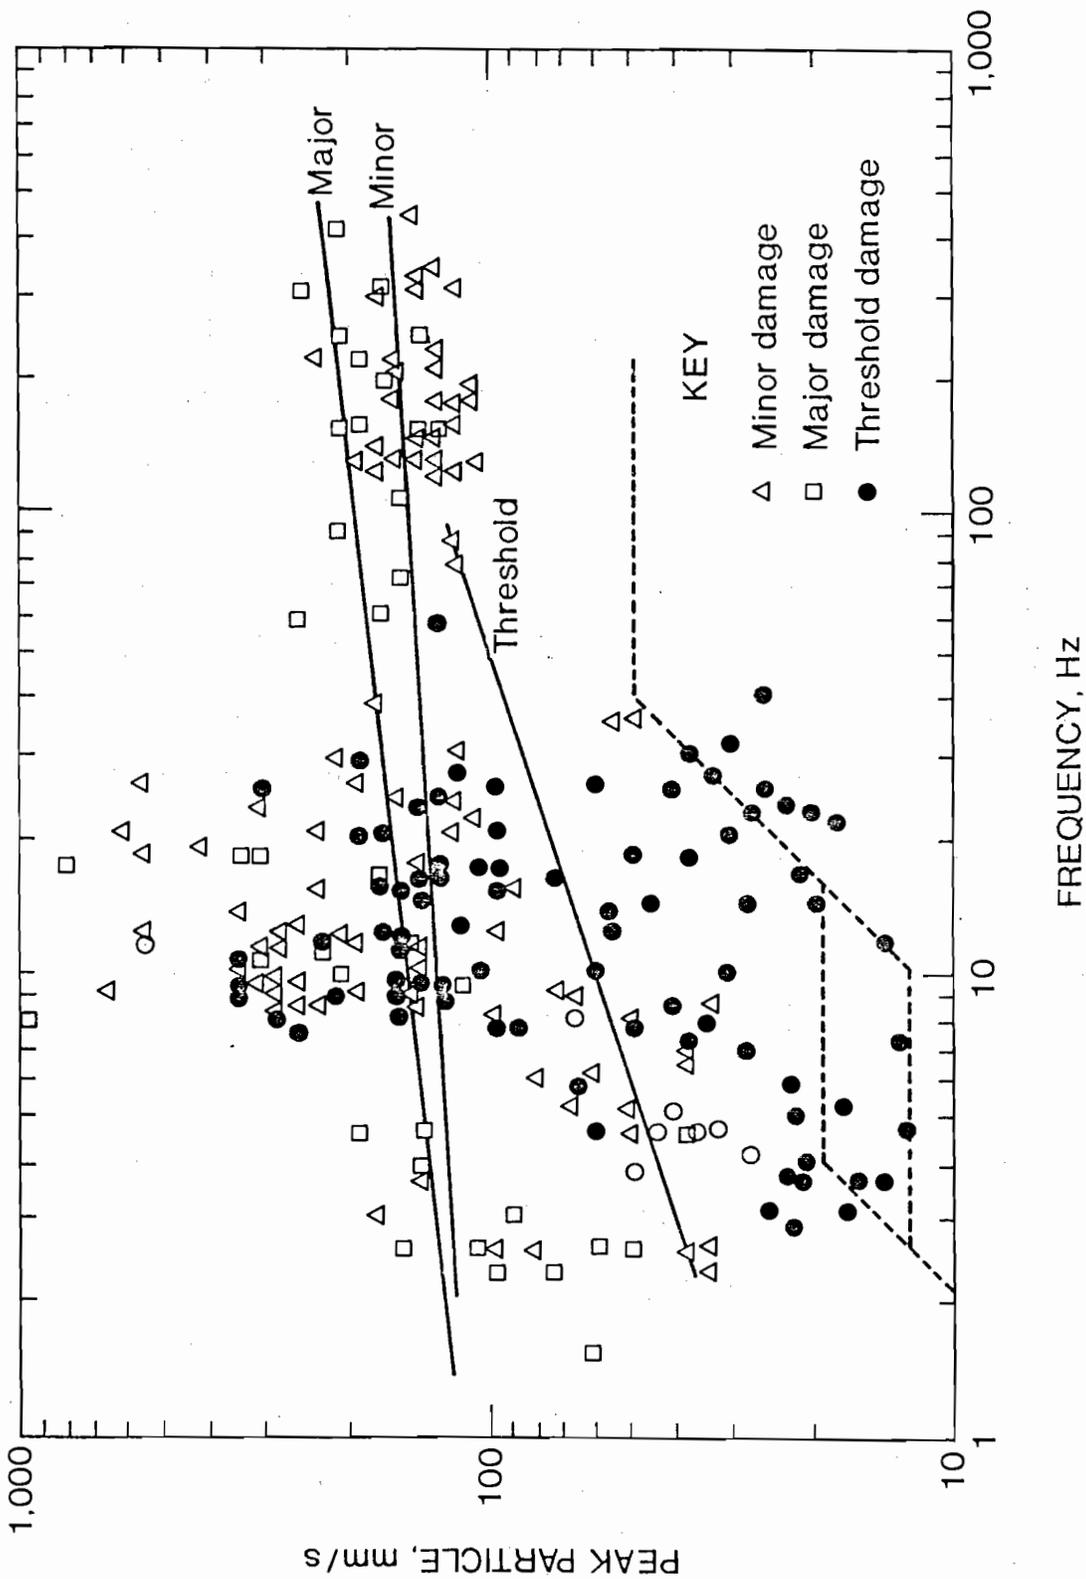
Figure A-2. - Vibration damage summary from Bureau of Mines RI 8507 (3). Envelope defining safe level limits uses a combination of velocity and displacement from Appendix B of RI 8507.

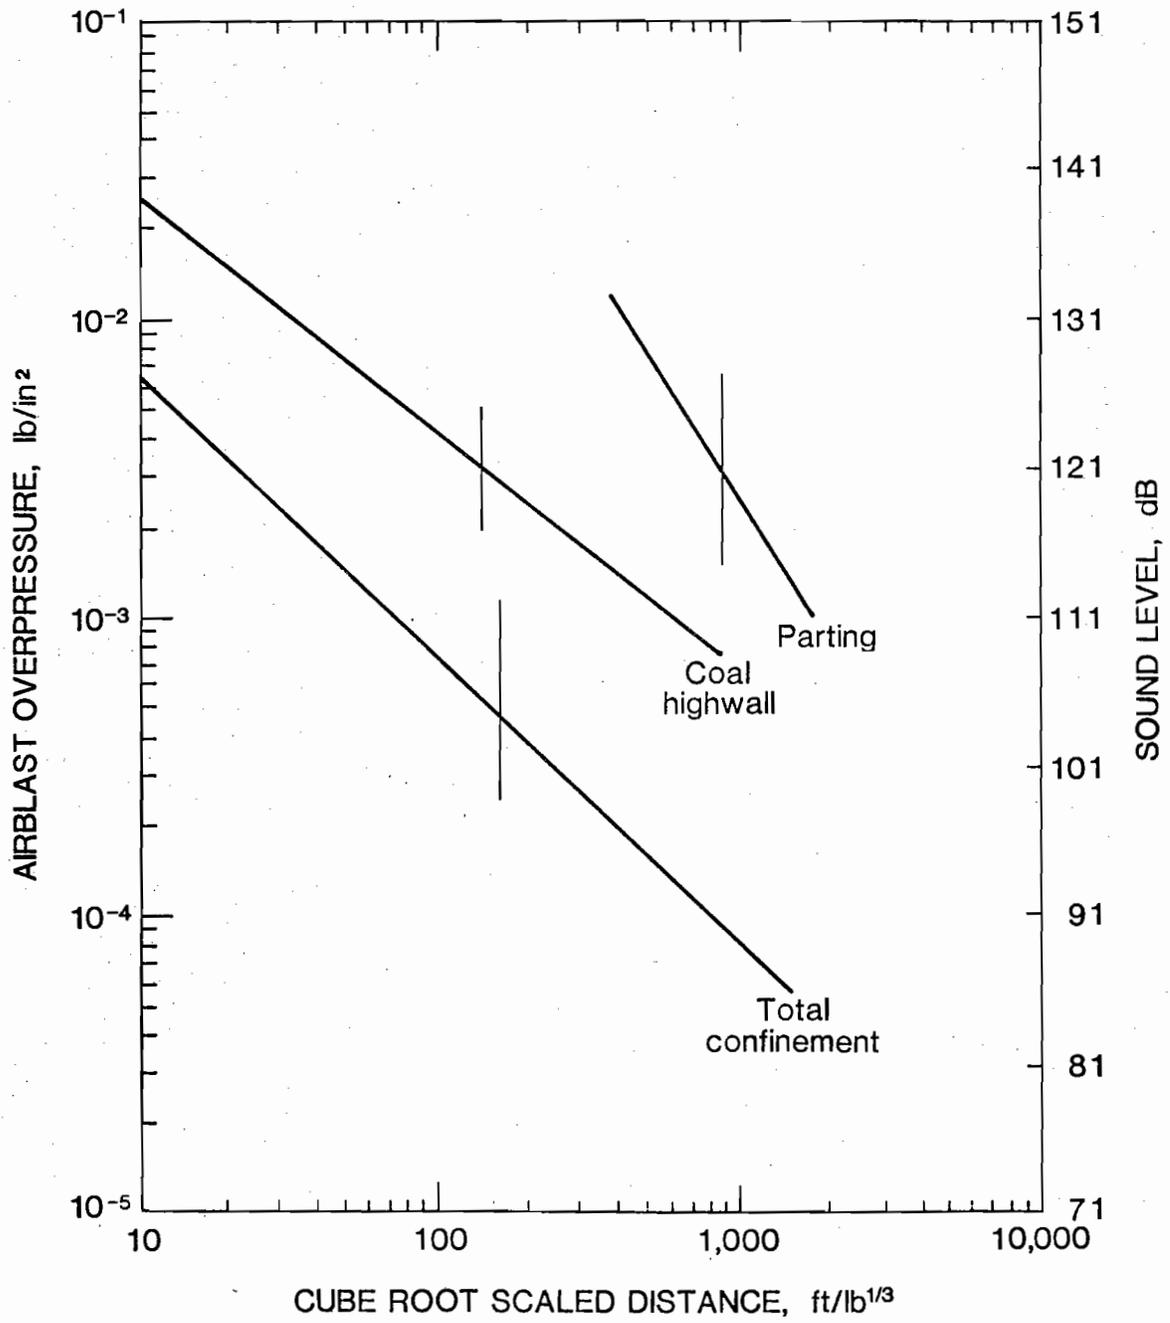
Figure B-1. - Airblast propagation from surface mining, from Bureau of Mines RI 8485 (4).

Figure B-1 summarizes mining airblasts for three cases: 1) Total confinement (deep burial), 2) mining highwall bench blasts, and 3) slightly

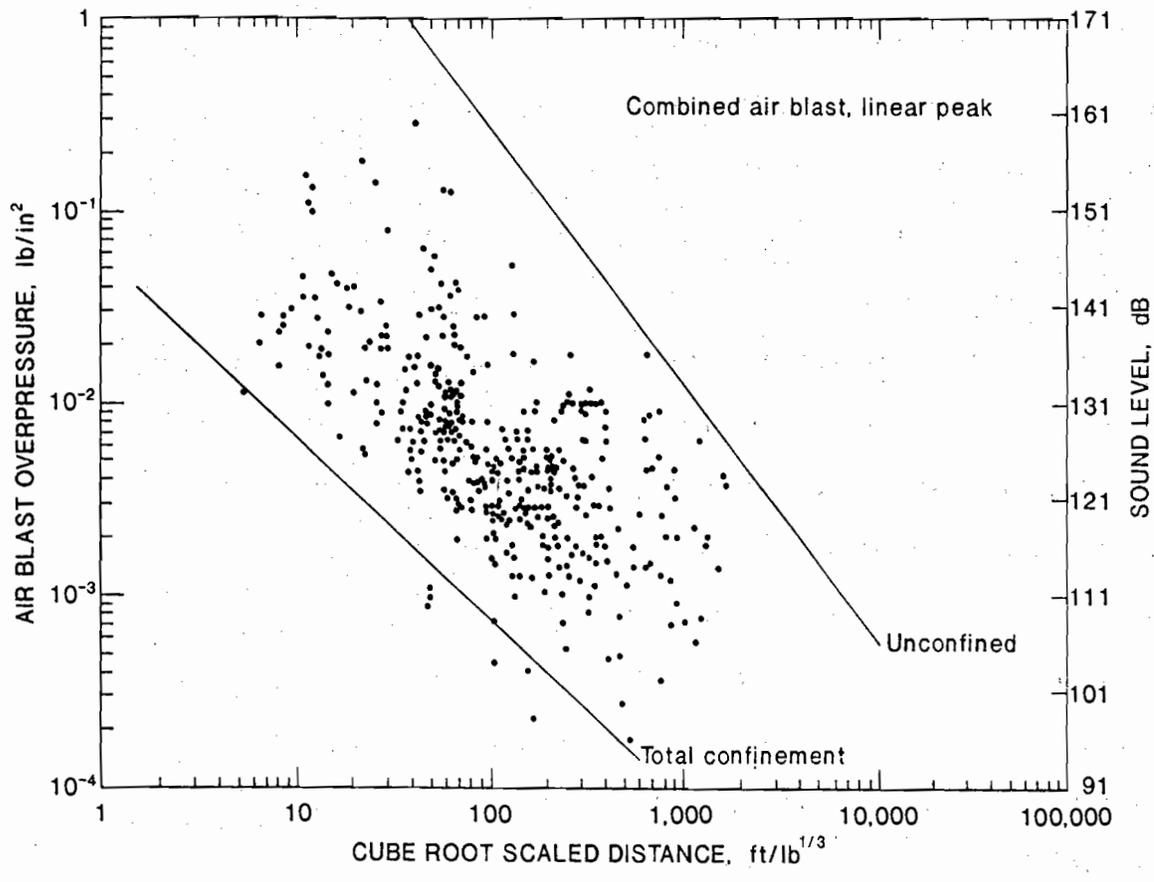
Figure B-2. - Combined mining airblast measurements for all sites, from Bureau of Mines RI 8485 (4).

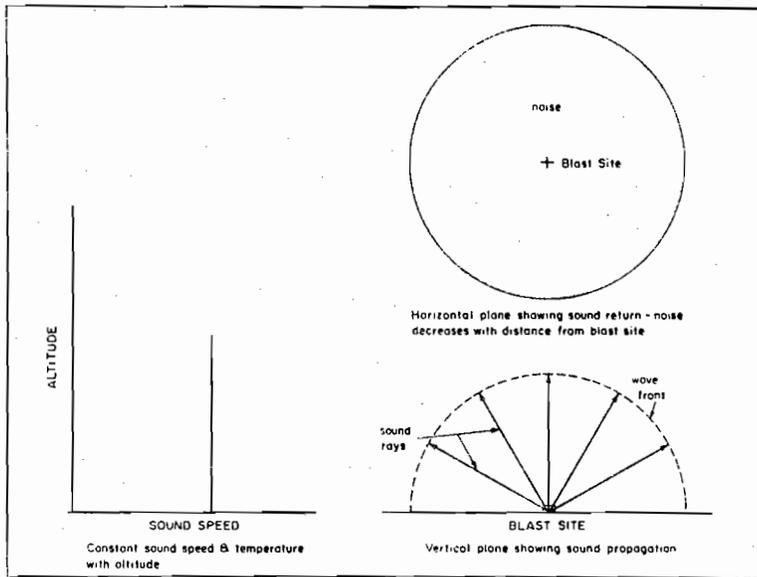
Figure B-3. - Sound propagation from an isothermal condition (speed is constant with altitude), from DuPont Blaster's Handbook (25).

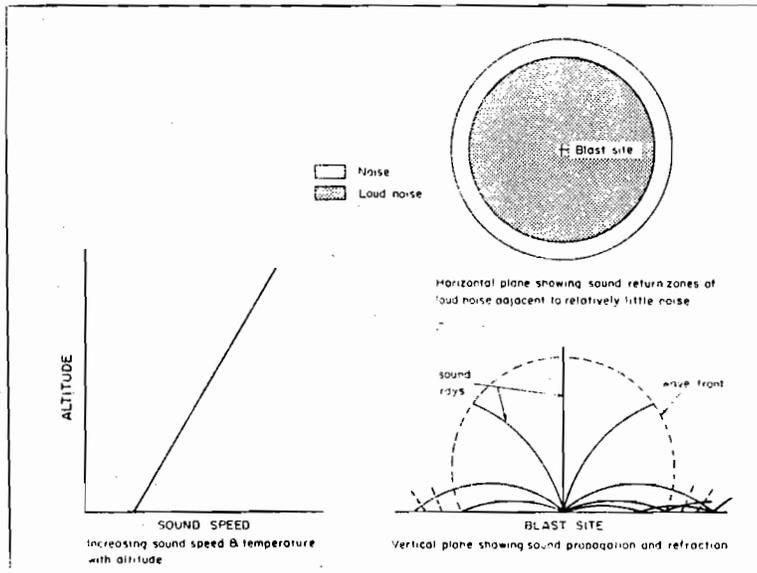
Figure B-4. - Sound propagation from a positive thermal gradient (speed increases with altitude), from DuPont Blaster's Handbook (25).

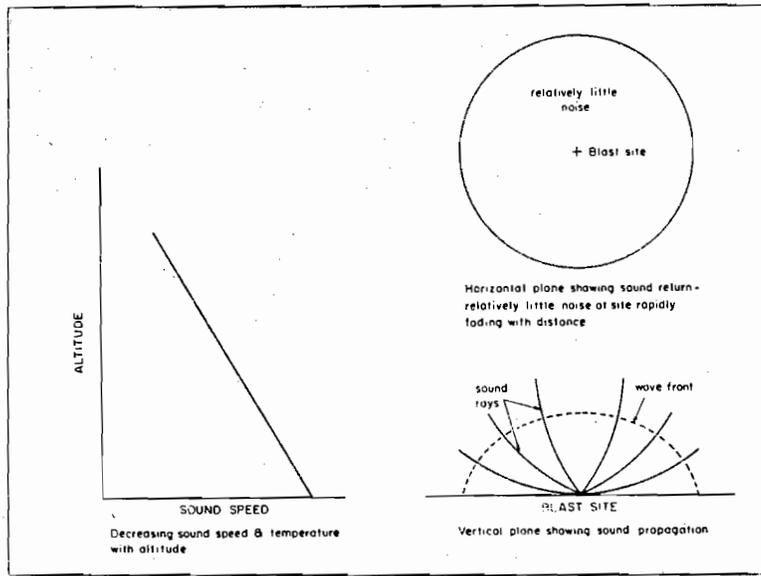
Figure B-5. - Sound propagation from a negative thermal gradient (speed decreases with altitudes), from DuPont Blaster's Handbook (25).

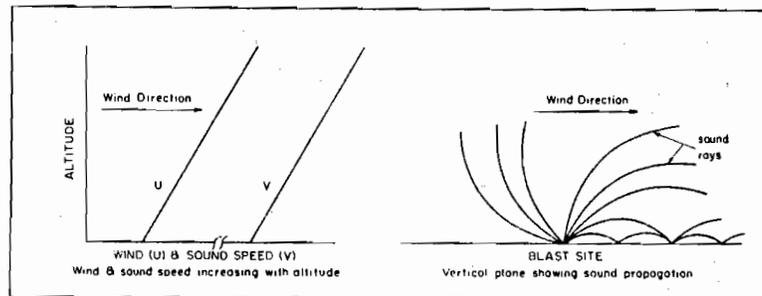
Figure B-6. - Sound propagation from a positive wind gradient (speed increasing with altitude), from DuPont Blaster's Handbook (25).

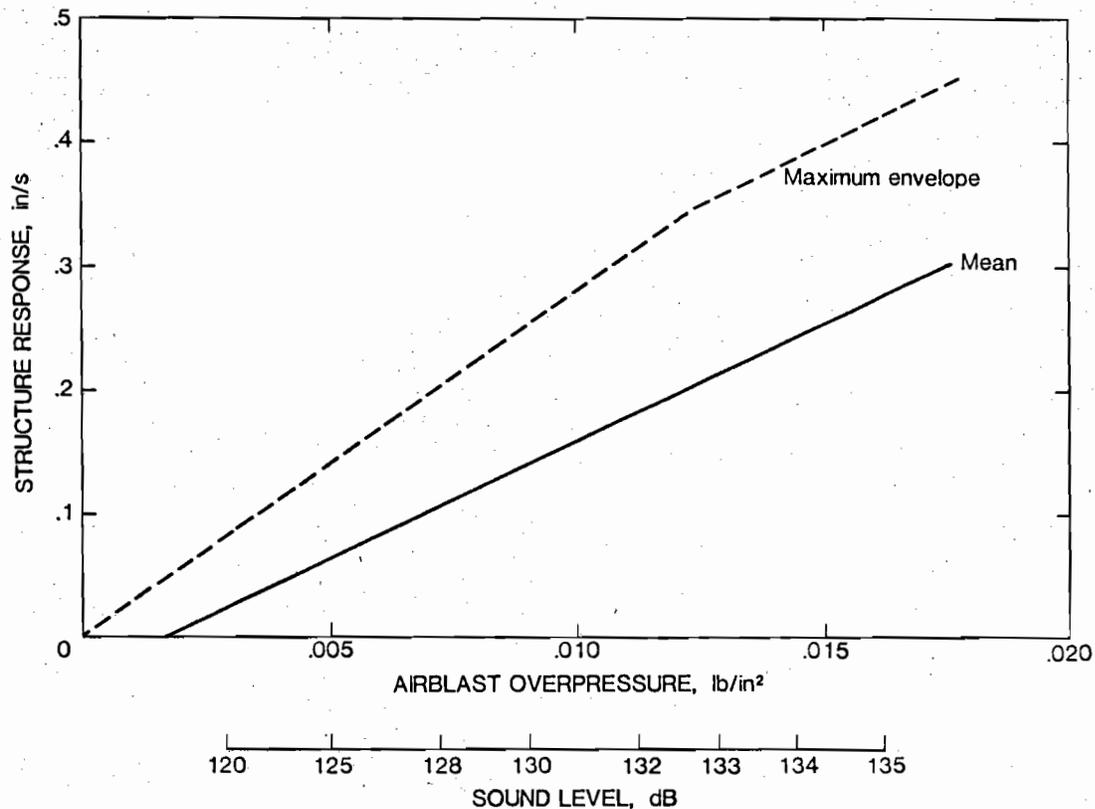
Figure B-7. - Structural response of low-rise structures from airblast overpressures, from Bureau of Mines RI 8485 (4).

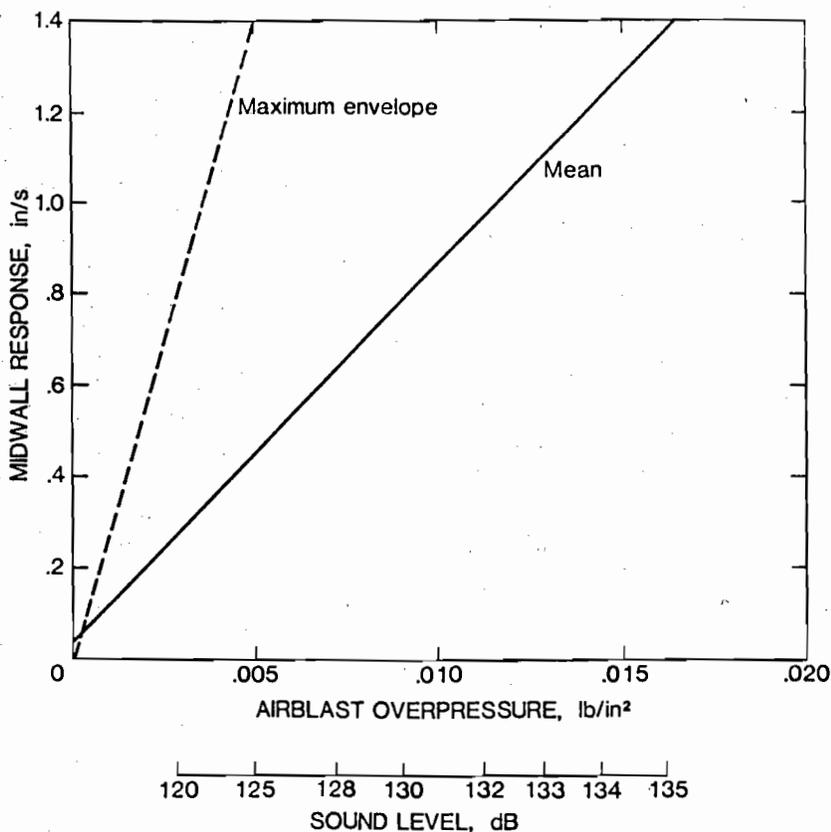
Figure B-8. - Midwall responses of low-rise structures from airblast overpressures, from Bureau of Mines RI 8485 (4).

Figure B-8 shows midwall responses to airblasts with considerably larger responses than racking from a given incident overpressure. As discussed in detail in RI 8485, this midwall response is not significant to cracking potential of structure walls with the exception of window glass. Indeed, cracking of glass has been found to be the first indication of airblast damage, as discussed later in this report. Midwall responses are responsible for much of the secondary rattling noise and other observed effects such as pictures, clocks, etc. being knocked askew or even occasionally off the wall. Although not significant to structural risk, these situations result in much
