Experimental Studies of the Effects of Blasting on Structures

By A. T. EDWARDS* and T. D. NORTHWOOD†

The results are presented of controlled blasting tests on six buildings on two different soils. Damage was correlated with size of charge and distance, and with displacement, velocity, acceleration, settlement, and strain measurements in the buildings. Peak velocity appears to provide the best correlation with damage for all soil conditions.

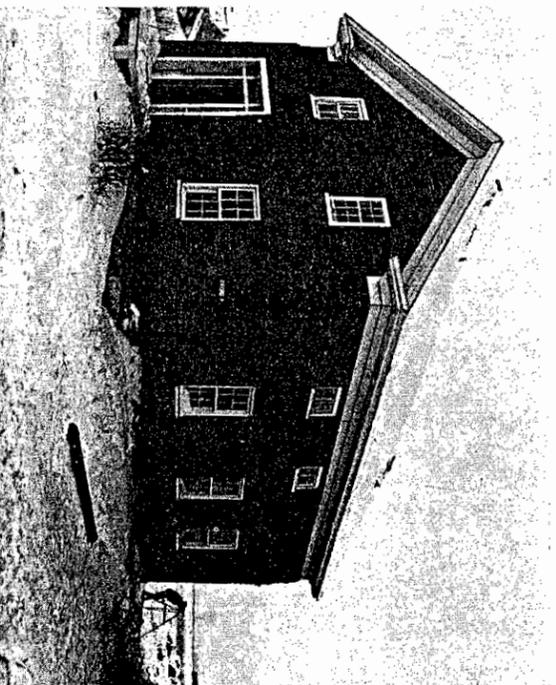
Fig. 2—Building E (after Test E11)

All structures were in good condition except for quite localized areas in one or two of them. Building R and part of building F were of frame construction above masonry basement walls. In the other buildings, structures above ground level were mainly of 12in solid brick, which was in good condition except that the bond between the bricks and the mortar was weak in two of the buildings. House E had a 45 deg. crack across the front wall which had been patched up and which was said to have been caused by the Cornwall earthquake of 1945. The crack may be seen in Fig. 2. Rock was encountered about 15ft down at house F.

Building E.—Damage first occurred with Test E10 (140 lb at 50ft) when some vertical and diagonal cracks developed in the basement and upper walls. An original diagonal crack in the front wall was opened up to $\frac{1}{2}$ in in width. Test E11 (140 lb at 25ft) demolished large sections of the two rear walls and caused the rear upper floor to collapse. The diagonal crack in the front wall opened up to about 1in in width.

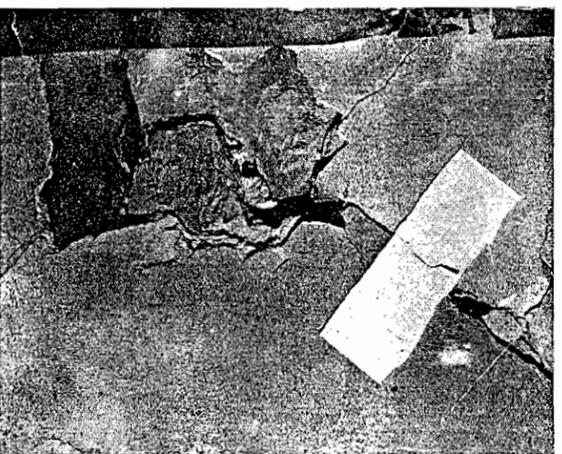
Fig. 5—Showing tell-tale across an original crack

was pasted across each crack (Fig. 5). The adhesive used was a type that is rigid when dry and thus does not yield under load. Consequently, a widening or extension of original cracking produced a tear in the paper.

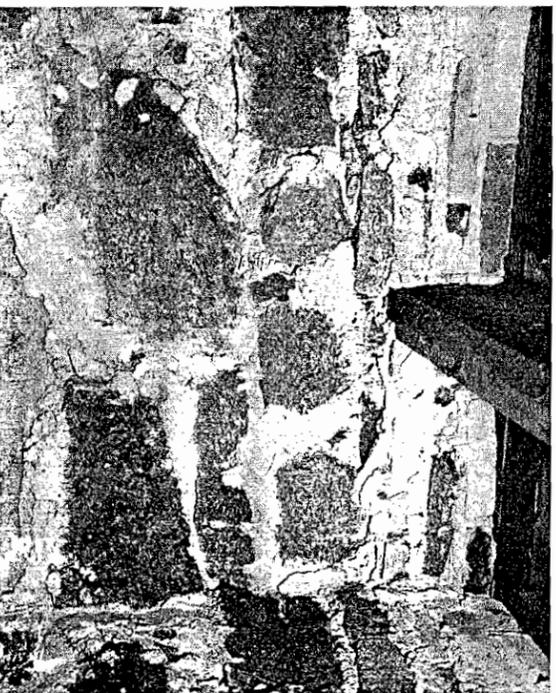
Fig. 8—Horizontal crack—building T

Building T.—Test T17 (350 lb at 80ft) caused a few of the tell-tales across original cracks to break, although none opened up. No new plaster cracks were noticed possibly because there were several layers of paper on the walls. A few of the bricks in the chimney became dislodged. Somewhat fewer tell-tales were broken by Test T18 (650 lb at 70ft). This caused some minor horizontal and vertical cracks in the basement walls, these being generally between courses or associated with windows, &c. Additional bricks were dislodged from the chimney.

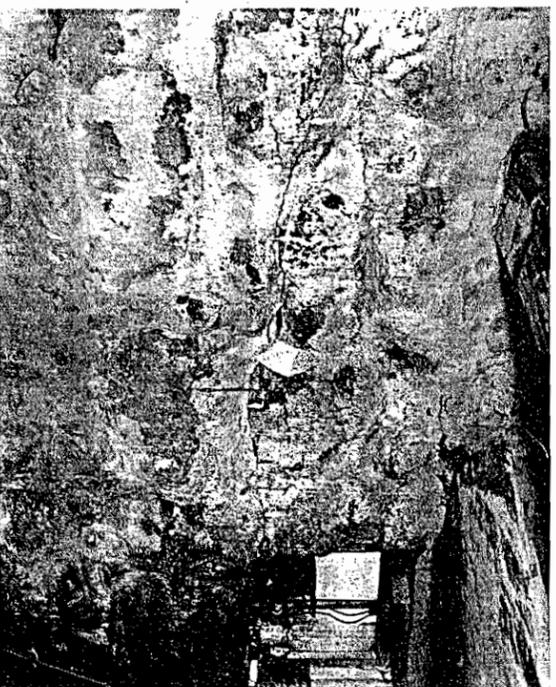
Fig. 9—Horizontal crack—building F

Building F.—Test F20 (400 lb at 90ft) caused some minor horizontal cracking in the

basement wall, generally between courses, and some stone to be dislodged from around one basement window. One partition wall, which was originally in poor shape, was cracked and a few fell-tales were broken. Major damage was inflicted on the building by Test F22 (750 lb at 70ft). Considerable sections of the rear basement wall fell away and the masonry walls above ground level were bulged out approximately 3in. Some of the upstairs partition walls became separated from the outside walls and there were a number of cracks 1/8 in to 3/4 in, both vertical and diagonal, associated with doorways and windows.

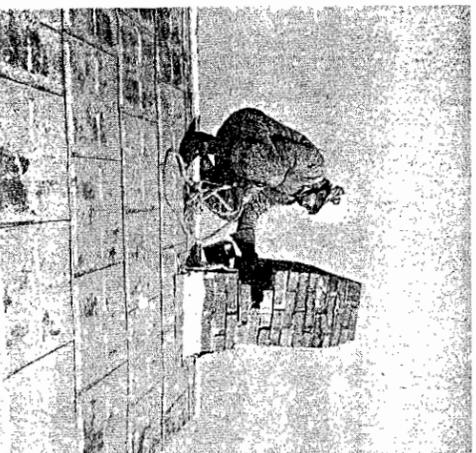
Fig. 10—Chimney damage—building R

building to show signs of weakness. Fig. 10 shows an example that occurred at building R. It may be concluded that the damage in the buildings in sand-clay was caused by failure of the soil, i.e. settlement, under the buildings rather than by wave energy within the building proper.
