BLAST VIBRATION DAMAGE ASSESSMENT STUDY AND REPORT

**PREPARED FOR:
THE MIAMI-DADE COUNTY BLASTING TASK FORCE**

FINAL REPORT

ASSESSMENT OF BLAST VIBRATION IMPACTS FROM QUARRY BLASTING IN DADE COUNTY

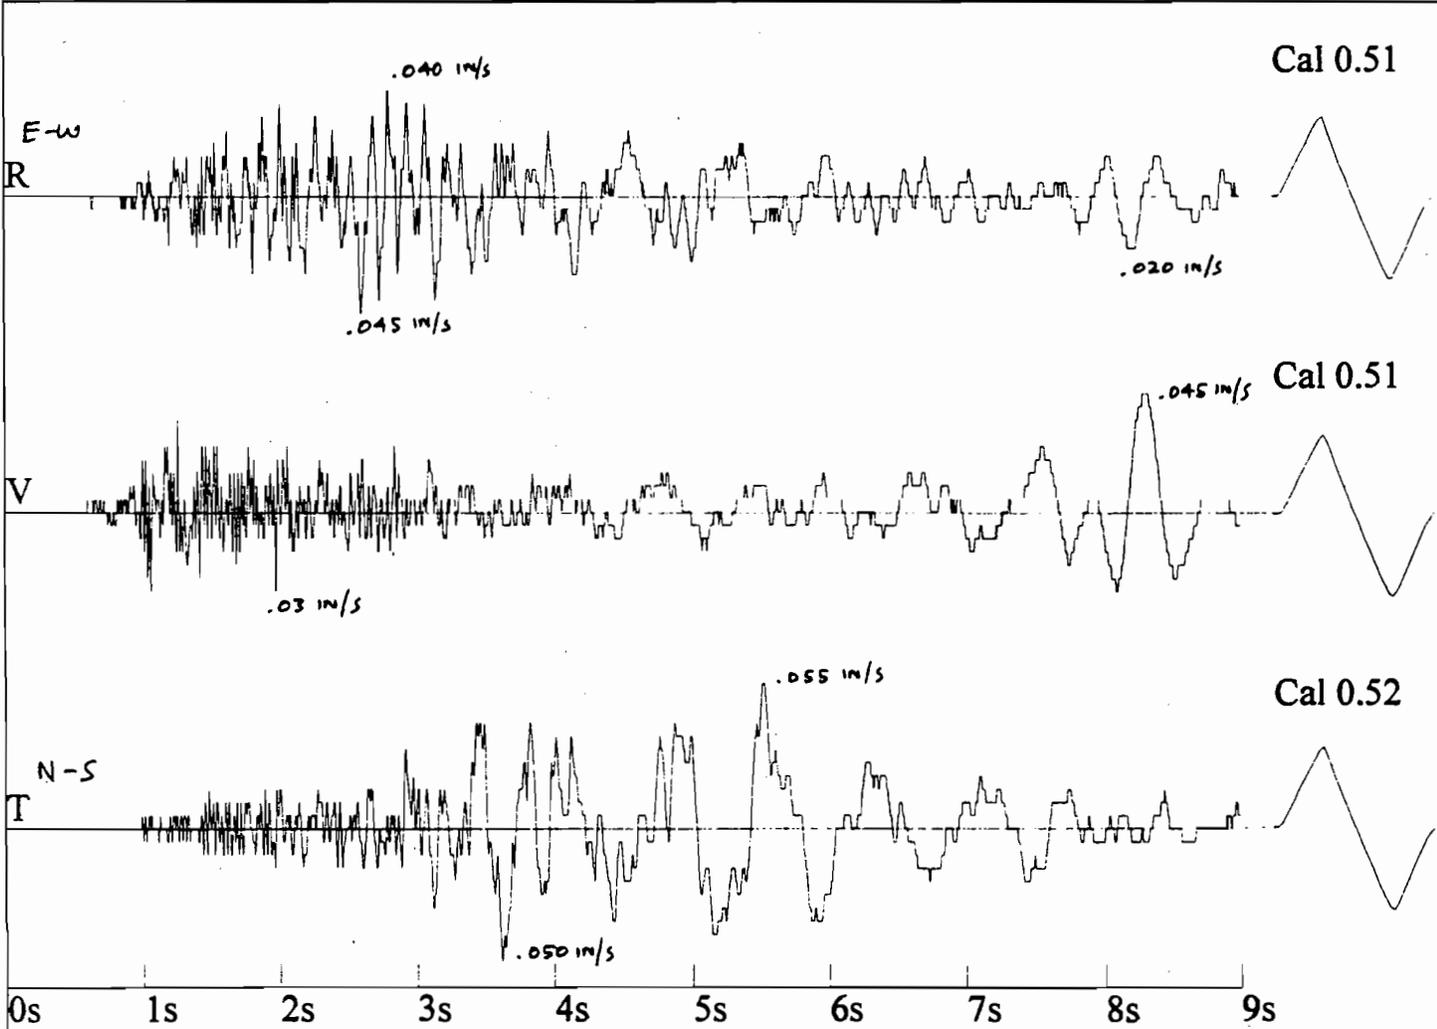
Figure 16.- Vibration record from monitoring at House 13 when structure response was also recorded (Figure 17). WRQ Section 7 blast at about 13,900 ft.

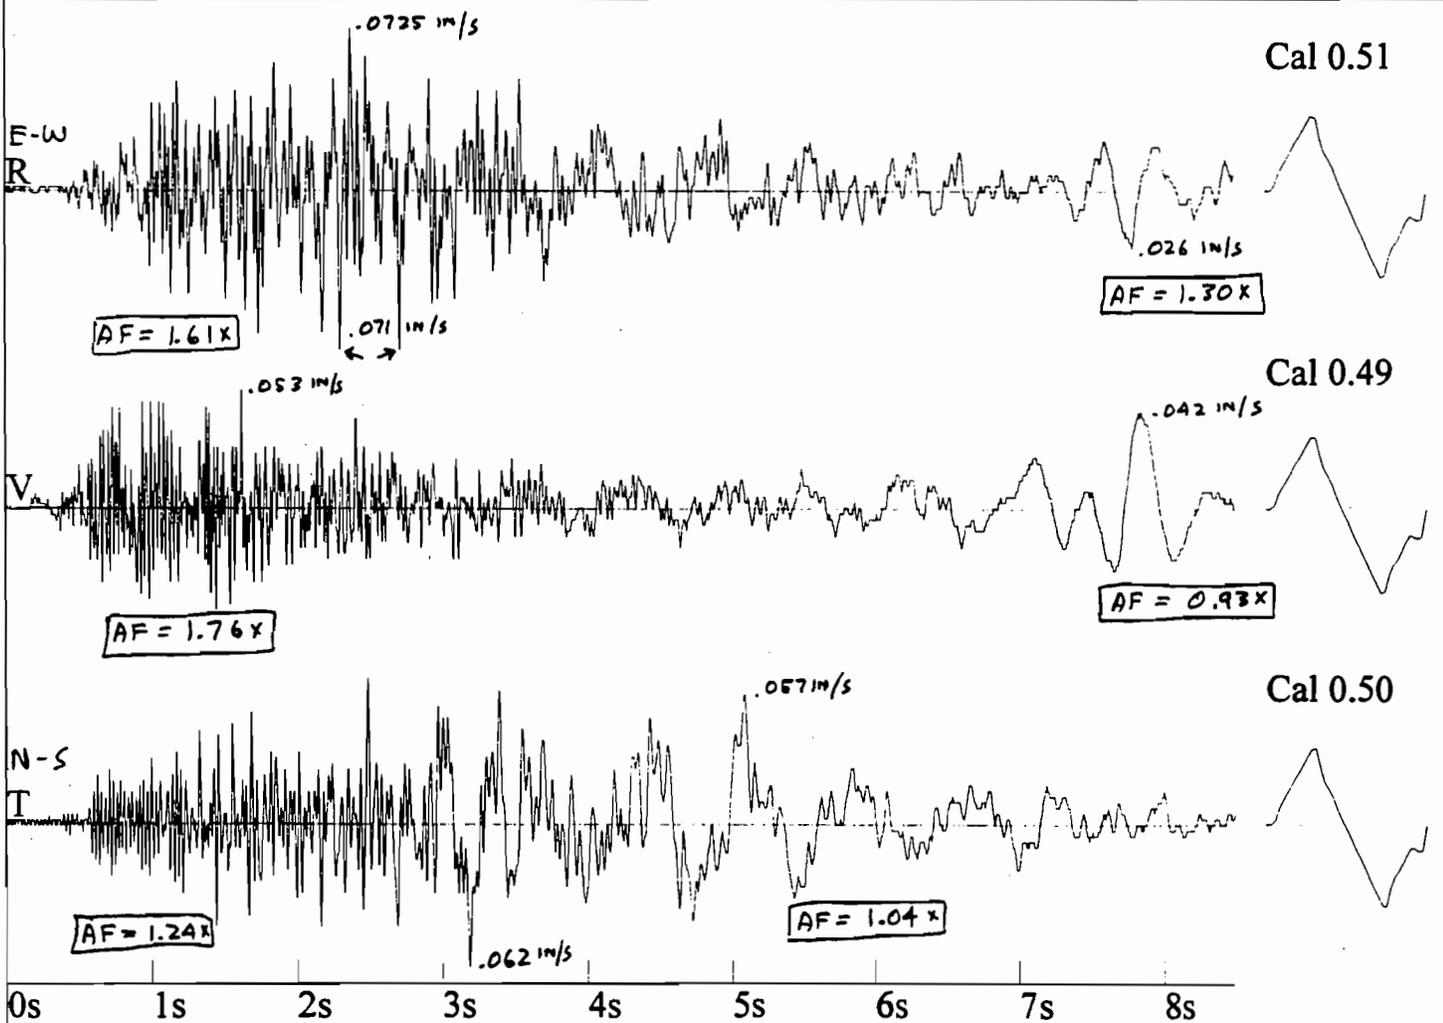
Figure 17.- Structure response record for House #13 from the same blast shown in Figure 16.

ceiling rafter and not a structural corner. Hence the vertical component does not measure whole structure response but rather mid-floor motion. House 13 by contrast measured corner responses with all three components of motion.

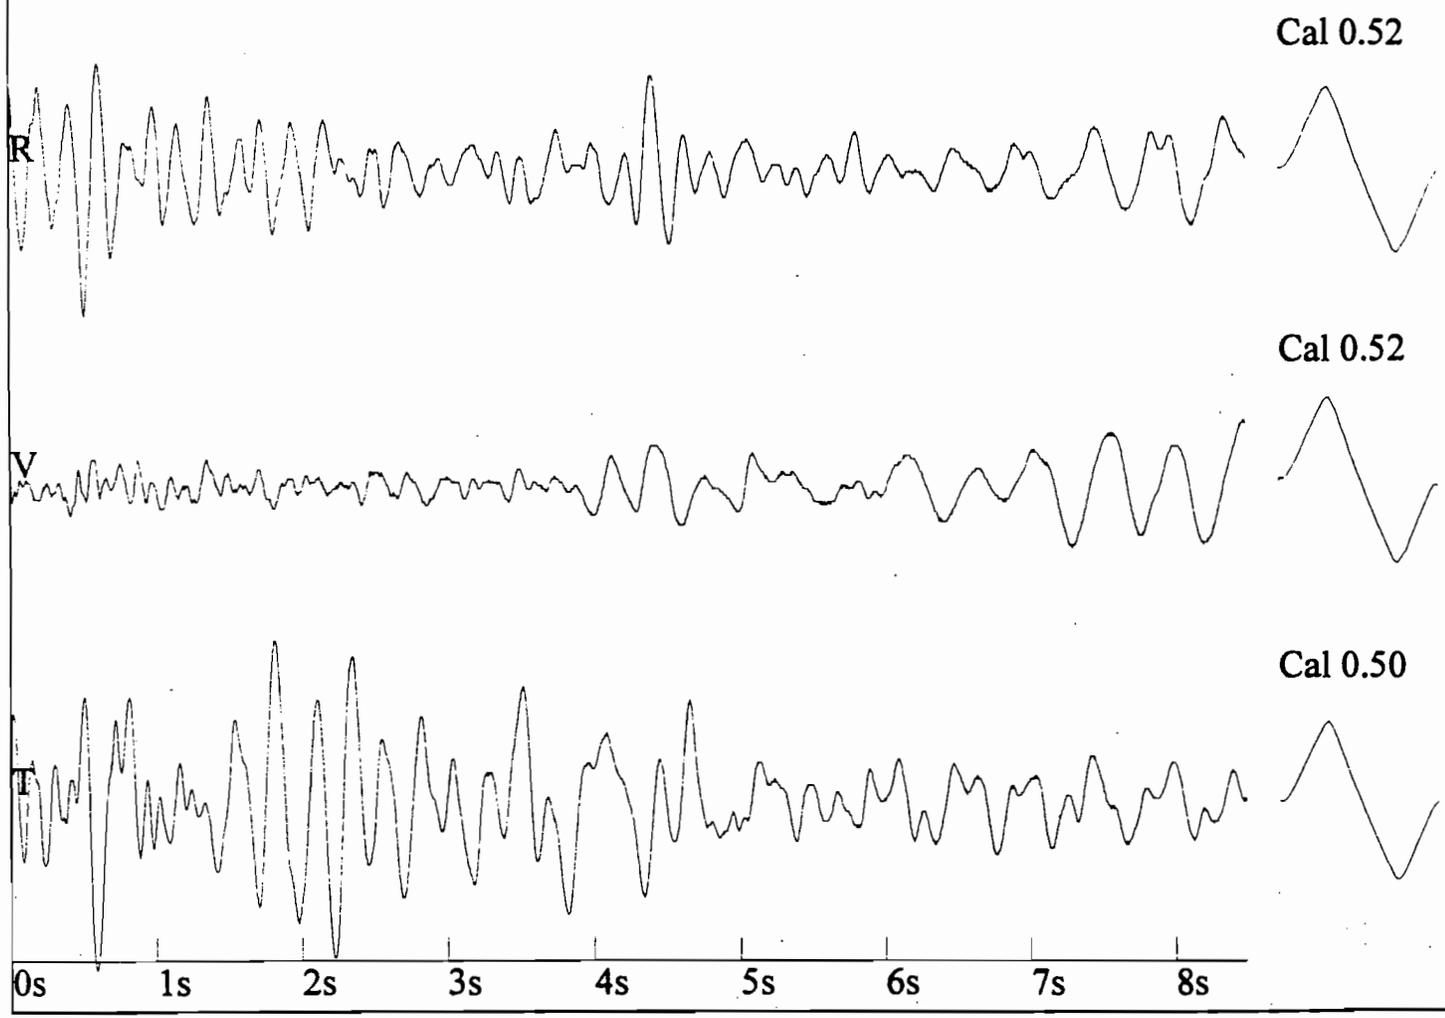
House 11: This house was far enough from the blasting that responses rather than ground vibrations were measured. There were only three triggers between 2-26 and 4-8 (23 blasts) and Figure 18 is the largest of these.

Figure 18.- Highest structure response record from House 11.

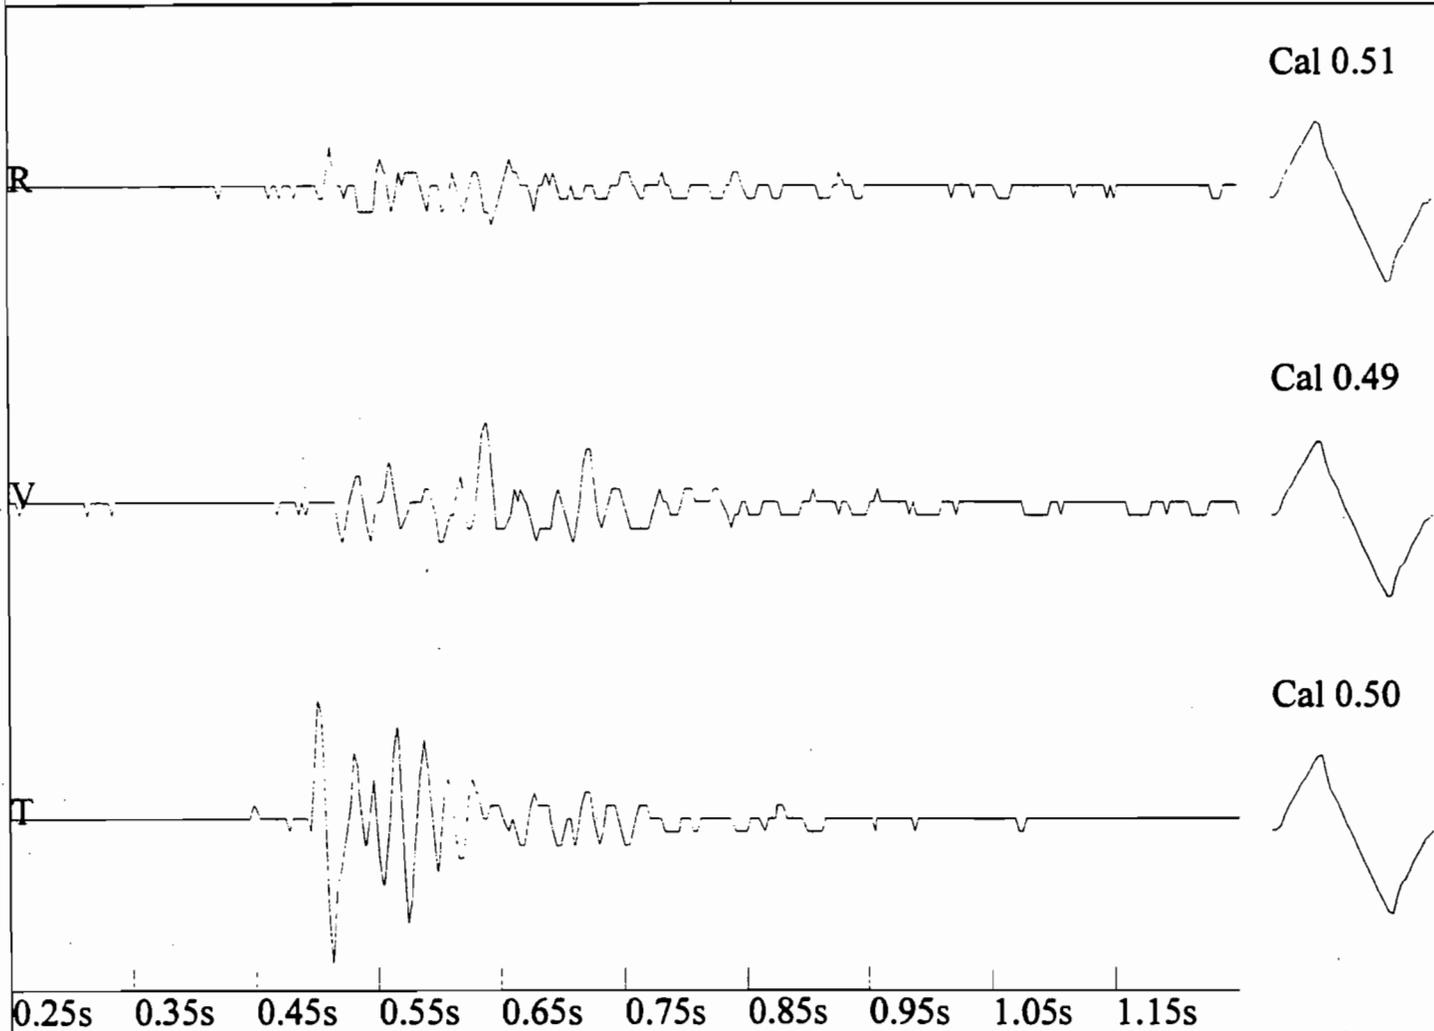
Non-blast responses: Figures 20 and 21 are non-blast structure responses. The one for House 13, Figure 20, is likely the closing of the sliding door in the wall beneath the corner being monitored. This amplitude was as high as many of the blasts. The House 12 record, Figure 21, appears to be a real event (and not an electronic spike) and is of a significant amplitude of 0.64 in/s in the E-W direction and is the largest of 86 such events. As the trusses run N-S, there is likely little stiffness transverse to them and such response from a hard door closing is possible. The high frequency suggests a component response rather than whole-structure.

Figure 20.- Non-blast structure response event recorded at House 13. Note that the time scale has been expanded and that frequencies are relatively high.

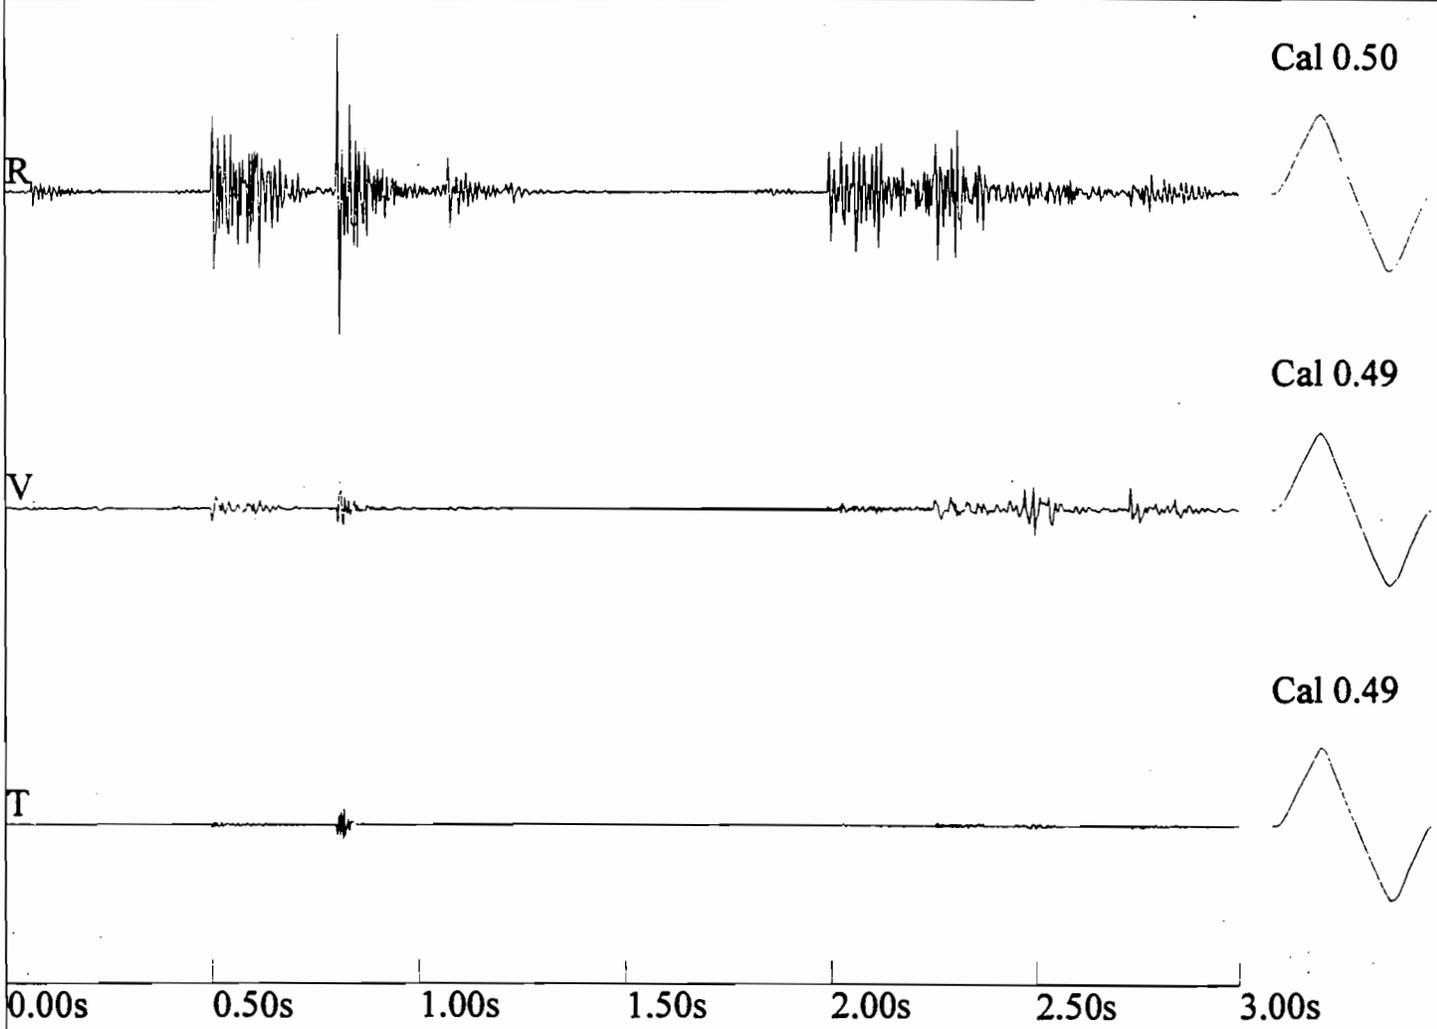
Figure 21.- Non-blast structure response event recorded at House 12. Note that the time scale has been expanded and that frequencies are relatively high.
