**INVESTIGATION OF DAMAGE TO STRUCTURES
IN THE McCUTCHANVILLE-DAYLIGHT
AREA OF SOUTHWESTERN INDIANA**

Volume 2 of 3

**INVESTIGATION OF BUILDING DAMAGE
IN THE McCUTCHANVILLE-DAYLIGHT, INDIANA AREA**

**The Office of Surface Mining Reclamation and Enforcement
Contract No. EF68-I491-13797**

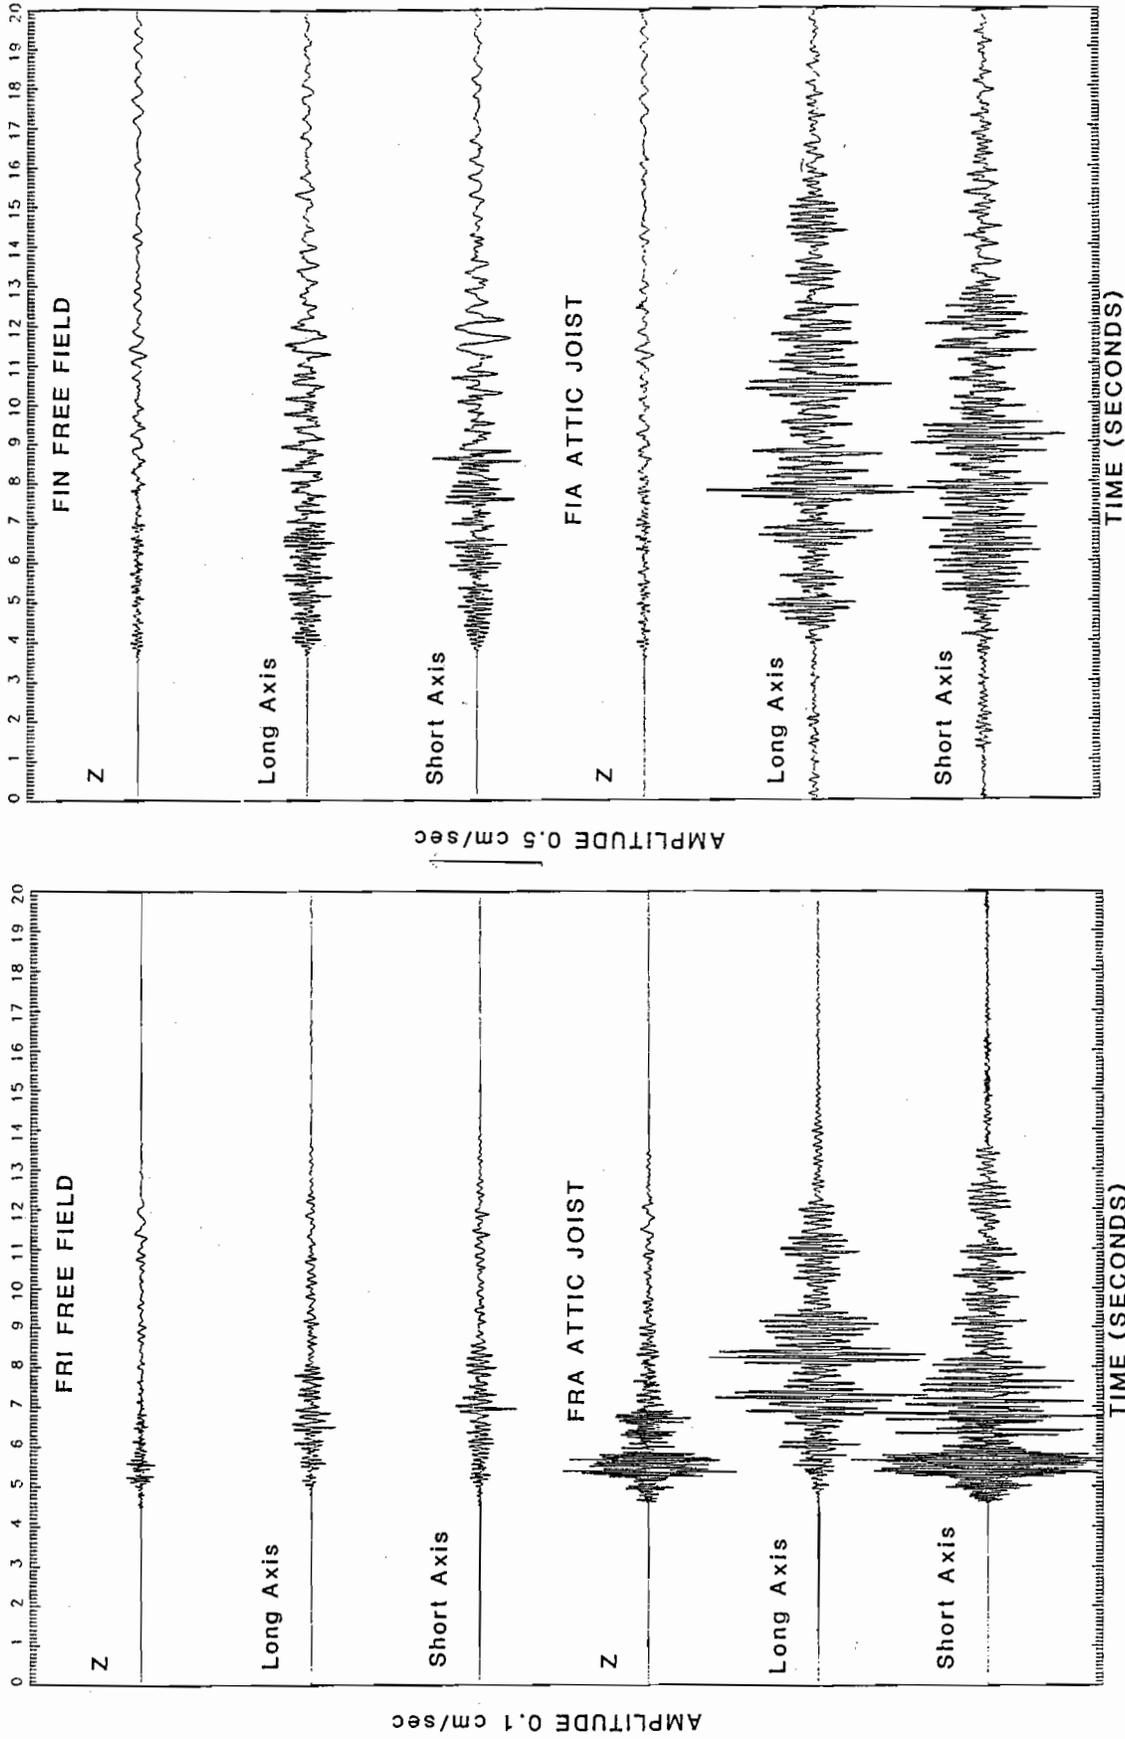
Figure 28. Seismograms at the comparison sites. All amplitudes and time scales are identical for comparisons. BOH, FRI, MCC, OSB, KIN, and FIN are the complainant sites.

Figure 28 shows the recorded seismic time-histories at the companion free-field sites. The amplitudes are all on the same vertical scale so that they can be visually compared. The time scales are also the same in order to show variations in the duration of the vibrations. The duration of vibrations induced by the blasts at a site can be compared by measuring the time or duration that the induced vibrations exceeds a set level such as 3 dB or 40 percent above the ambient background. Inspection of the paired vibration time-histories show less than a 1 sec difference in duration (Figure 28). Peak-particle velocities are compared by dividing the recorded ground motion values at the companion non-complainant site into the PPV at the complainant site. The difference at most of the paired sites is 30 percent or less (Table 8). Larger differences were recorded at complainant sites FRI and FIN for a maximum PPV ratio of 1.6 in the N-S direction at FIN and a ratio of 1.5 in the E-W direction at FRI.
