**INVESTIGATION OF DAMAGE TO STRUCTURES  
IN THE M<sup>c</sup>CUTCHANVILLE-DAYLIGHT  
AREA OF SOUTHWESTERN INDIANA**

**Volume 3 of 3**

**Part IX: Environmental Conditions Related to Geology, Soils, and Precipitation, McCutchanville and Daylight, Vanderburgh County, Indiana.**

PART IX: ENVIRONMENTAL CONDITIONS  
RELATED TO GEOLOGY, SOILS, AND PRECIPITATION  
McCUTCHANVILLE AND DAYLIGHT, VANDERBURGH COUNTY, IN

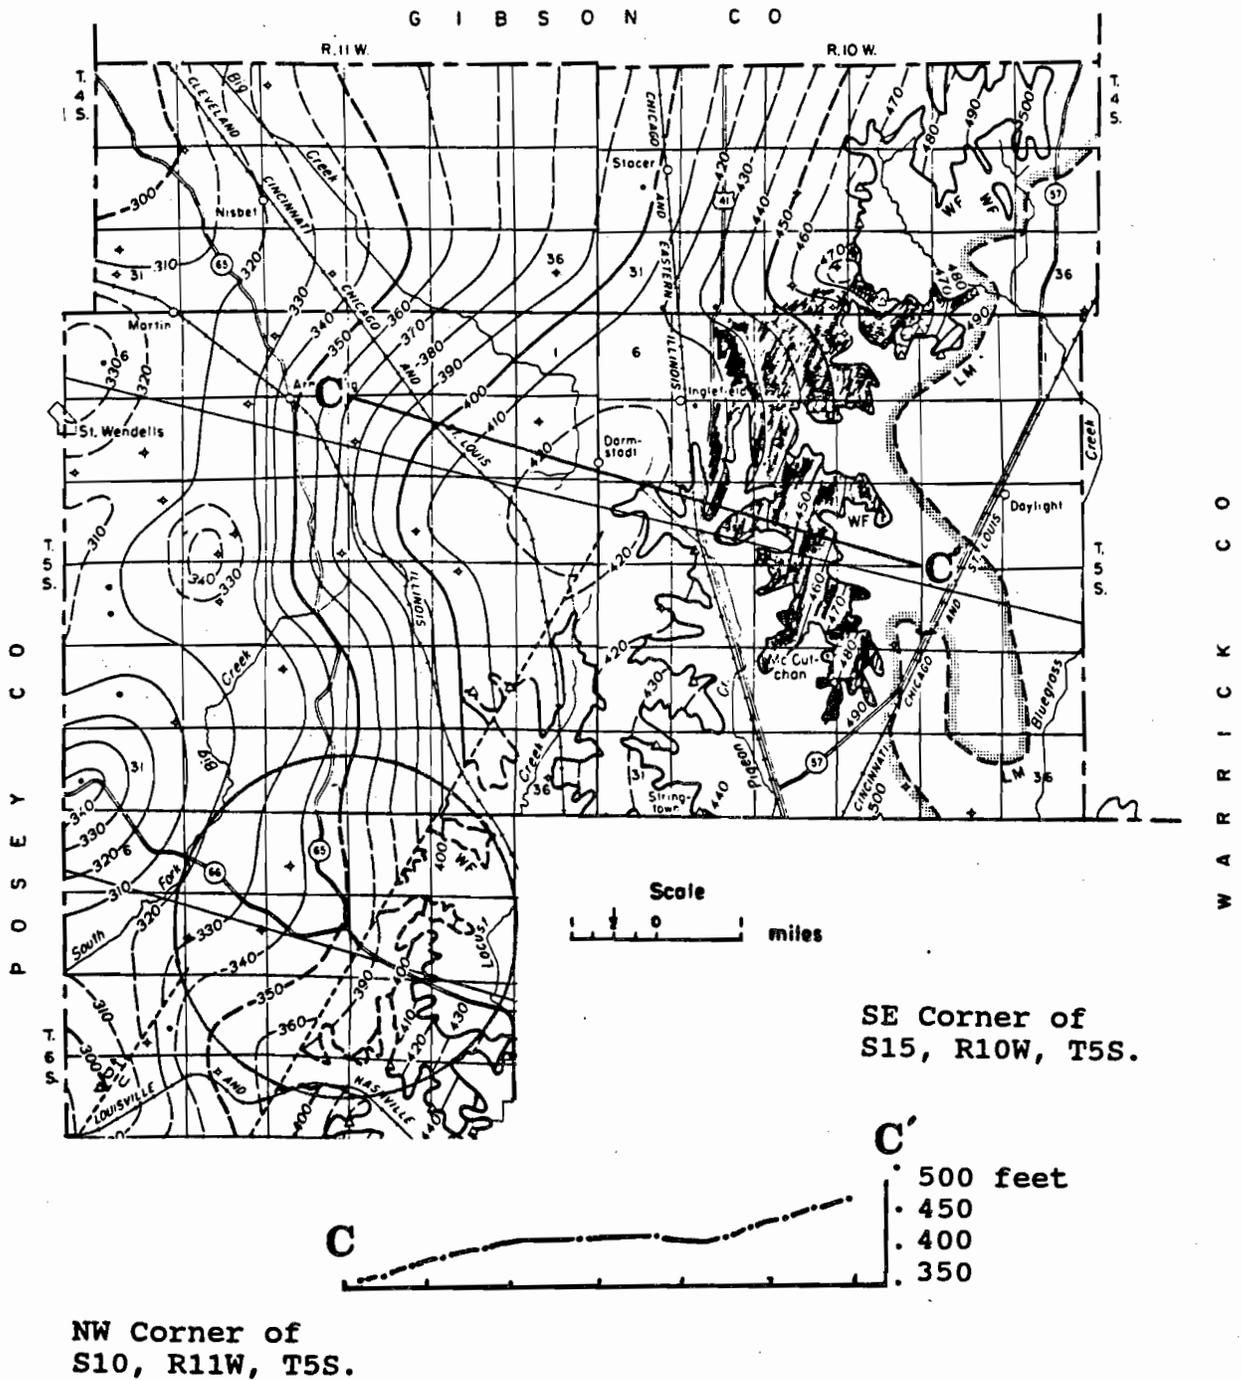
Figure 1. Geologic Structure map of Evansville North and Daylight, (R.10 W., T.5 S.), IN, 7.5 minute topographic map area. Cross-section C-C' is drawn along the general dip of the shaded McCutchanville ridge. Structure contours are drawn on the top of the West Franklin limestone (1954, INDOC-GS).

The structural geology of McCutchanville and Daylight, IN is shown on Figure 1. Structure contours are drawn on the top of the West Franklin limestone. Contours are solid where this rock unit has been located and dashed where inferred. The strike of the strata is north-northeast and the dip is west northwest at a rate of about 25 to 30 feet per mile. Cross-section C-C' shows the strata dipping, flattening near Darmstadt, IN and continuing to dip westward (Indiana Department of Conservation-Geologic Survey IDOC-GS, 1954).

The study area on Figure 1 is bounded by Base Line Road to the north; the intersection of U.S. 41 and State Route 57 and Millersburg Road to the south; U.S. Route 41 to the west; and County Line Road on the east. The primary complaint area is the shaded McCutchanville ridge area.

The West Franklin limestone member of the Shelburn Formation underlies the McCutchanville ridge in those areas where topographic elevation exceeds geologic structure contour elevation (Figure 1; INDOC-GS, 1954). West Franklin limestone strikes northeast-southwest, and includes a tongue-like extension into the Blue Grass area. The West Franklin crops out along re-entrant valleys of the McCutchanville ridge and the Blue Grass Cemetery area, and dips in a northwest direction (Figure 1).

The control area was selected by interagency representatives for comparison to the McCutchanville and Daylight study area. The control area lies within two miles of the merging of Indiana Routes 65 and 66 (circled on Figure 1). This area includes the southeast and northeast corners of the Kasson, and West Franklin, IN 7.5 minute quadrangles. The maximum distance between the control and study area is about 10 miles.

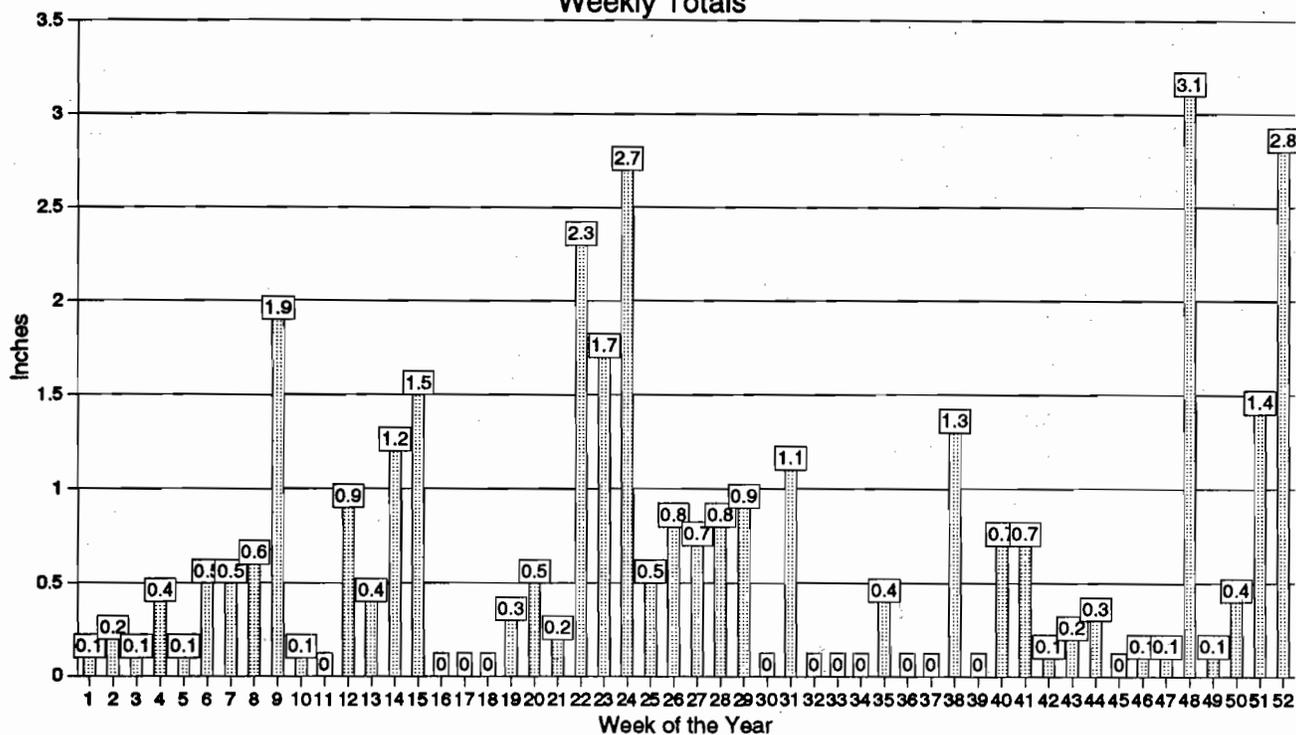
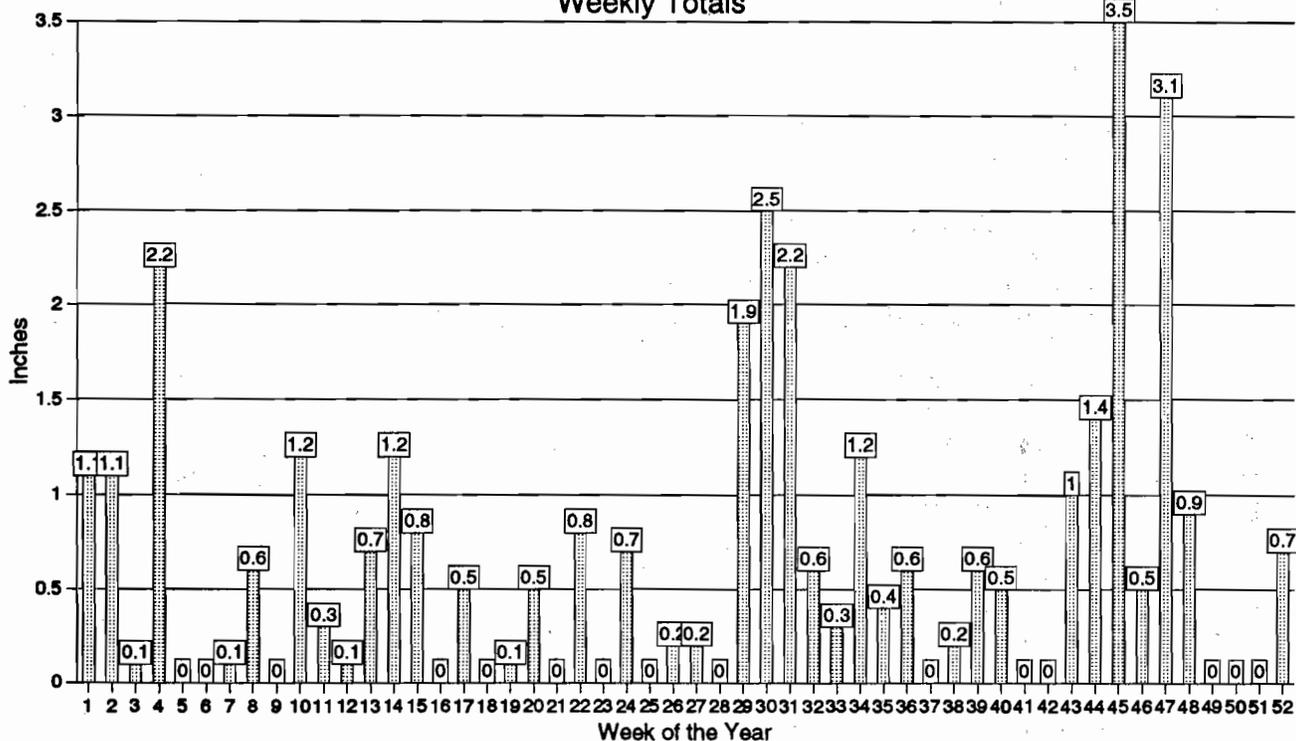
# 1987 Precipitation

# 1988 Precipitation

Figure 3. Weekly precipitation in inches for 1987 and 1988 (1992, USDOC, NOAA, NCDC).

Figure 3 bar graphs show weekly precipitation distribution for 1987 and 1988. Visual inspection shows there are numerous single and multiple weeks of 0.20 in. or less.

The precipitation pattern in the 12 months preceding the drought of June 1988 included the following (Figure 3) (1) July through November 1987 received 10.23 inches. This is a 42.43% drop in precipitation from an 11 year average of 17.77 inches; (2) December 1987 through February 1988 received 12.93 inches of precipitation. This is a surplus of 3.48 inches above the 11-year average of 9.45 inches for these months; and (3) March through June 1988 received 7.1 inches. This is a 58.11% drop in precipitation from an 11-year average of 16.95 inches for these months. In July 1988 precipitation jumped 2.39 inches above the 11-year average to 6.63 inches (USDOC, NOAA, NCDC, 1992).

The precipitation patterns shown on Table 2 and Figure 3 appear complementary to the concepts described by Bauer (1982), Chen (1988), and SHC-BRC-UI-ISGS (1988). The opportunity for cyclic soil wetting/drying and swelling/shrinkage increased as the number of single and multiple week intervals of low precipitation increased between the years of 1982 and 1990.

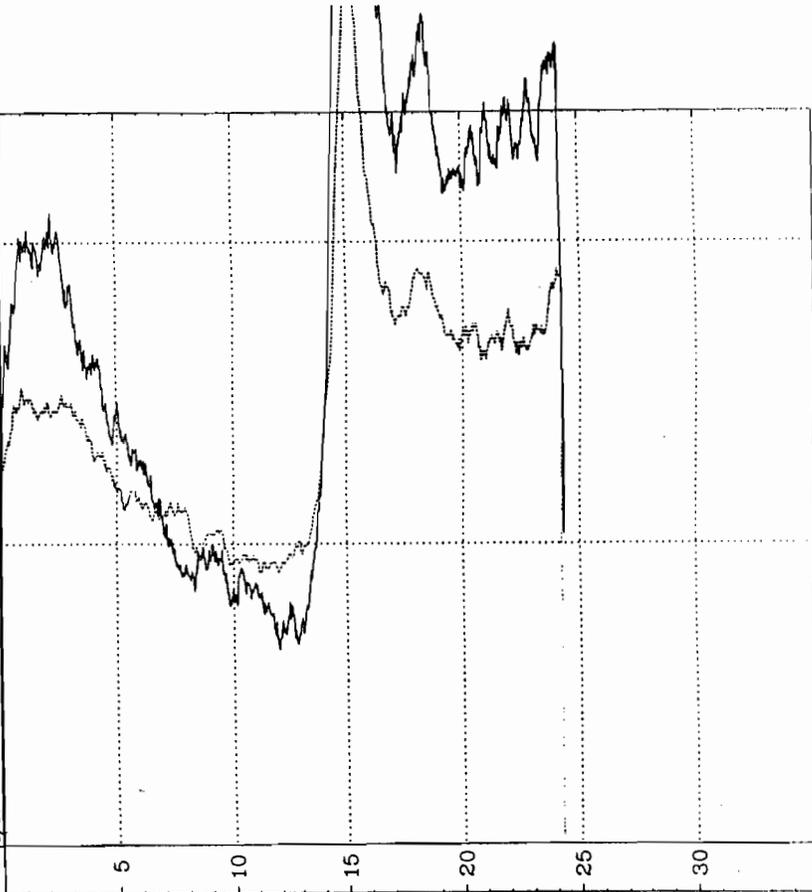
TC = 5 RATE = 5 FT/MIN OSM-1 LOG # 89-306

COUNTS PER SECOND  
 (100 COUNTS = 75 APT UNITS)  
 50 - 150 SCALE = SOLID  
 0 - 200 SCALE = DASHED  
 200/100

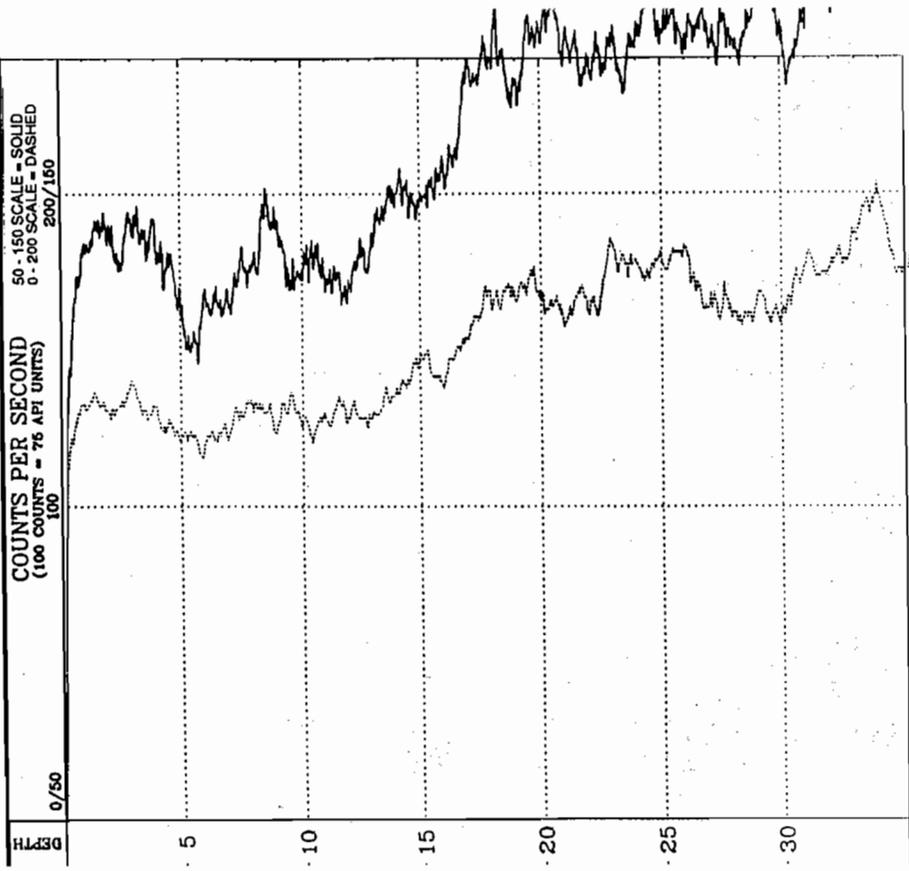
TC = 5 RATE = 5 FT/MIN OSM-3 LOG # 89-310

0/50  
COUNTS PER SECOND  
(1000 COUNTS = 76 API UNITS)  
50-150 SCALE = SOLID  
0-200 SCALE = DASHED  
200/150

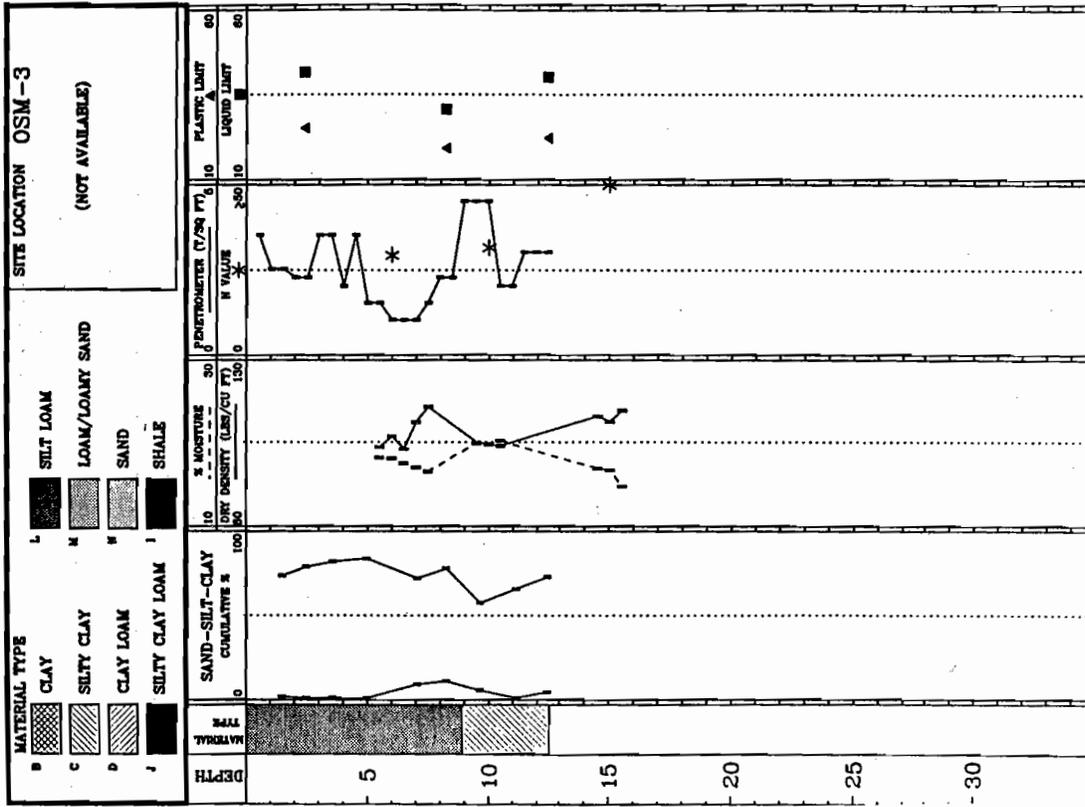
IVC - 122-150" shale; massive but cut by many steeply dipping joints with slickensided faces; varicolored 2.5Y 7/1, diffuse stains to 10YR 6/6, thin, subhorizontal SR banding below top 1'

Comments: Profile is basic Hosmer series, with fragipan. The complex IIIB2 appears to be a granular mix of various fragments, i.e., not simply formed-in-place concretionary masses. It is interpreted as a stone line, as evidence of an erosional surface atop the physically disaggregated shale of the IVB3 horizons which are relatively thin (100-122')

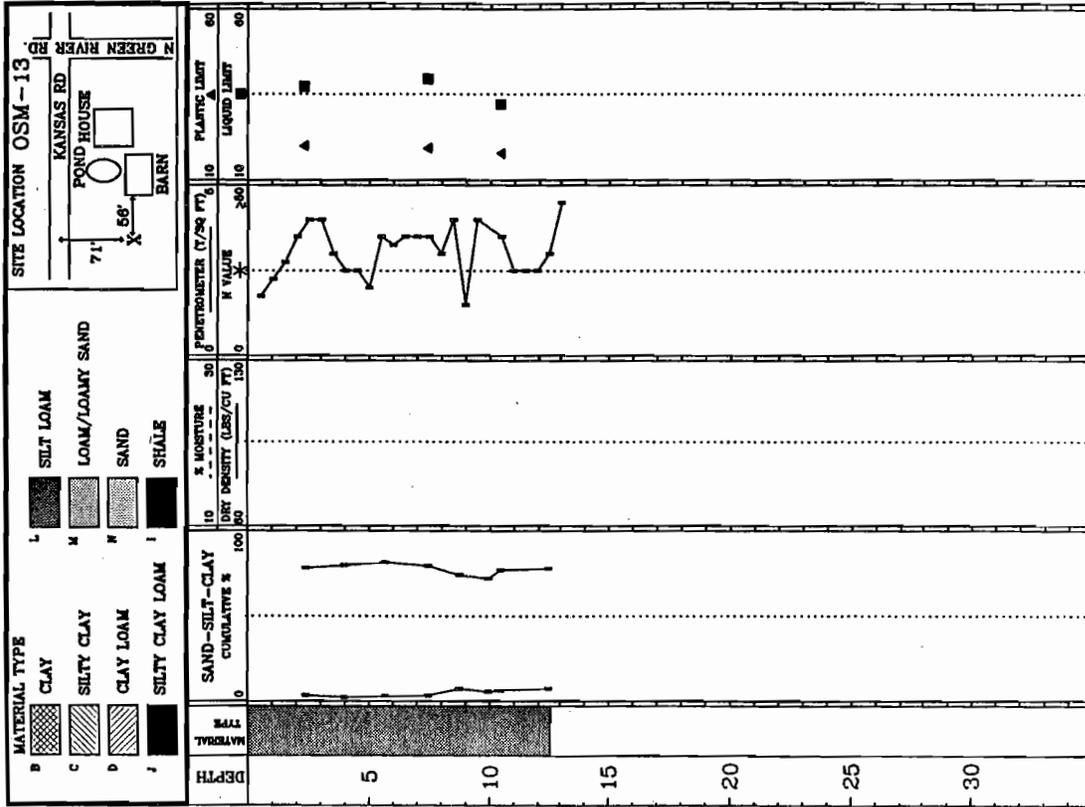
OSM-13	6	1.75
OSM-13	12	2.25
OSM-13	18	2.75
OSM-13	24	3.50
OSM-13	30	4.00
OSM-13	36	4.00
OSM-13	42	3.00
OSM-13	48	2.50
OSM-13	54	2.50
OSM-13	60	2.00
OSM-13	66	3.50
OSM-13	72	3.25
OSM-13	78	3.50
OSM-13	84	3.50
OSM-13	90	3.50
OSM-13	96	3.00
OSM-13	102	4.00
OSM-13	108	1.50
OSM-13	114	4.00
OSM-13	120	
OSM-13	126	3.50
OSM-13	132	2.50
OSM-13	138	2.50
OSM-13	144	2.50
OSM-13	150	3.00
OSM-13	156	4.50

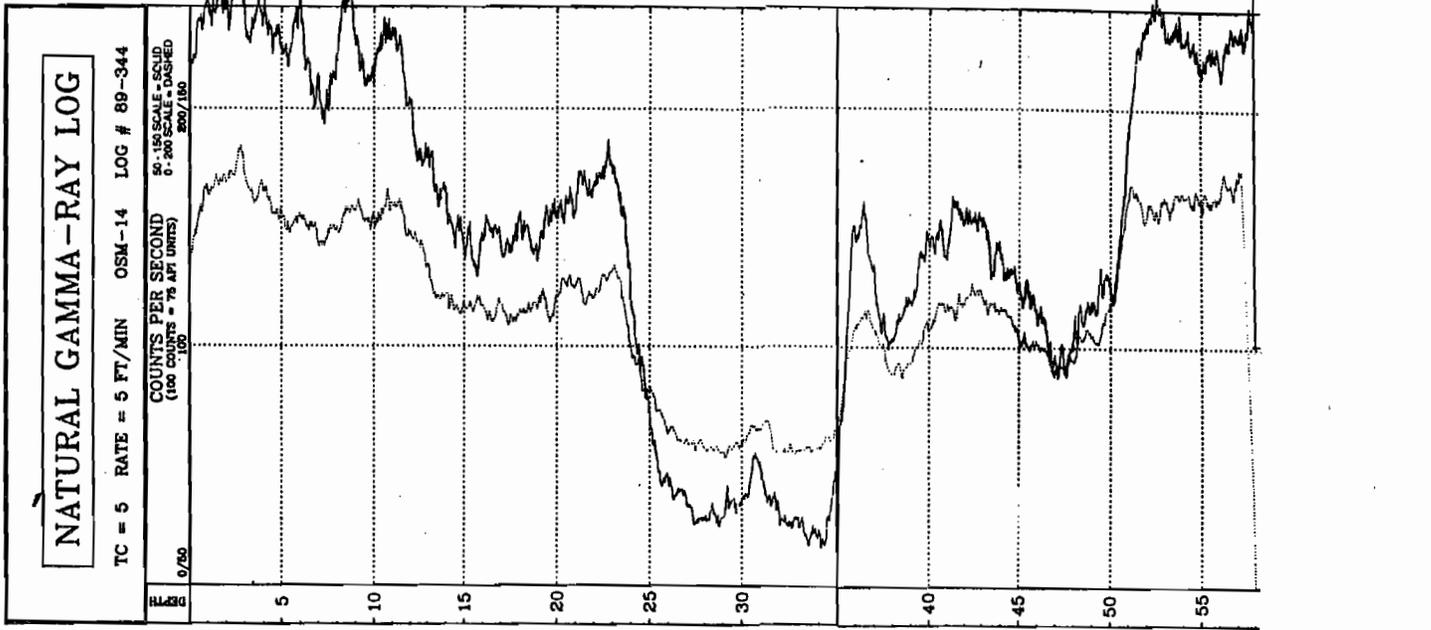
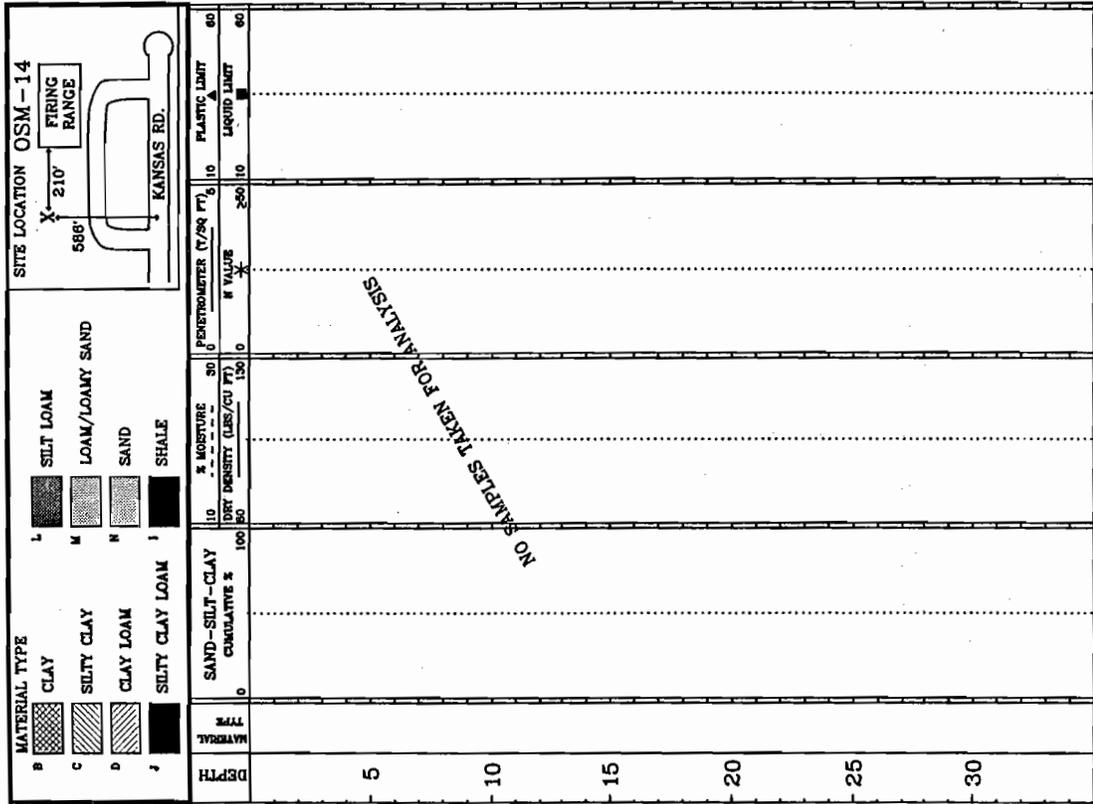
Dept. of Natural Resources  
 State of Indiana  
**BORING#14**  
 Page 1 of 1  
 LOCATION: 1/4 SE 1/4 SW 1/4 SE 1/4 SEC 24 T. 5 S. R. 10 W. ELEVATION: 380  
 DATE: METHOD: 4 IN. RIG: B-34 DRILLED BY: ARNOLD/RIDDLE  
 GAMMA LOGGED BY: CHITWOOD DESCRIBED BY: BLEUER

DEPTH	SAMPLE INTERVAL		DESCRIPTION
	FT	IN	
5			GAMMA-RAY LOG ONLY  WATER (ON RODS)
10			
15			
20			
25			
30			
			TD at 58'

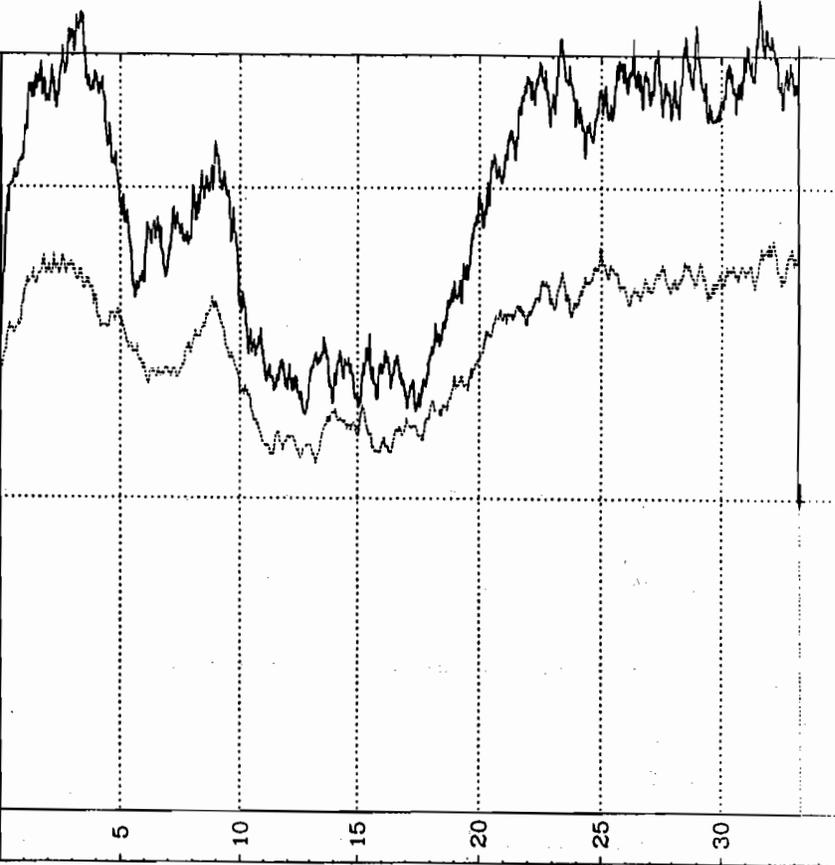
TC = 5 RATE = 5 FT/MIN OSM-15 LOG # 89-346

50-150 SCALE - SOLID  
0-200 SCALE - DASHED  
COUNTS PER SECOND  
(100 COUNTS = 76 API UNITS)  
200/150

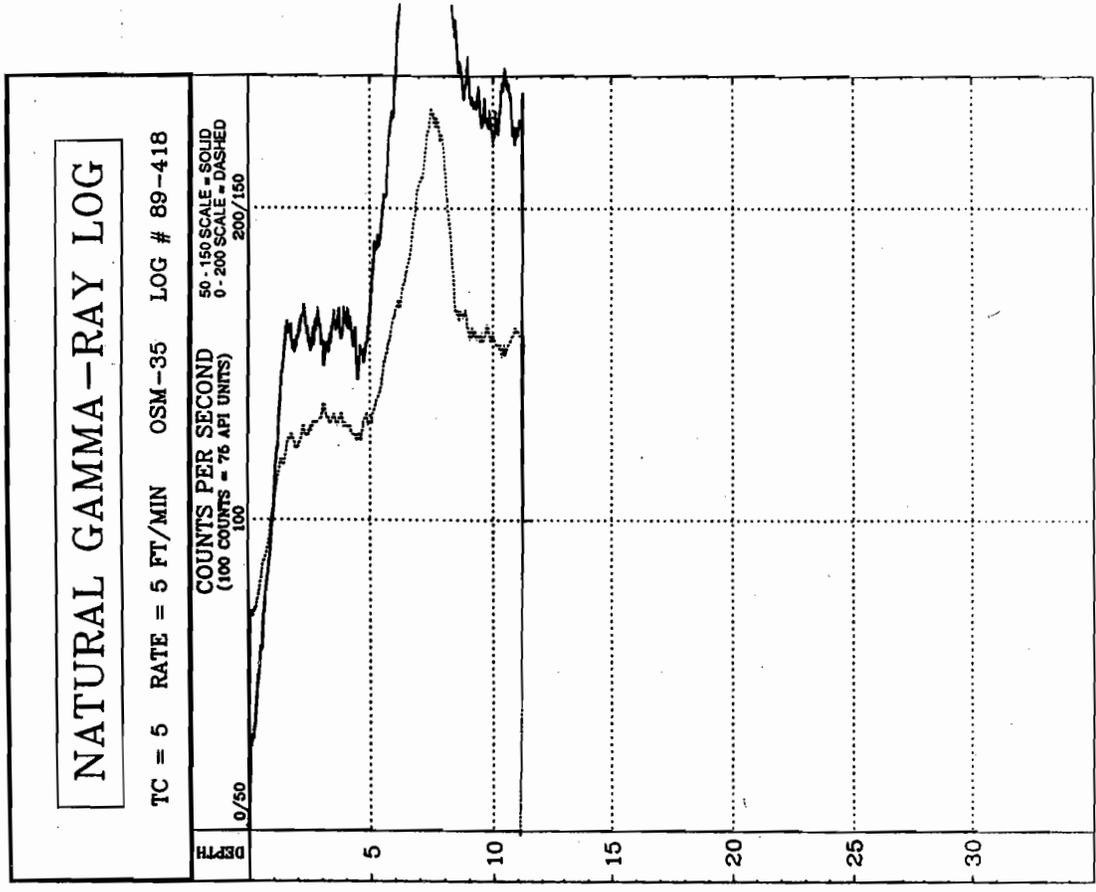
INDIANA GEOLOGICAL SURVEY Dept. of Natural Resources State of Indiana		BORING# 35 Page 1 of 1		
OSM - EVANSVILLE PROJECT		LOCATION: 1/4 SE1/4 NW1/4 SEC 2 T. 5 S. R. 10 W. ELEVATION: 480'		
METHOD: 4 IN. RIG: B-34		DRILLED BY: ARNOLD/RIDDLE		
GAMMA LOGGED BY: CHITWOOD		DESCRIBED BY: BLEUER		
DEPTH	SAMPLE INTERVAL			DESCRIPTION
	FEET	INCHES	FEET	
0				
5				
10				TD
15				
20				
25				
30

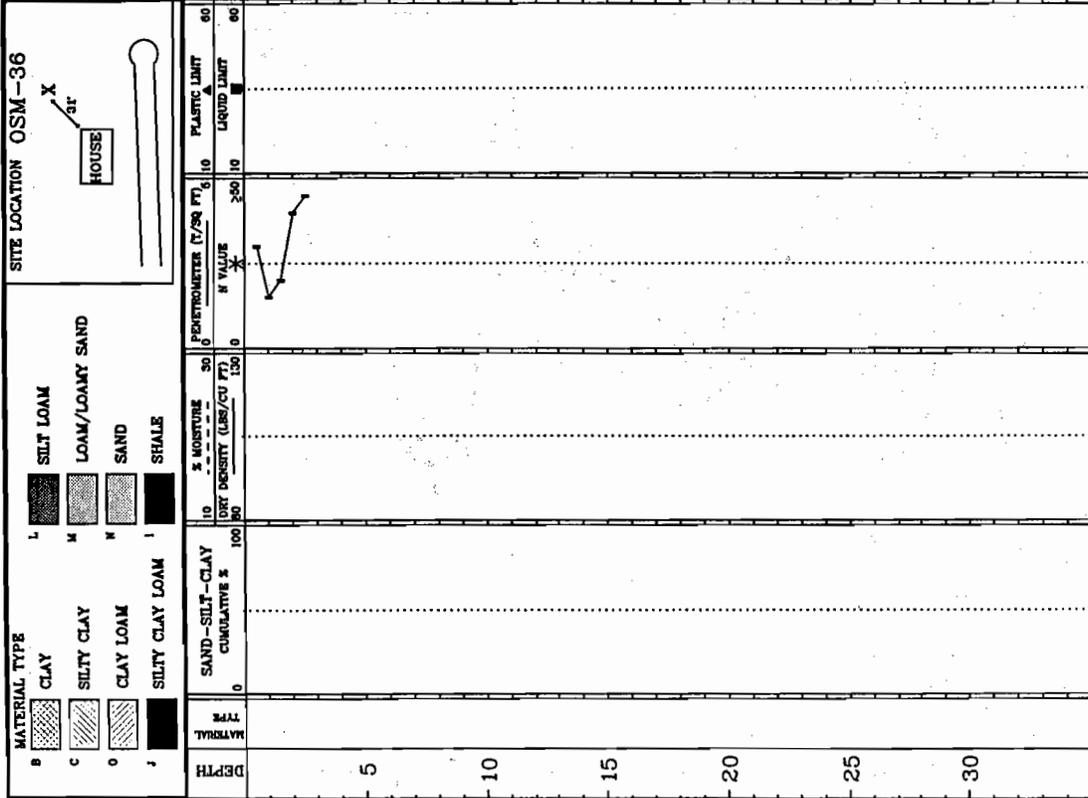
**BORING# 36**

**BORING DATA**

BORING DEPTH	P.P.	N VAL
in.	t/sq ft	
OSM-36 6	3.00	
OSM-36 12	1.50	
OSM-36 18	2.00	
OSM-36 24	4.00	
OSM-36 30	4.50

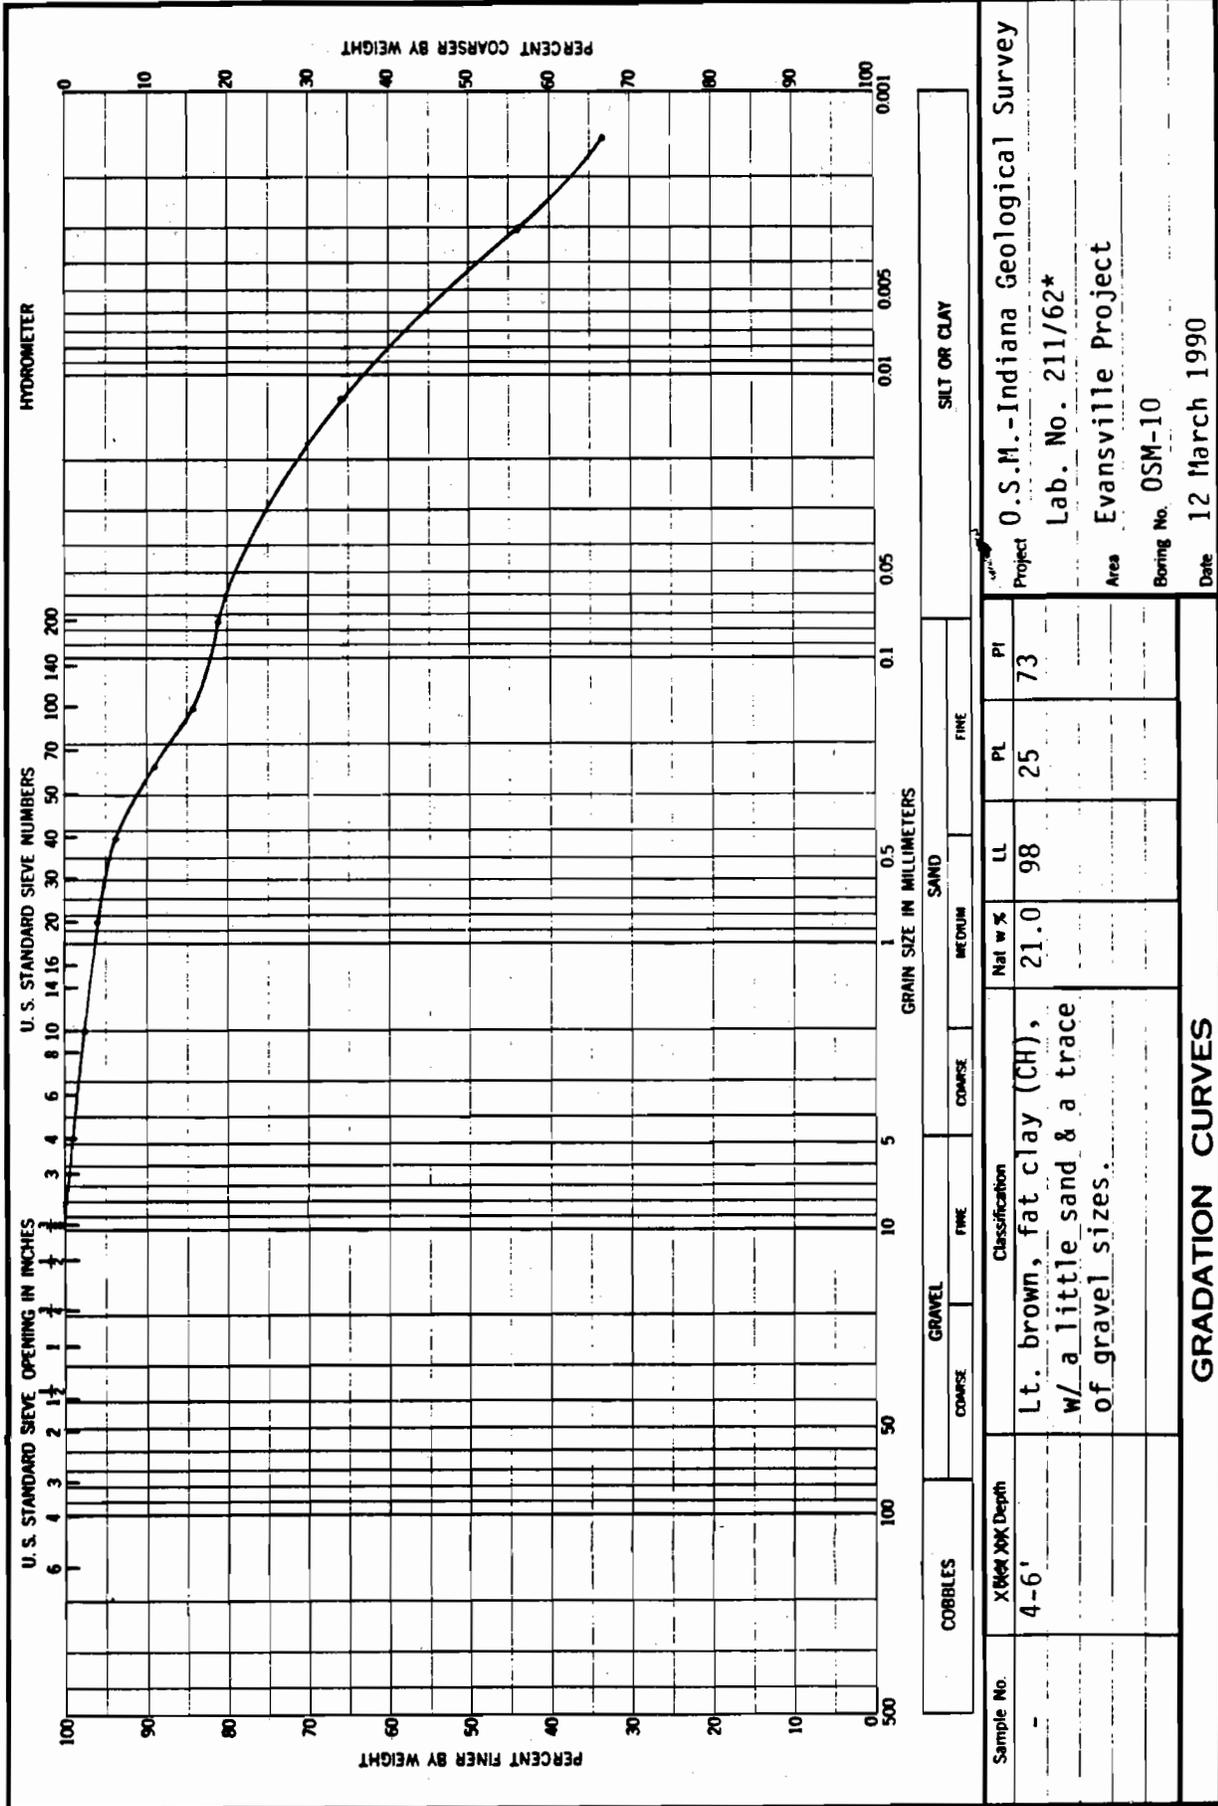
COBBLES		GRAVEL		SAND		FINE		SILT OR CLAY		
Sample No.	X 644 JK Depth 4-6'	Classification	Lt. brown, fat clay (CH), w/ a little sand & a trace of gravel sizes.		LL	98	PL	25	PI	73
				Nat w %		21.0				
Project: O.S.M.-Indiana Geological Survey										
Lab. No. 211/62*										
Area: Evansville Project										
Boring No. OSM-10										
Date: 12 March 1990										
<b>GRADATION CURVES</b>

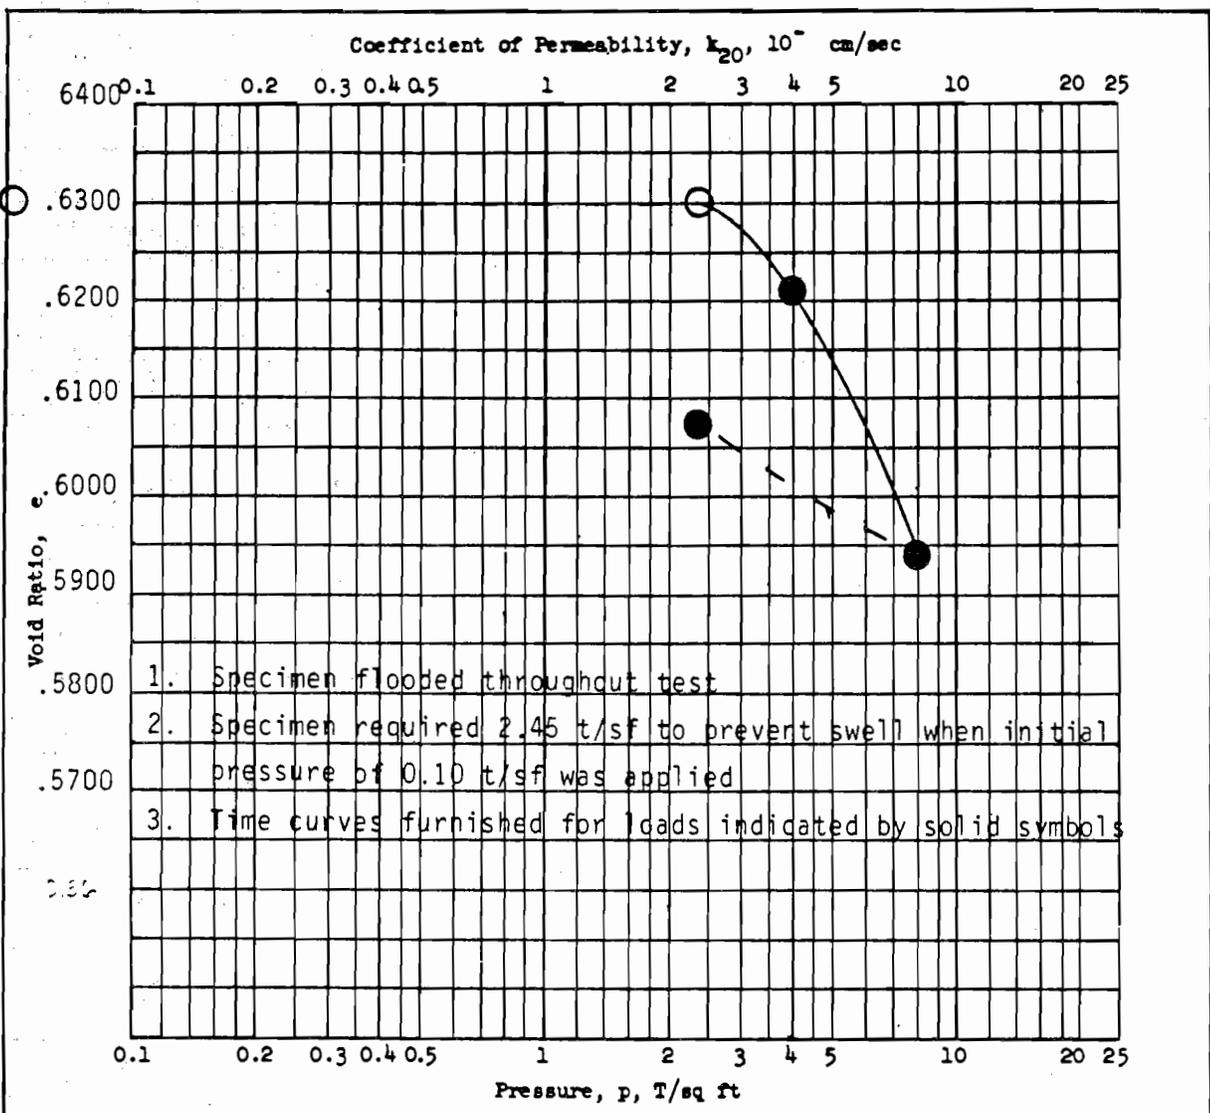
1. Specimen flooded throughout test
2. Specimen required 2.45 t/sf to prevent swell when initial pressure of 0.10 t/sf was applied
3. Time curves furnished for loads indicated by solid symbols

Type of Specimen		undisturbed		Before Test		After Test	
Diam	2.49 in.	Ht	1.00 in.	Water Content, $w_o$	19.5 %	$w_f$	21.9 %
Overburden Pressure, $P_o$	T/sq ft			Void Ratio, $e_o$	.630	$e_f$	.607
Preconsol. Pressure, $P_c$	T/sq ft			Saturation, $S_o$	85.6 %	$S_f$	100.0 %
Compression Index, $C_c = 0.086$				Dry Density, $\gamma_d$			
Lt. brown, fat clay (CH), w/ a little sand & trace of gravel sizes				$k_{20}$ at $e_o =$ $\times 10^{-7}$ cm/sec			
LL	98	$G_s$	2.77	Project O.S.M. Indiana Geological Survey			
PL	25	$D_{10}$	< 0.002mm	Lab. No. 211/62			
Remarks See gradation curve and additional information on ENG Form 2087.				Area Evansville Project			
				Boring No. OSM-10		Sample No. --	
				Depth 4-6'		Date 12 March 1990	
<b>CONSOLIDATION TEST REPORT</b>

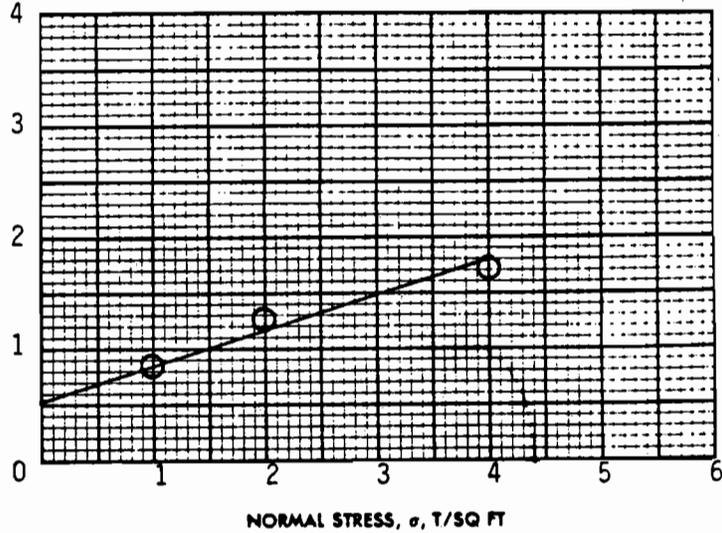
SHEAR STRENGTH,  $s$ , T/SQ FT

TEST NO.		1	2	3	
INITIAL	WATER CONTENT	$w_o$ 18.9 %	20.3 %	24.4 %	%
	VOID RATIO	$e_o$ .664	.692	.796	
	SATURATION	$S_o$ 78.9 %	81.4 %	84.8 %	%
	DRY DENSITY, LB/ CU FT	$\gamma_d$ 103.9	102.2	96.3	
VOID RATIO AFTER CONSOLIDATION		$e_c$ .666	.696	.727	
TIME FOR 50 PERCENT CONSOLIDATION, MIN		$t_{50}$	SPECIMENS SWELLED		
FINAL	WATER CONTENT	$w_f$ 24.5 %	22.7 %	25.5 %	%
	VOID RATIO	$e_f$ .680	.696	.706	
	SATURATION	$S_f$ 100.0 %	100.0 %	100.0 %	%
NORMAL STRESS, T/SQ FT		$\sigma$ 1.0	2.0	4.0	
MAXIMUM SHEAR STRESS, T/SQ FT		$\tau_{max}$ 0.86	1.24	1.71	
ACTUAL TIME TO FAILURE, MIN		$t_f$ 45	45	60	
RATE OF STRAIN, IN./MIN		.0007	.0007	.0007	
ULTIMATE SHEAR STRESS, T/SQ FT		$\tau_{ult}$ 0.50	.92	1.04

TYPE OF SPECIMEN undisturbed 2.00 IN. SQUARE 0.50 IN. THICK

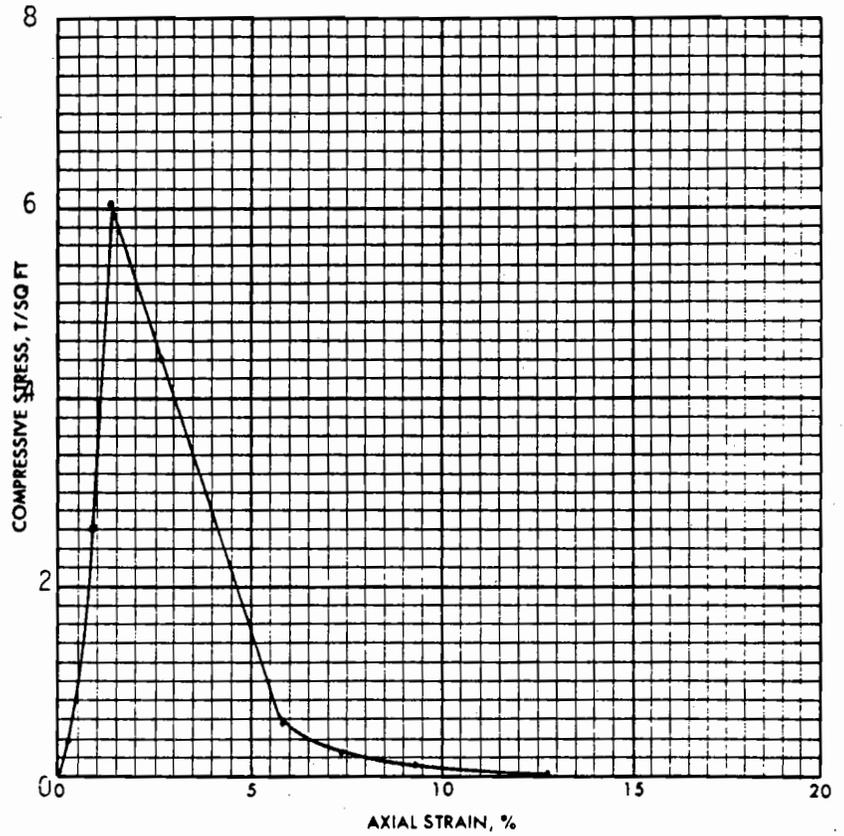
TEST NO.		1			
TYPE OF SPECIMEN		undisturbed			
INITIAL	WATER CONTENT	w <sub>o</sub>	21.9 %	%	%
	VOID RATIO	e <sub>o</sub>	.693		
	SATURATION	s <sub>o</sub>	87.3 %	%	%
	DRY DENSITY, LB/CU FT	γ <sub>d</sub>	102.1		
TIME TO FAILURE, MIN		t <sub>f</sub>	4.75		
UNCONFINED COMPRESSIVE STRENGTH, T/SQ FT		q <sub>u</sub>	6.01		
UNDRAINED SHEAR STRENGTH, T/SQ FT		s <sub>u</sub>	3.00		
Rate of strain, %/min		s <sub>i</sub>	0.75		
INITIAL SPECIMEN DIAMETER, IN		D <sub>o</sub>	1.38		
INITIAL SPECIMEN HEIGHT, IN.		H <sub>o</sub>	3.08		
CLASSIFICATION Lt. brown, fat clay (CH), w/ a little sand & trace of gravel sizes					
LL	98	PL	25	PI	73

G.	2.77
REMARKS See gardation curve and additional information on ENG Form 2087.		PROJECT OSM-Indiana Geological Survey			
		Lab. No. 211/62			
		AREA Evansville Project			
		BORING NO. OSM-10		SAMPLE NO. --	
		DEPTH 4-6'		DATE 12 March 1990	
<b>UNCONFINED COMPRESSION TEST REPORT</b>

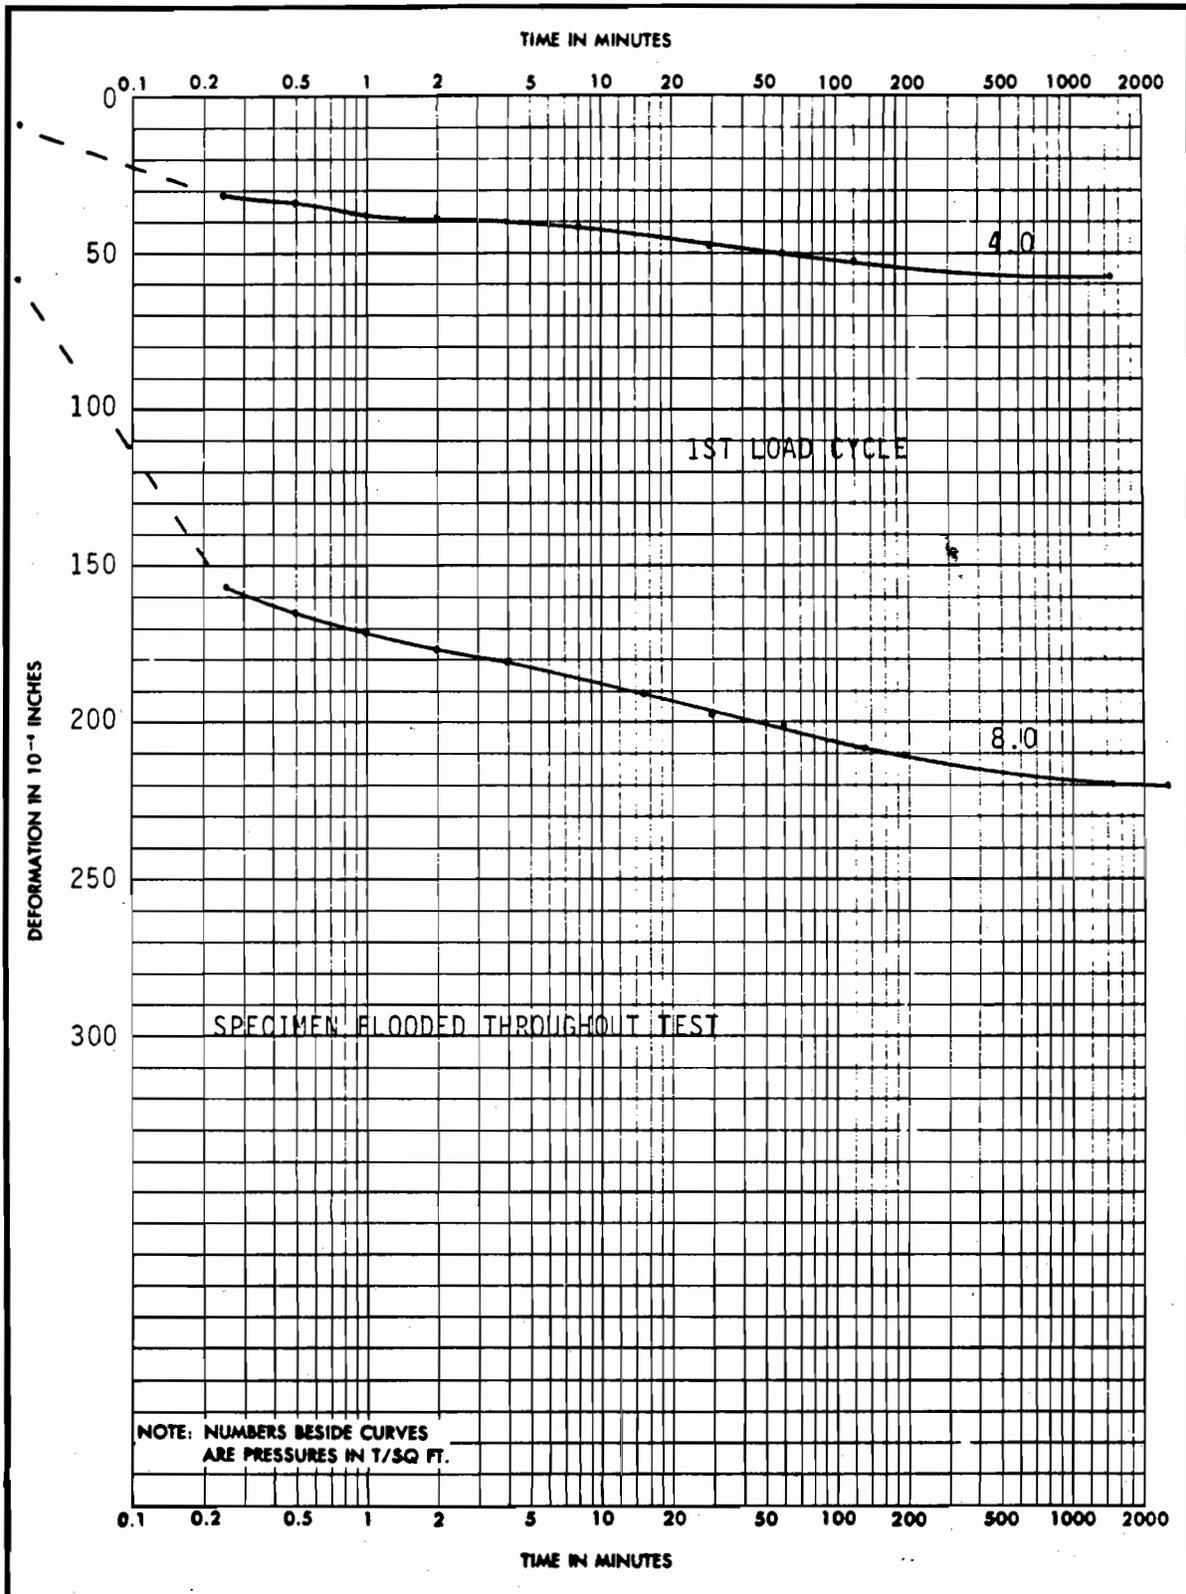
PROJECT O.S.M. - Indiana Geological Survey			
AREA Evansville Project		Lab. No. 211/62	
BORING NO. OSM-10	SAMPLE NO. --	DEPTH EX 4-6'	DATE 12 March 1990
ENG FORM 2088 1 MAY 63	PREVIOUS EDITIONS ARE OBSOLETE.	<b>CONSOLIDATION TEST—TIME CURVES</b> (TRANSLUCENT)

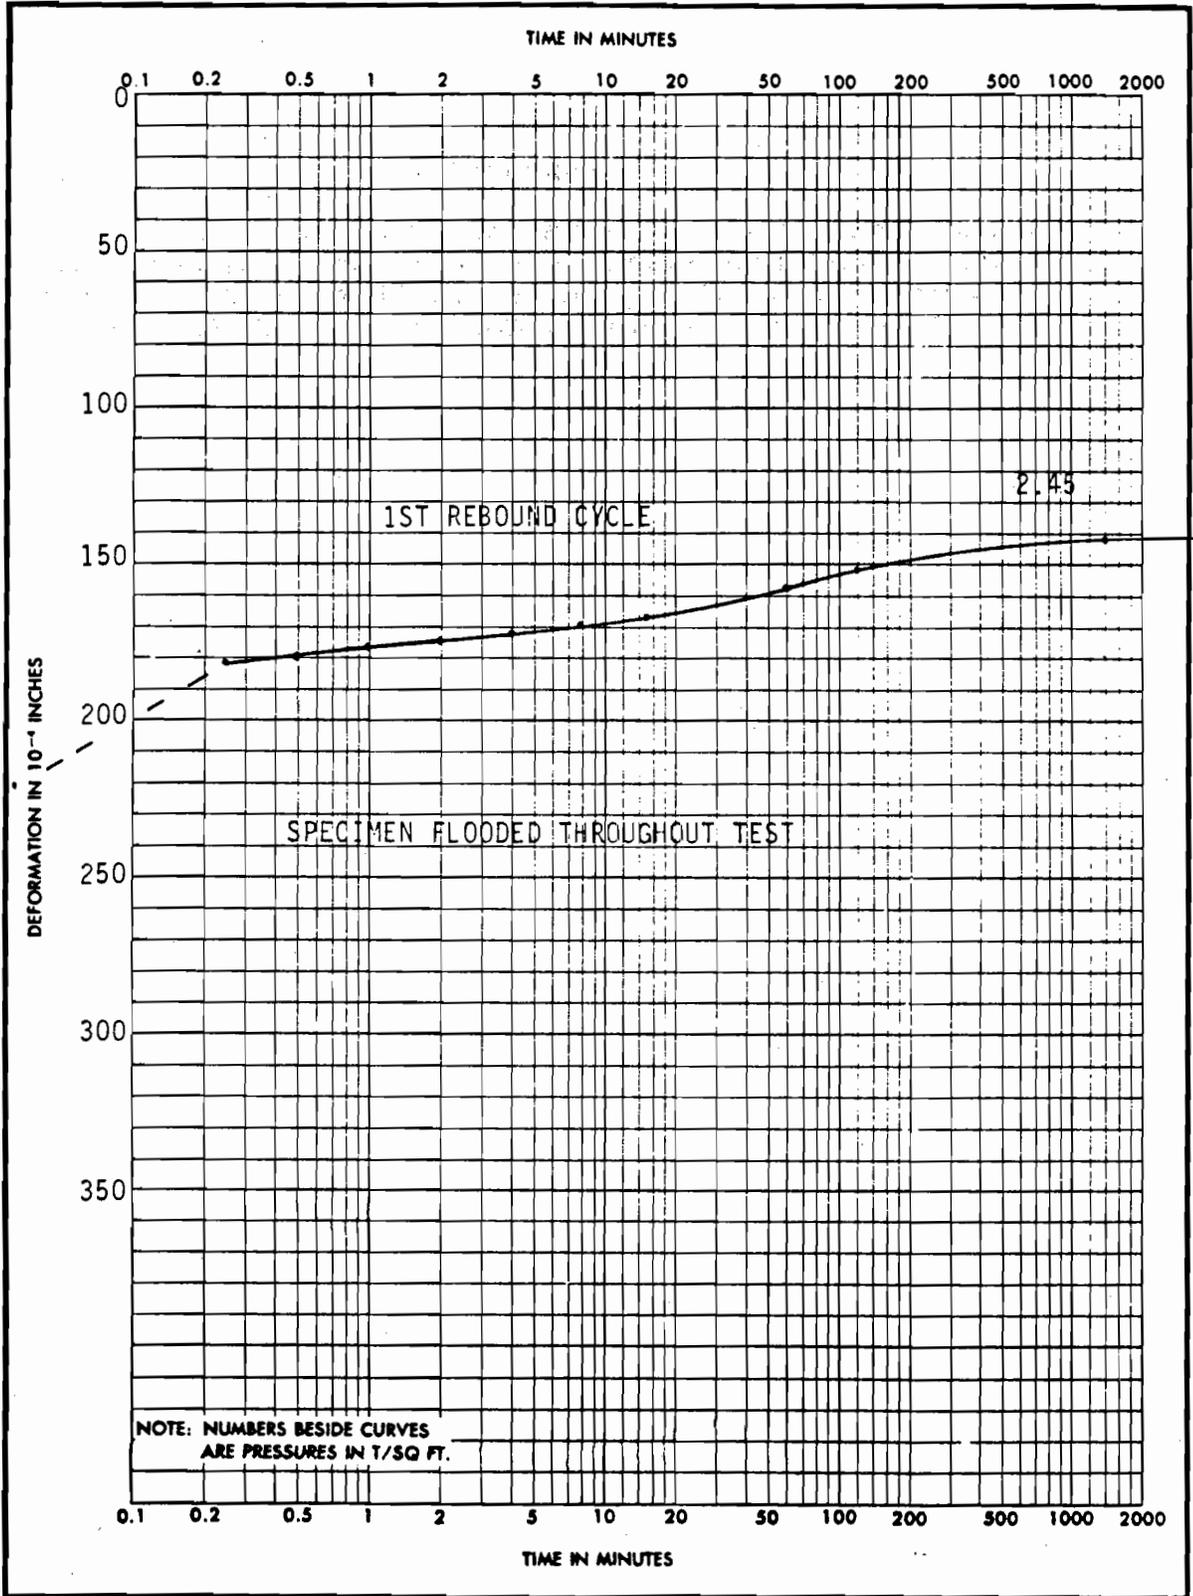
PROJECT O.S.M. - Indiana Geological Survey			
AREA Evansville Project Lab. No. 211/62			
BORING NO. OSM-10	SAMPLE NO. ---	DEPTH 4-6'	DATE 12 March 1990
ENG FORM 2088 1 MAY 63	PREVIOUS EDITIONS ARE OBSOLETE.	CONSOLIDATION TEST—TIME CURVES (TRANSLUCENT)
