**INVESTIGATION OF DAMAGE TO STRUCTURES  
IN THE M<sup>c</sup>CUTCHANVILLE-DAYLIGHT  
AREA OF SOUTHWESTERN INDIANA**

**Volume 3 of 3**

**Part IX: Environmental Conditions Related to Geology, Soils, and Precipitation, McCutchanville and Daylight, Vanderburgh County, Indiana.**

PART IX: ENVIRONMENTAL CONDITIONS  
RELATED TO GEOLOGY, SOILS, AND PRECIPITATION  
McCUTCHANVILLE AND DAYLIGHT, VANDERBURGH COUNTY, IN

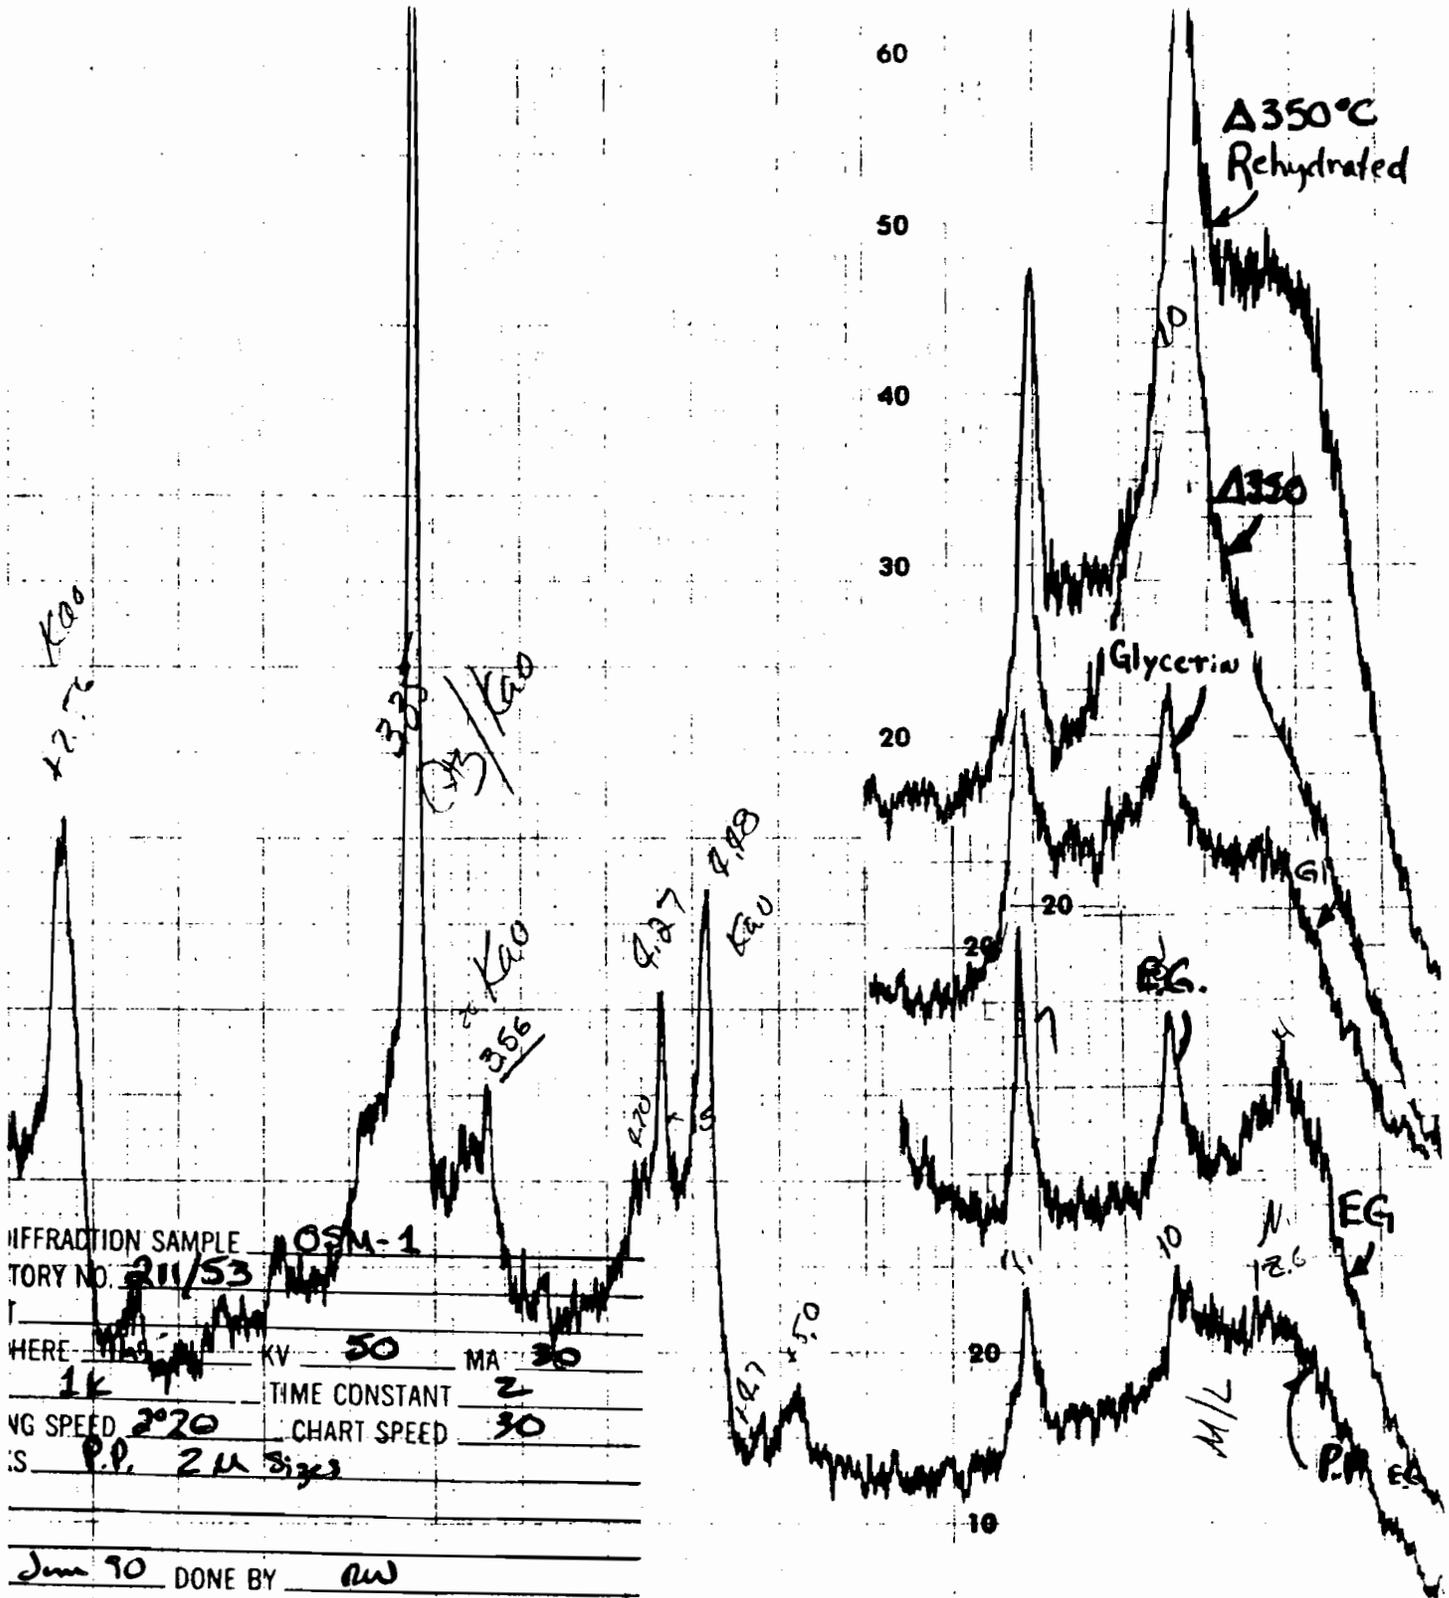
Plate 1. X-ray diffractograms for Sample OSM-1, d. 30-52 inches.

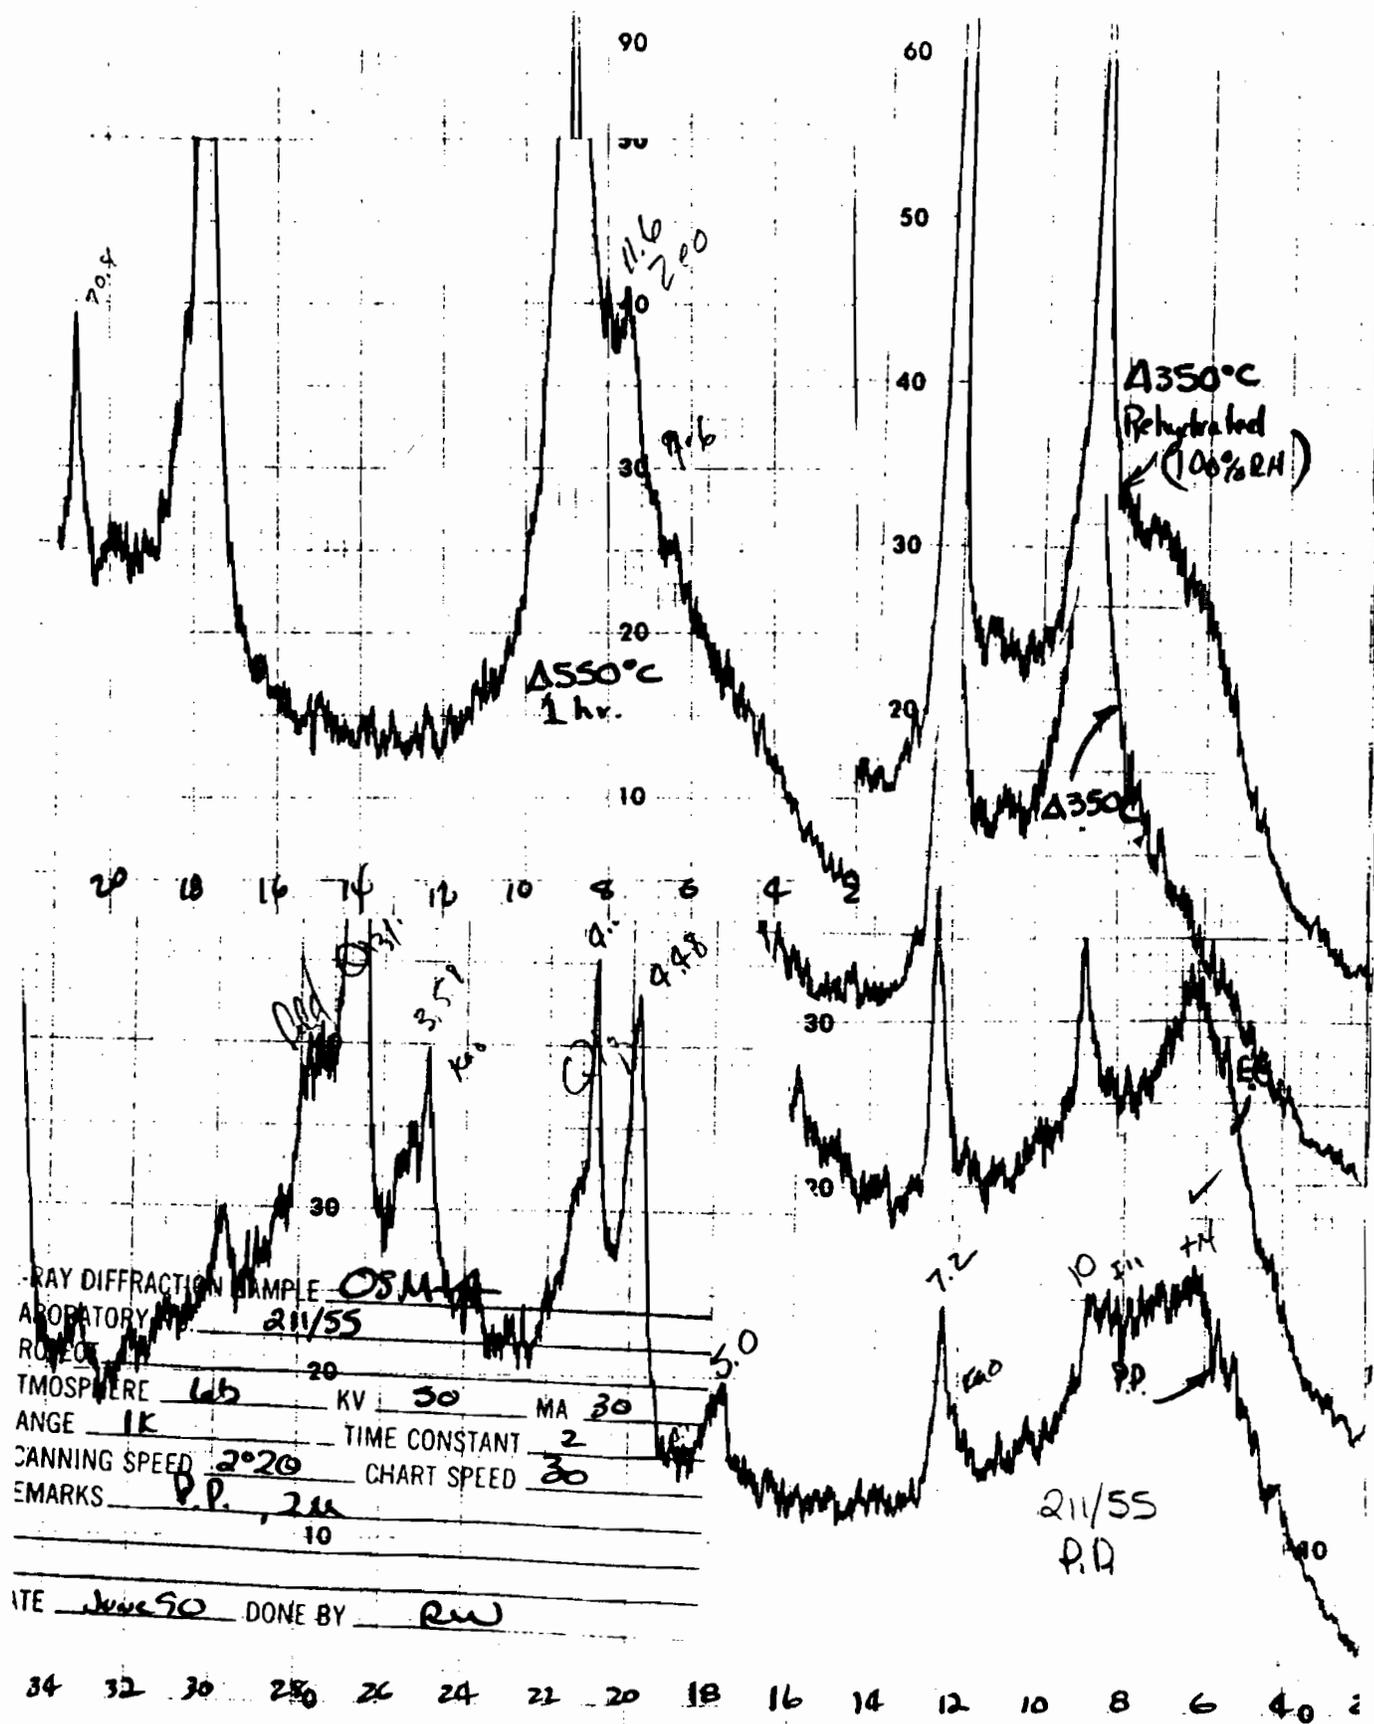
Plate 2. X-ray diffractograms for Sample OSM-4, d. 3-5 feet.

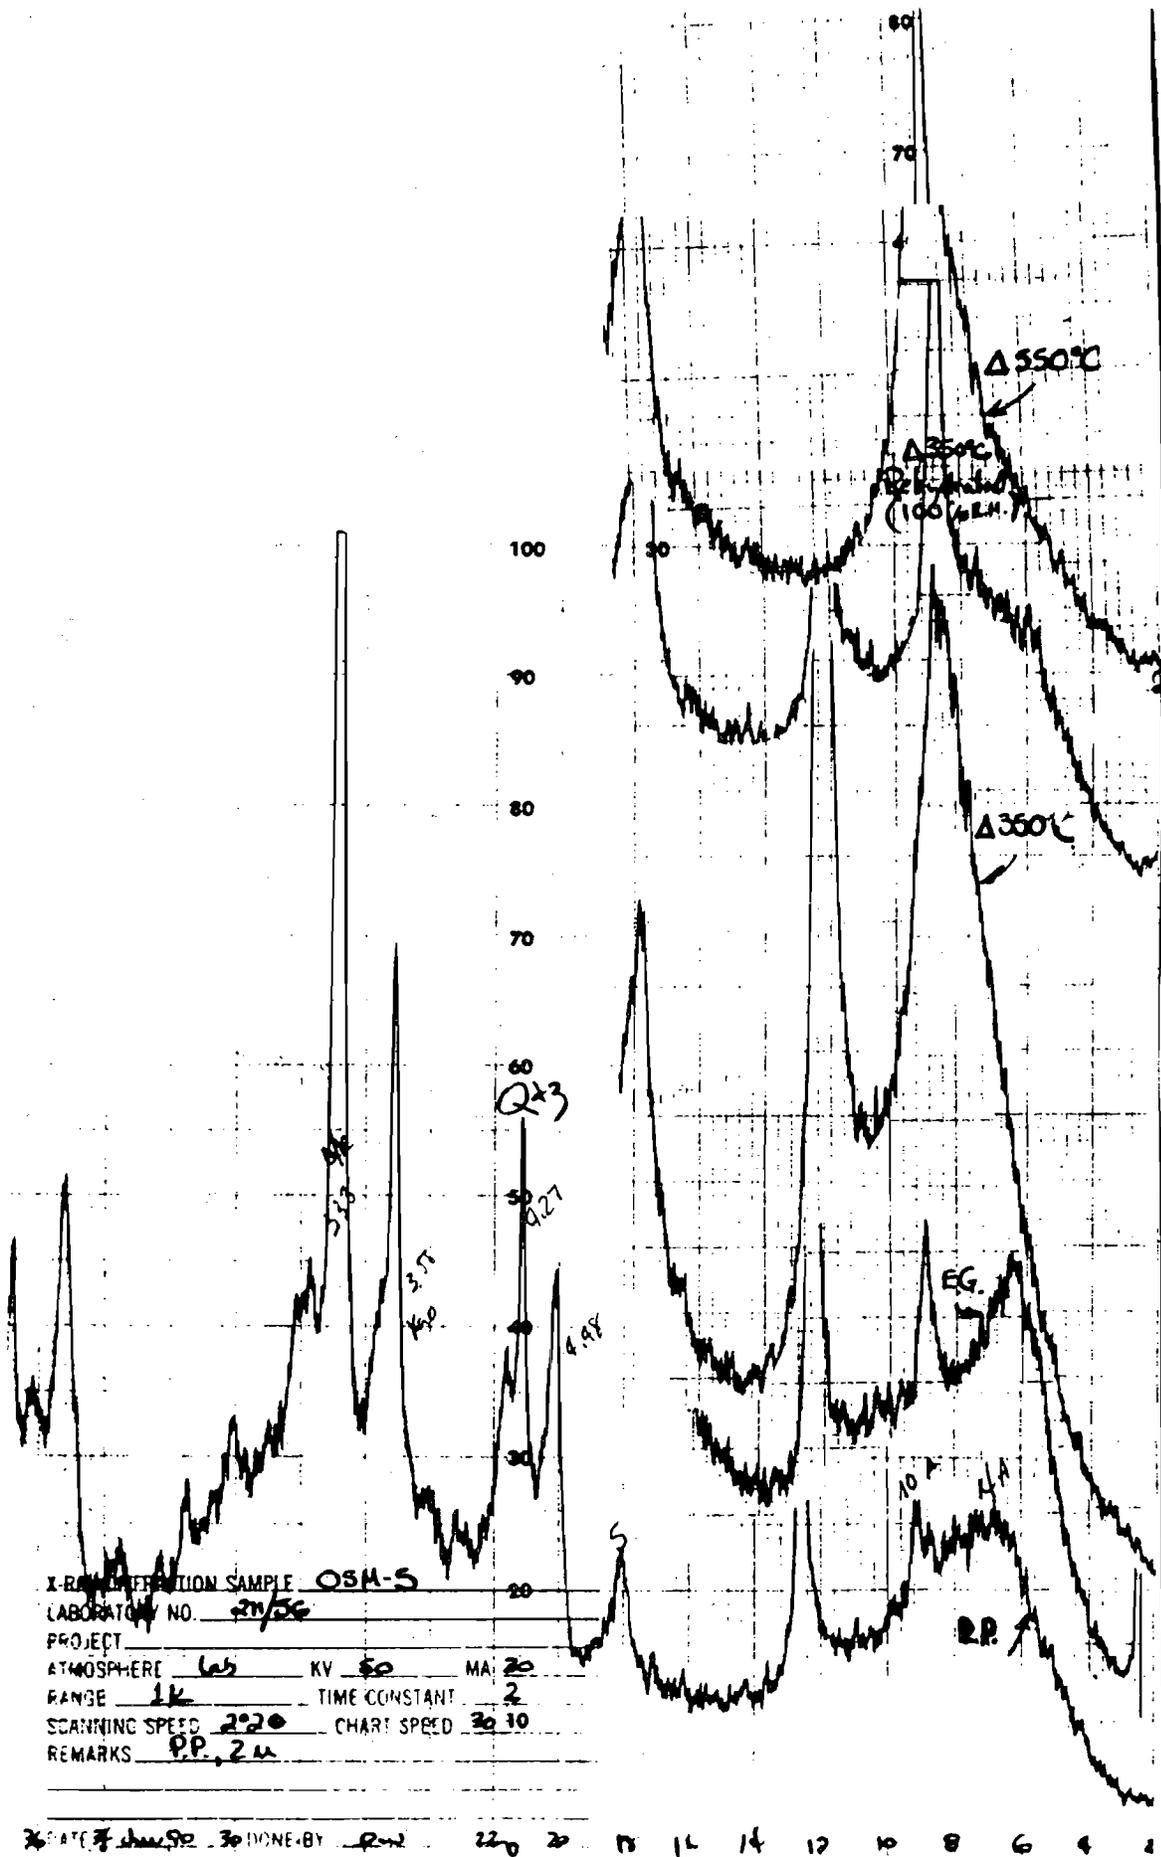
Plate 3. X-ray diffractograms for Sample OSM-5, d. 3-5 feet.

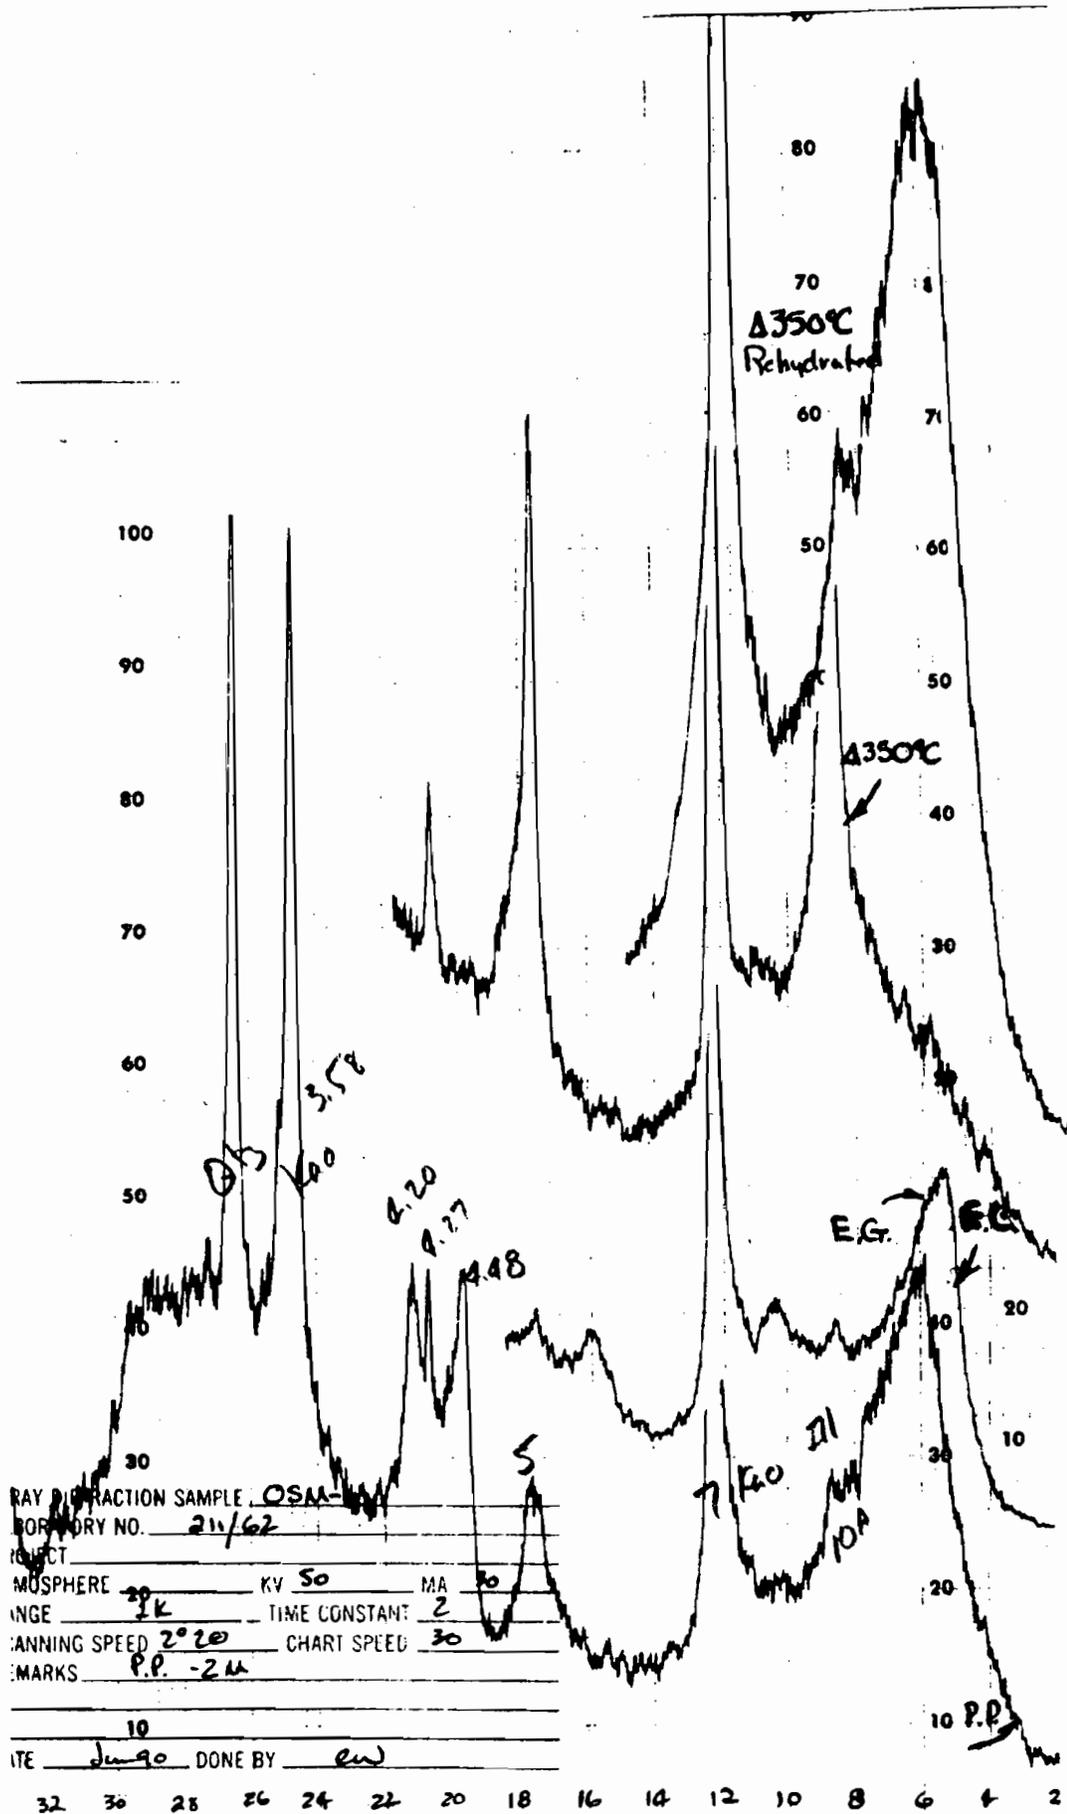
X-RAY DIFFRACTION SAMPLE OSM-10  
 LABORATORY NO. 211/62  
 PROJECT \_\_\_\_\_  
 ATMOSPHERE 20 KV 50 MA 10  
 RANGE 2K TIME CONSTANT 2  
 SCANNING SPEED 2°/20 CHART SPEED 30  
 MARKS P.P. - 2μ  
 DATE Jun 90 DONE BY ew

Plate 4. X-ray diffractograms for Sample OSM-10, d. 4-6 feet.

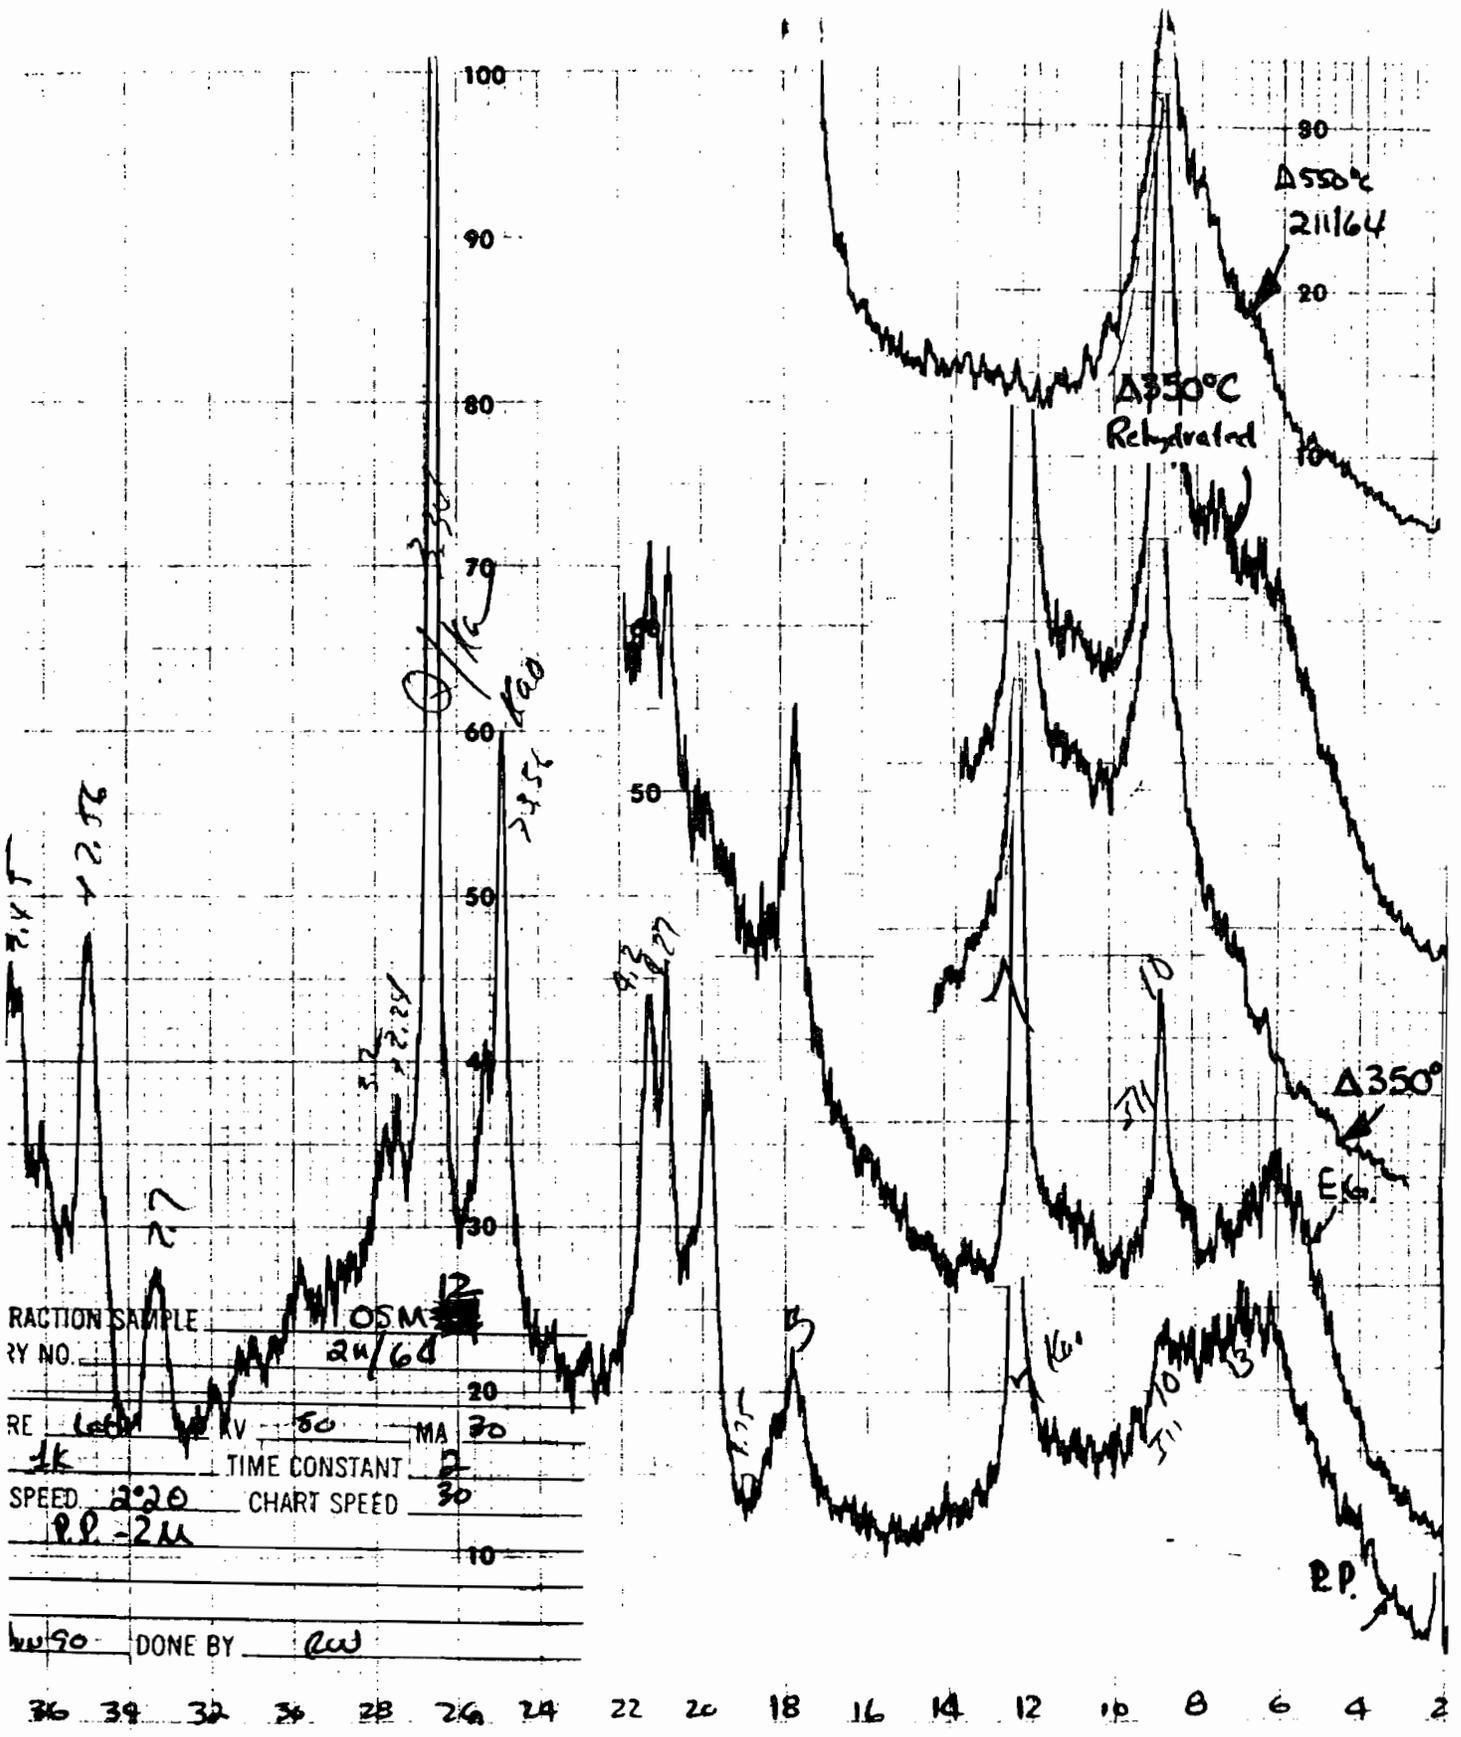
Plate 5. X-ray diffractograms for Sample OSM-12, d. 9-11 feet.

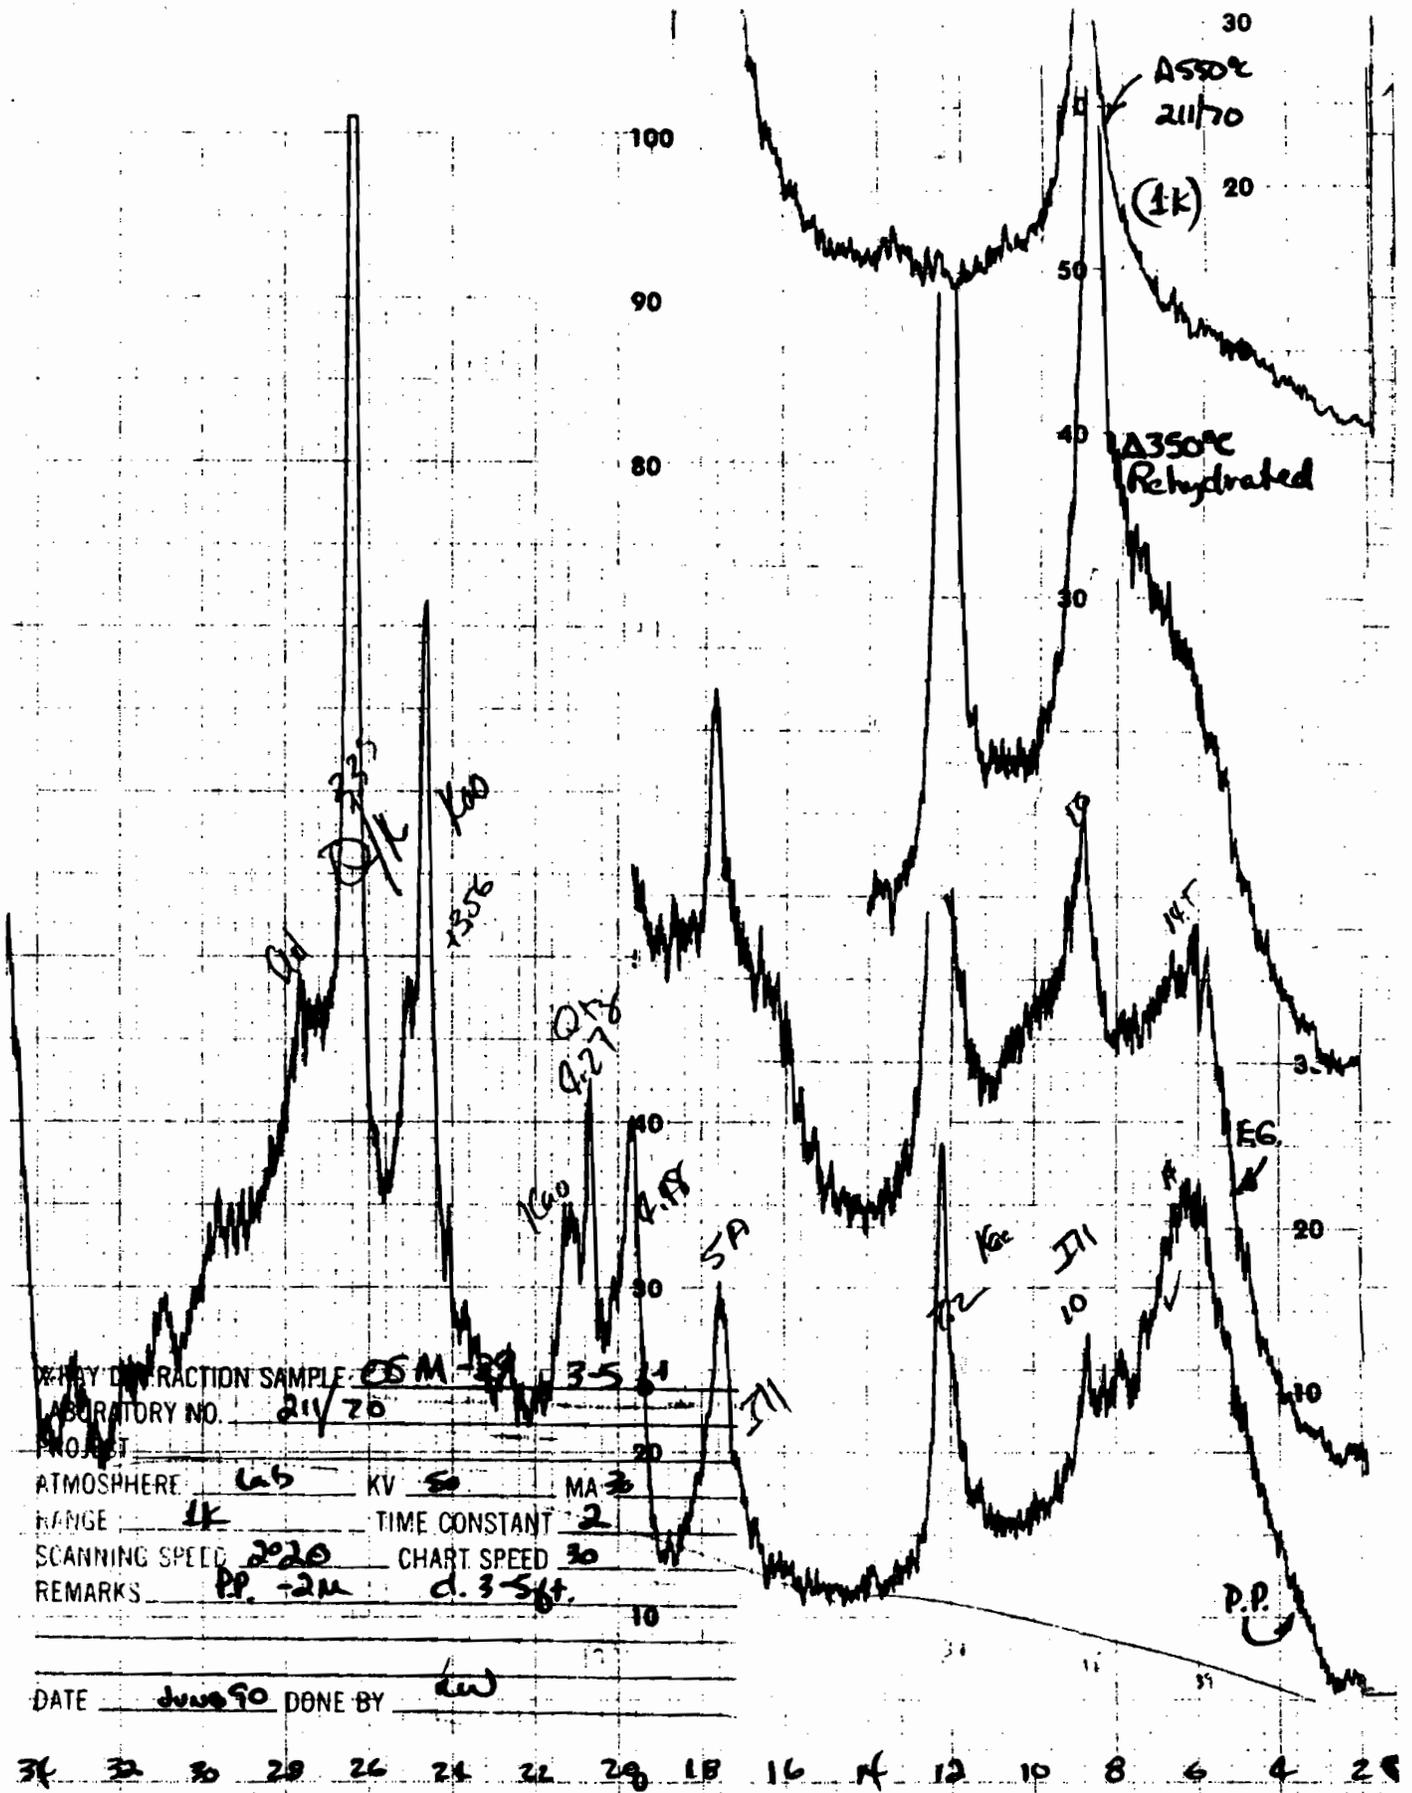
X-RAY DIFFRACTION SAMPLE: OSM-29 d. 9-11  
 LABORATORY NO. 211/70  
 PROJECT \_\_\_\_\_  
 ATMOSPHERE: Lab KV 50 MA 3  
 RANGE: 1k TIME CONSTANT 2  
 SCANNING SPEED 2020 CHART SPEED 30  
 REMARKS: P.P. -2u d. 3-5ft.

Plate 6. X-ray diffractograms for Sample OSM-29, d. 9-11 feet.

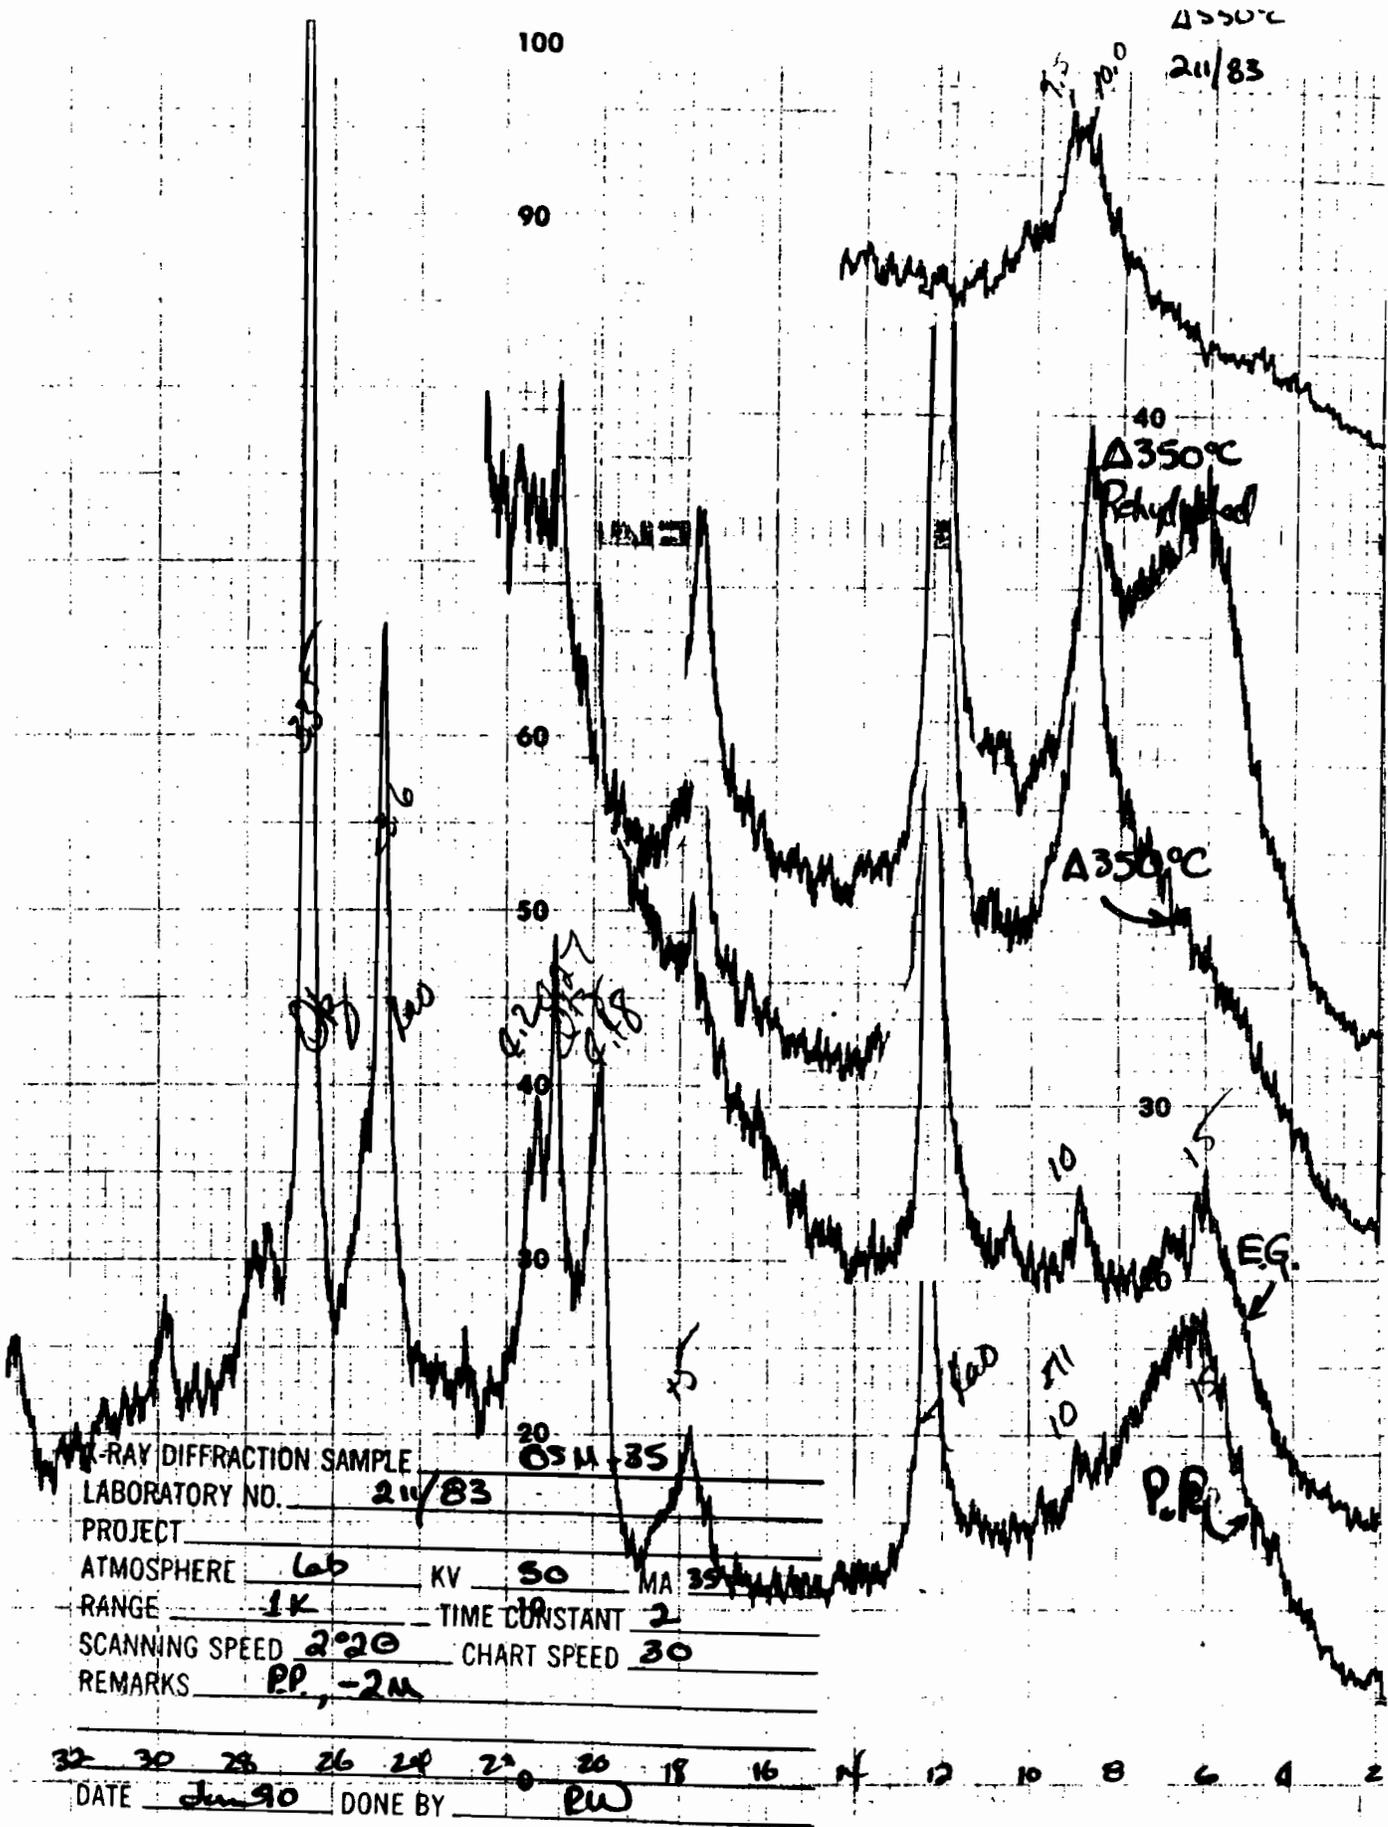
Plate 7. X-ray diffractograms for Sample OSM-35, d. 3-5 feet

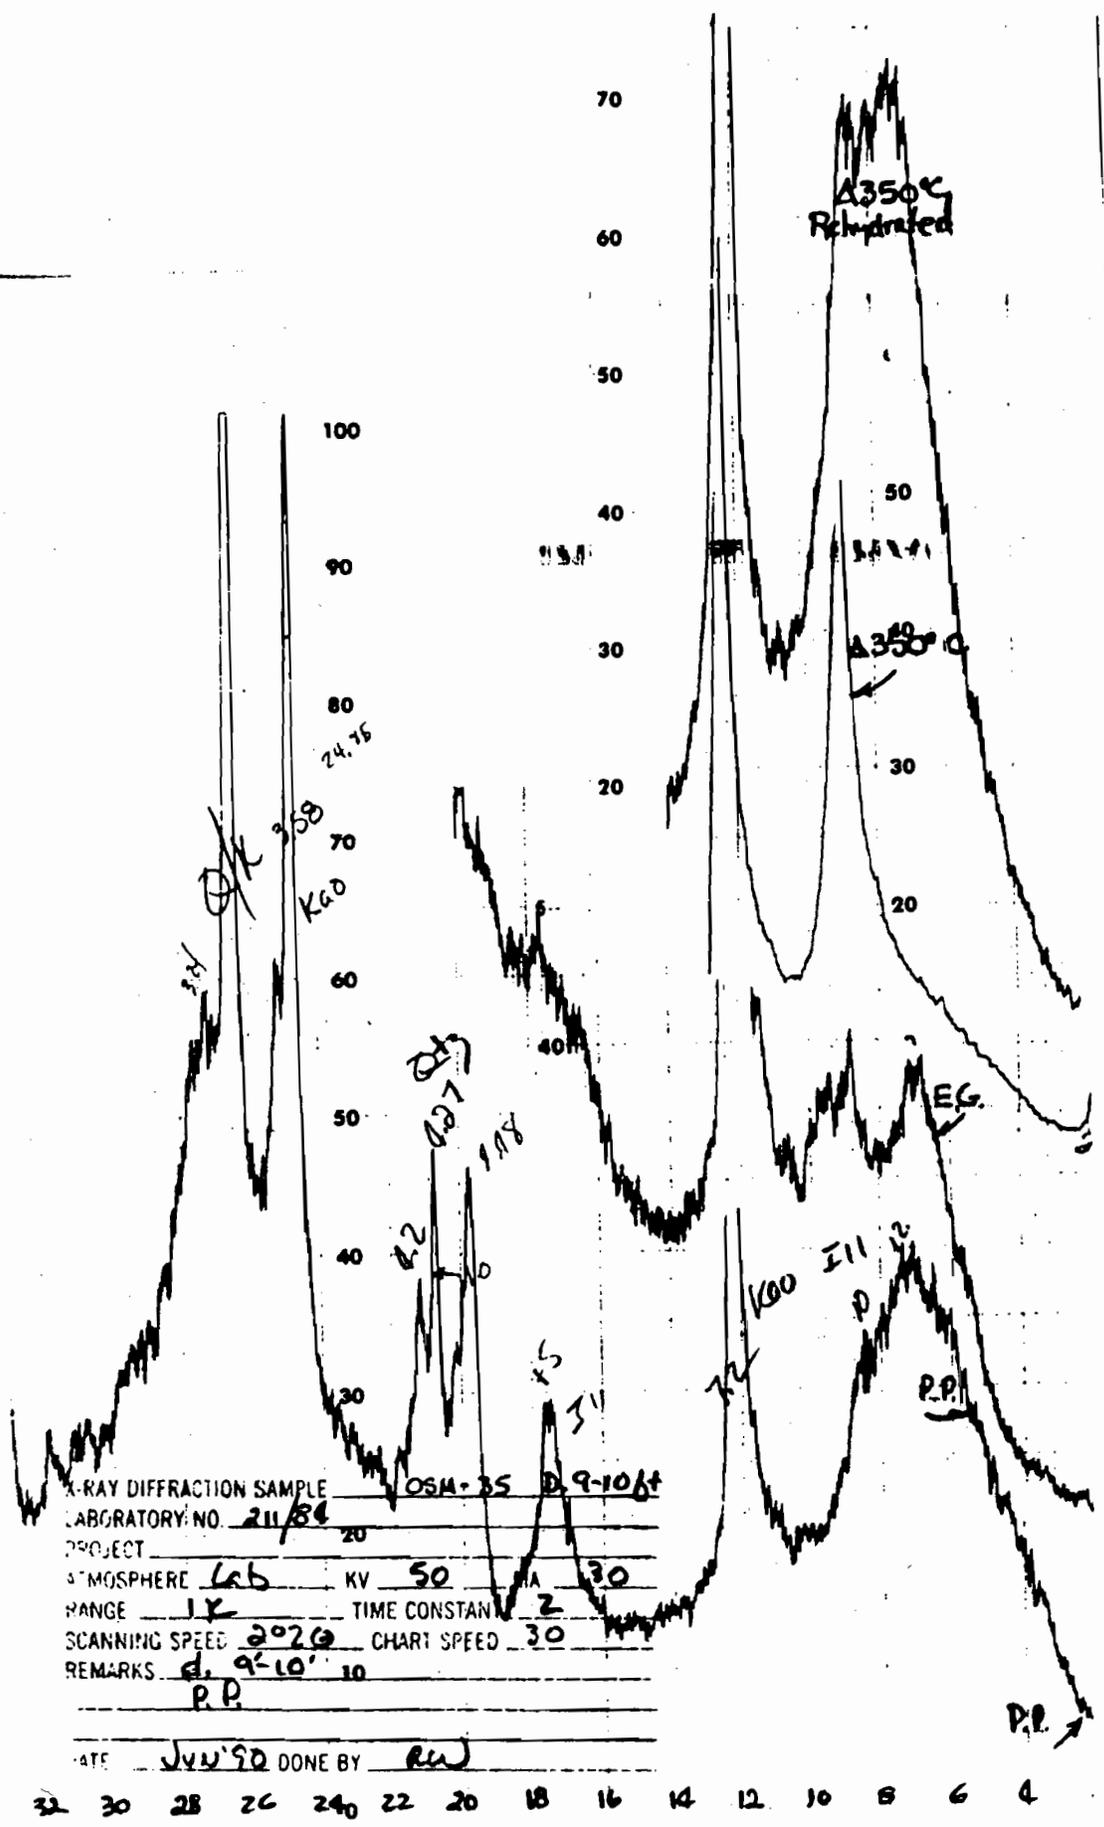
Plate 8. X-ray diffractograms for Sample OSM-35, d. 9-10 feet.
