Report of Investigations 8896

Effects of Repeated Blasting on a Wood-Frame House

By Mark S. Stagg, David E. Siskind,
Michael G. Stevens, and Charles H. Dowding

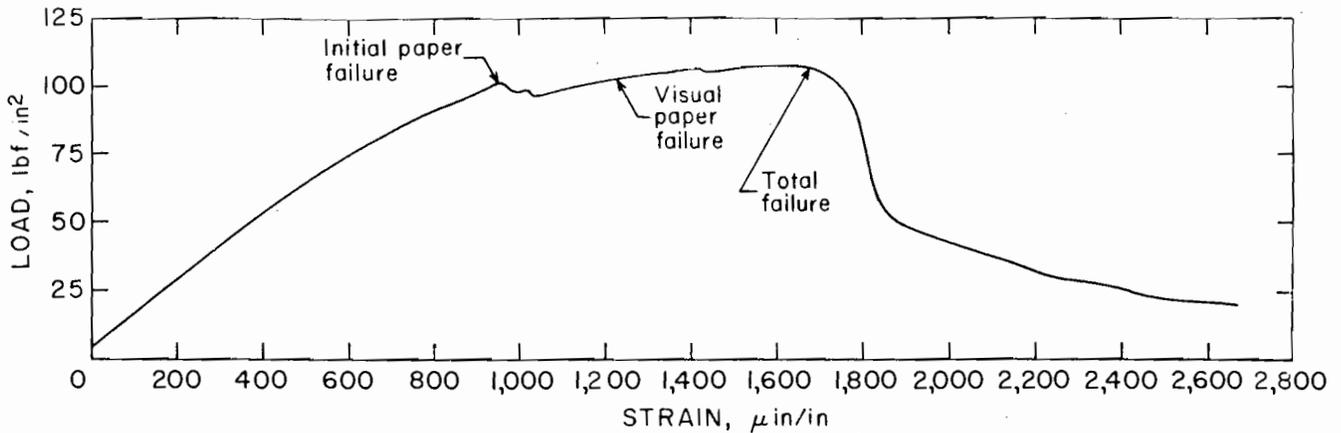
FIGURE 1. - Tensile stress strain-deformation curve for 1/2-in-thick wallboard.

- For visual cracking, paper failure is the controlling factor. Its nonlinear response point occurs at $\sim 1,000$ to $1,200 \mu\text{in}/\text{in}$ (fig. 1). However, visual observation of buckling or cracking is not possible until a slightly higher strain level is reached.

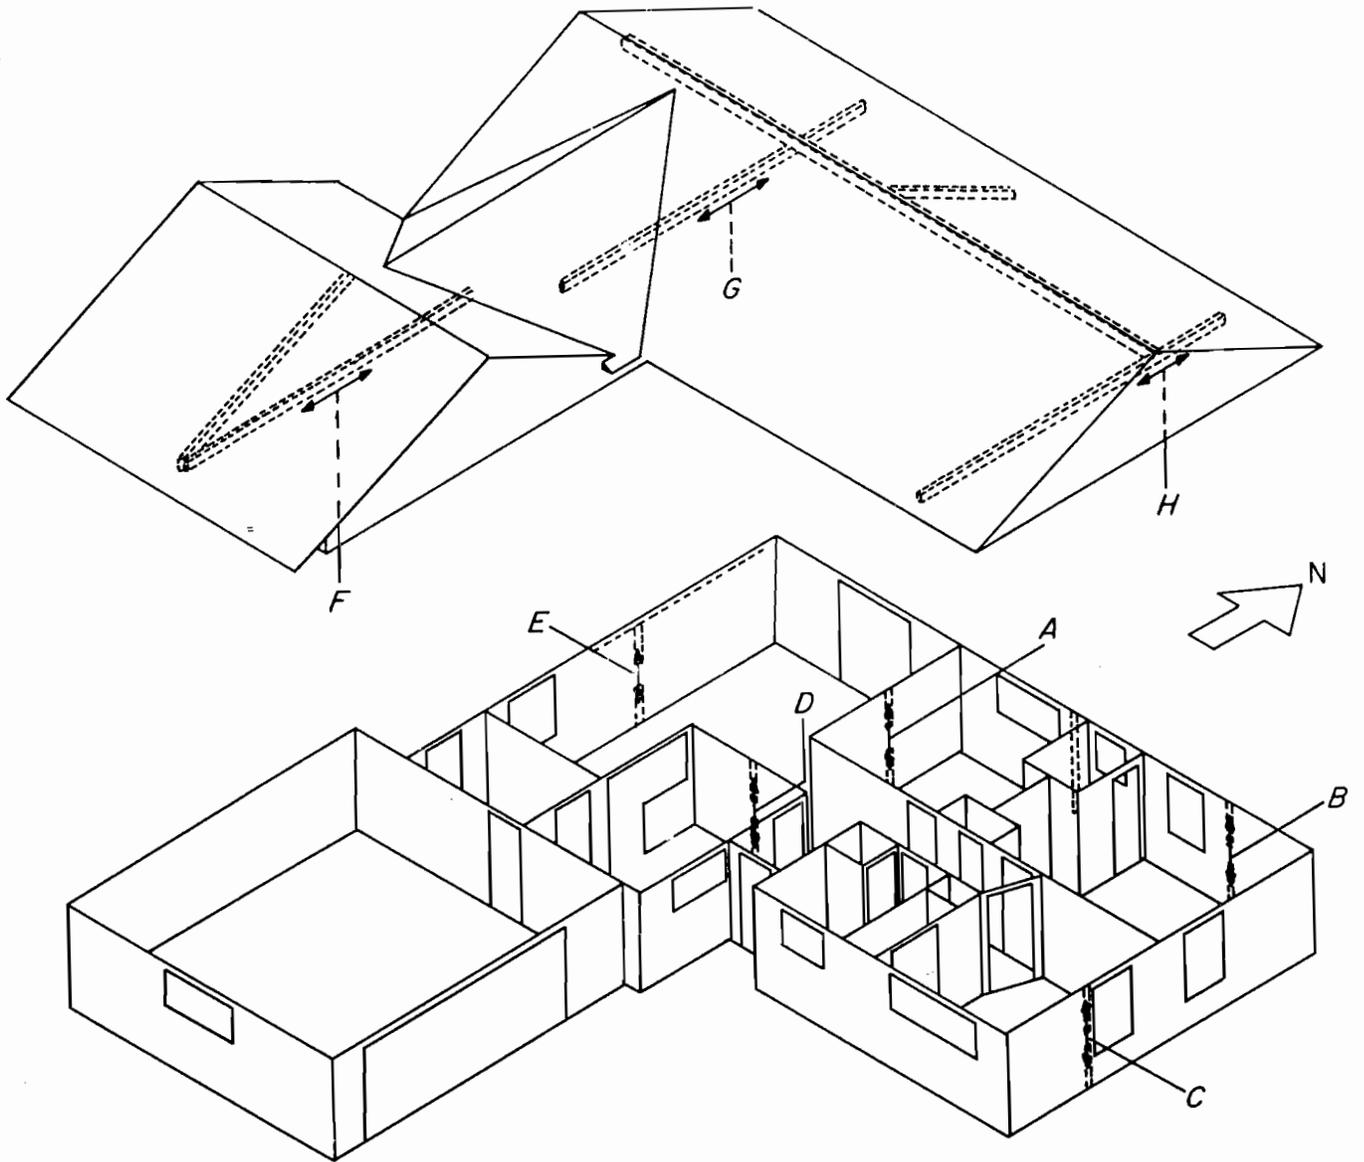
FIGURE 2. - Strain gauge locations in sonic boom study (3), house 1. (*Italic letters identify locations listed in table 1.*)

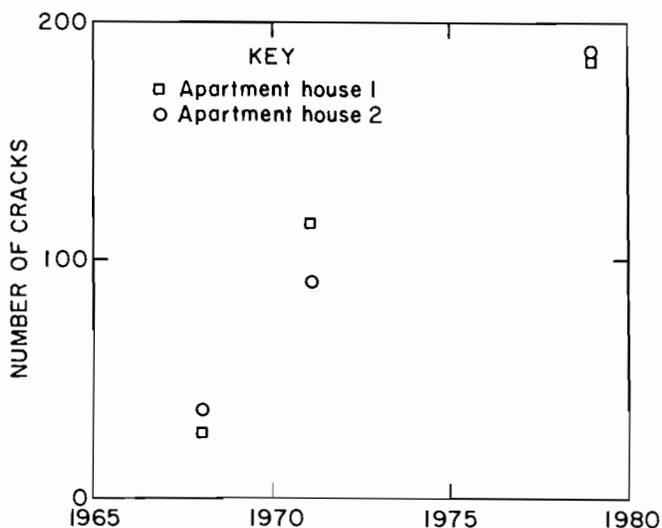
FIGURE 3. - Building age versus crack occurrences, after Holmberg (27).

Structures crack naturally over time, and this section reports the results of several studies wherein the rates of crack occurrences were measured. Holmberg (27) recently analyzed inspection reports to estimate a crack rate for apartment buildings in Sweden. Two apartment buildings were inspected for cracks three times between 1968 and 1980. The number of observed cracks is plotted as a function of time in figure 3. An average of 12 to 13 new cracks per year occurred for these particular structures.

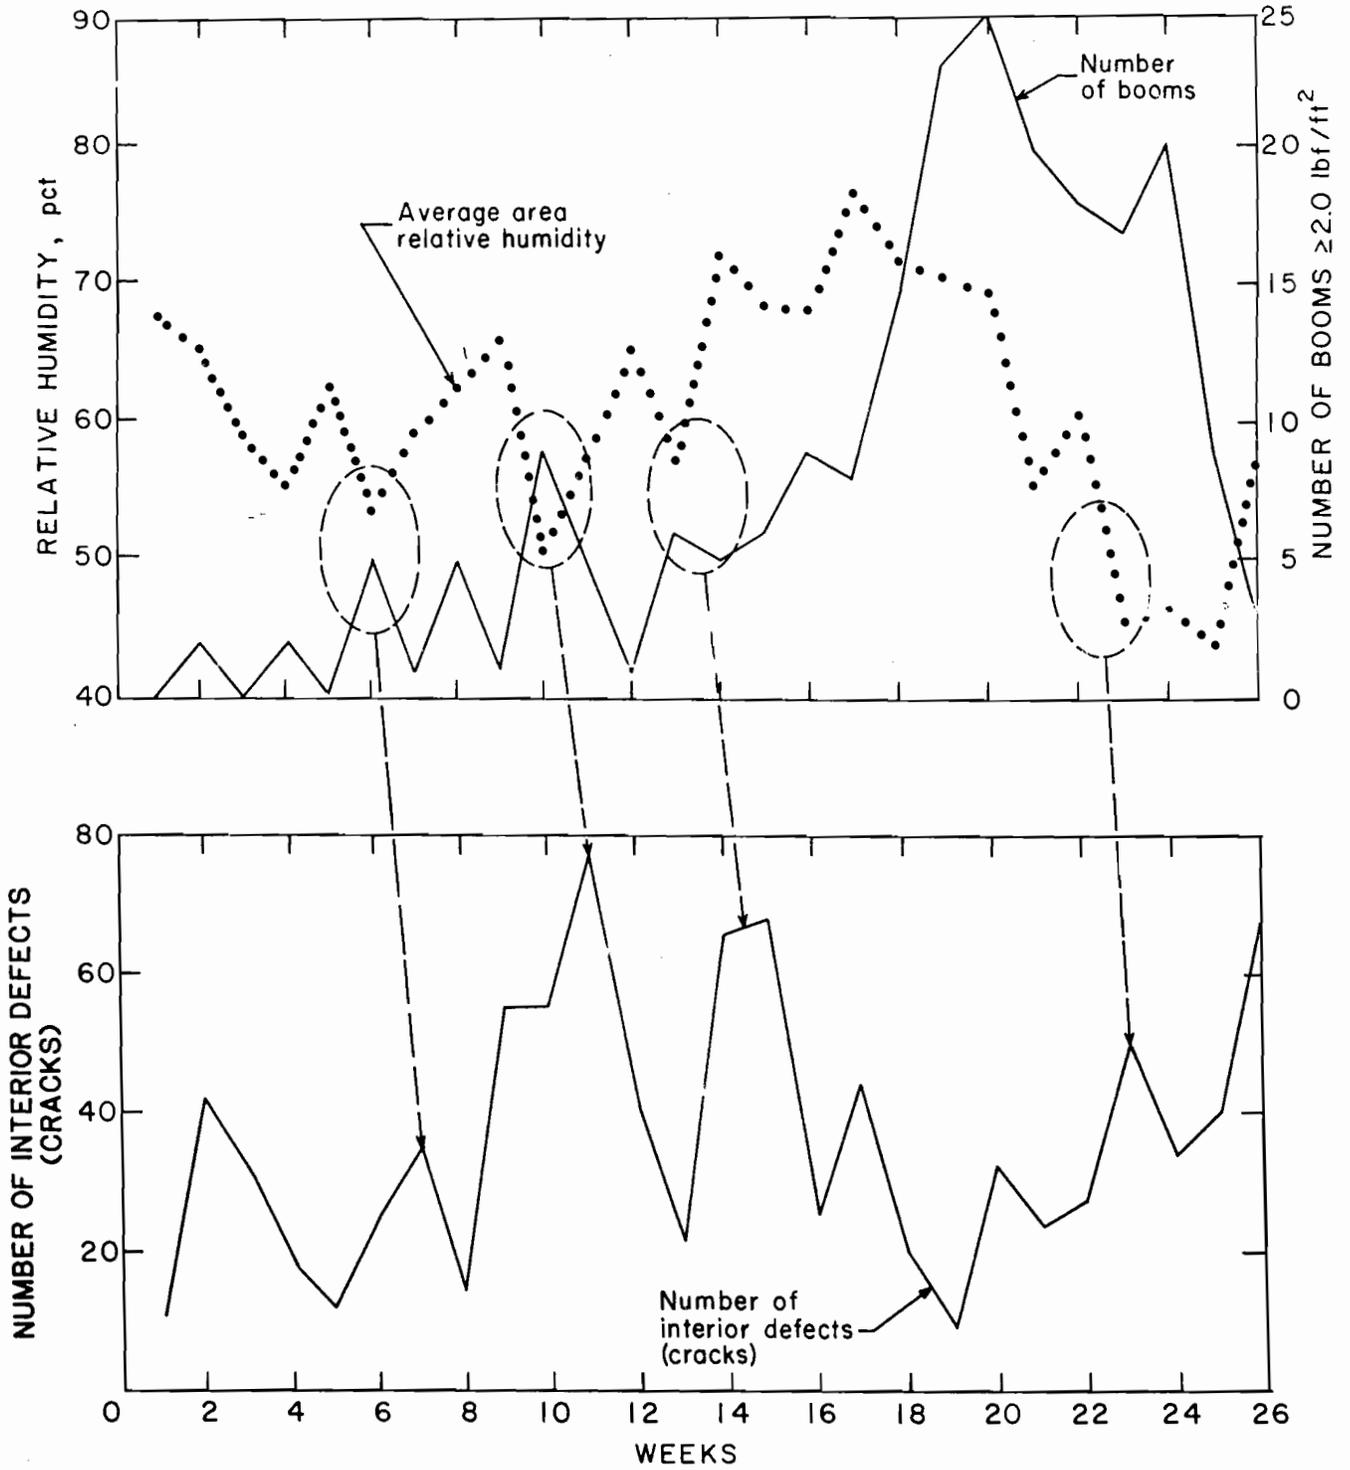
FIGURE 4. - Weekly comparison of crack occurrences to sonic boom amplitudes of 134 dB and to relative humidity (at homes 3 and 4 as shown in table 2).

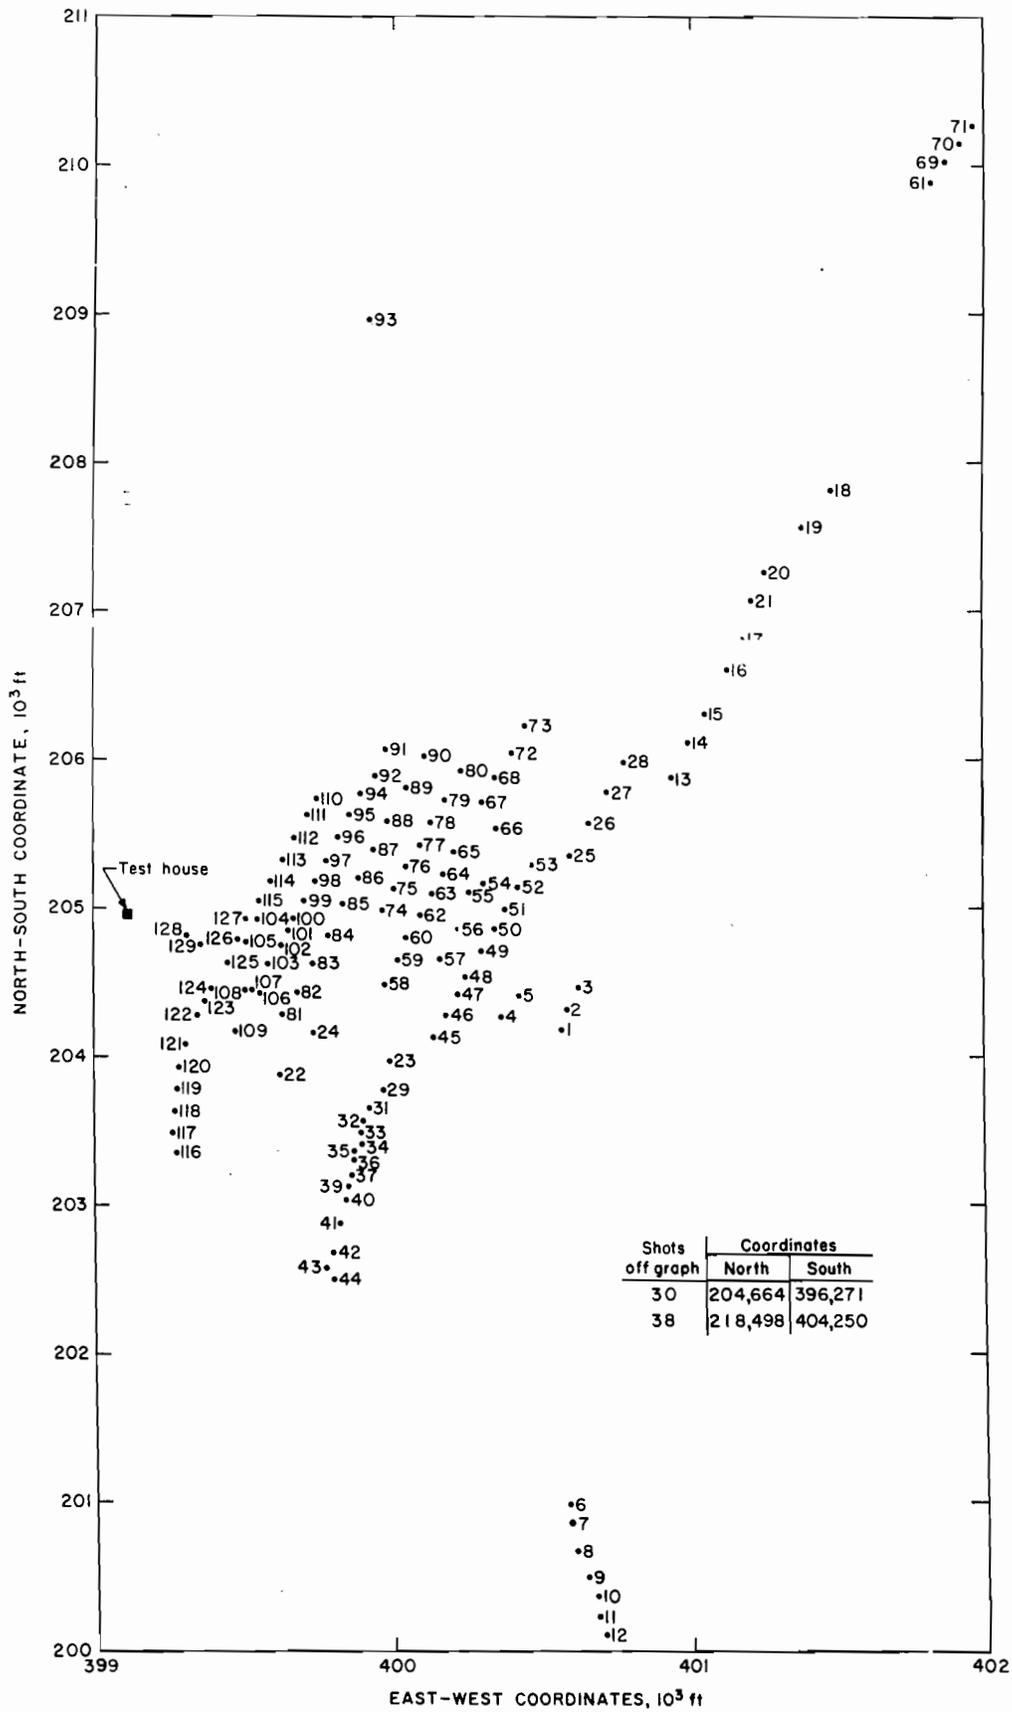
FIGURE 5. - Test house and shot locations.

The Bureau chose a location at the Ayrshire Mine near Evansville, IN, for construction of the test house, and siting of the house there was made possible through an agreement with AMAX Coal Co., the owner of the mine. Figure 5 shows the test-site location and the locations of the blasts relative to the house during the 2-yr test period. The site location allowed a response of at least 1 yr to natural stress-inducing influences before the blast vibrations would reach a level of about 0.75 in/s, the lowest level at which a probability of cracking wallboard had been observed in previous research (2).

The duration of the low-level vibration phase was 16 months, during which the test house was subjected to 645 mining blasts with ground vibrations of <0.75 in/s peak particle velocity. An attempt was made to hold the vibration level of blasts during this period to that level (<0.75 in/s), which is the recommended peak level for Drywall houses (2). Only one shot exceeded this level, by 0.03 in/s, which was within the tolerance of the seismograph's calibration (± 10 pct). The house's response to shots 1 to 44 (fig. 5) was recorded during this period.

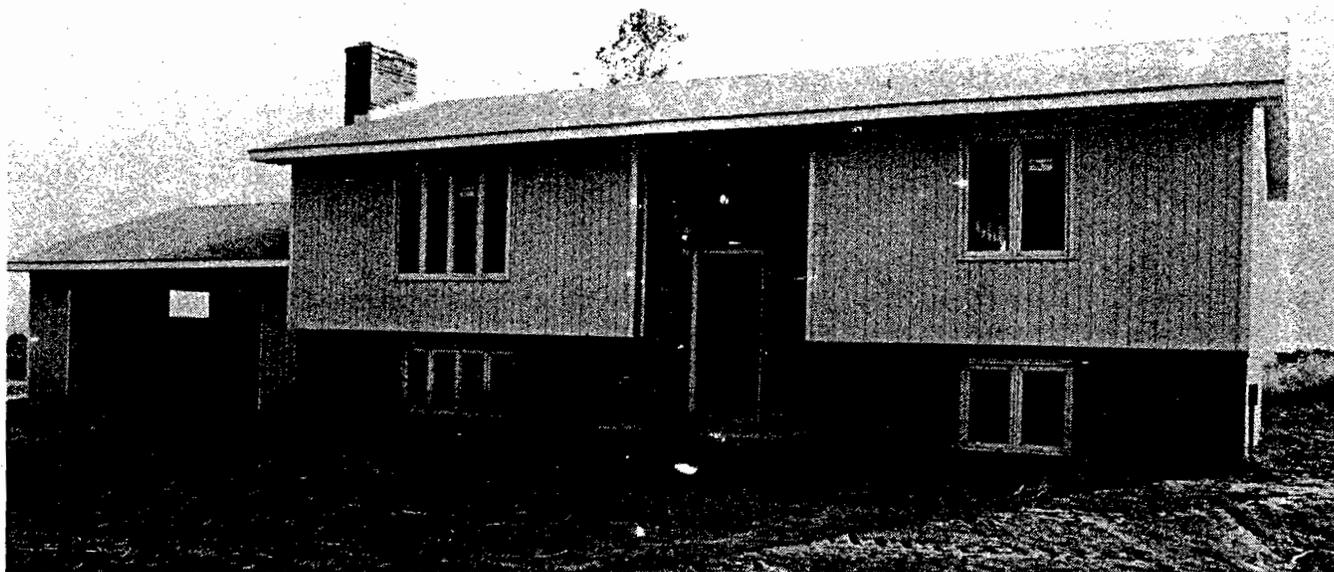
FIGURE 6. - Front view of test house.

After site selection, the Bureau contacted the local carpenters' union to establish the typical house design, then chose a split-level model. The 1,144-ft² test house (fig. 6) had a concrete block basement, brick veneer, and a brick fireplace. Interior walls were 1/2-in wallboard with taped and plastered joints. The kitchen-dining room area received an additional 3/16-in coat of veneer plaster. Plumbing, cupboards, finish molding, and interior doors were not installed, but 75 concrete blocks were used to simulate normal household loads. Design details are shown in appendix B. Ed Scheesele & Sons, a local contractor, built the structure between June and October 1979. As a cost-saving measure, the Bureau arranged for a local engineering firm, VME-Nitro Consult, Inc. (VME), to conduct construction inspections at the completion of the following stages: (1) footings--before pouring, (2) foundation, (3) frame and masonry, (4) electrical, and (5) finish.

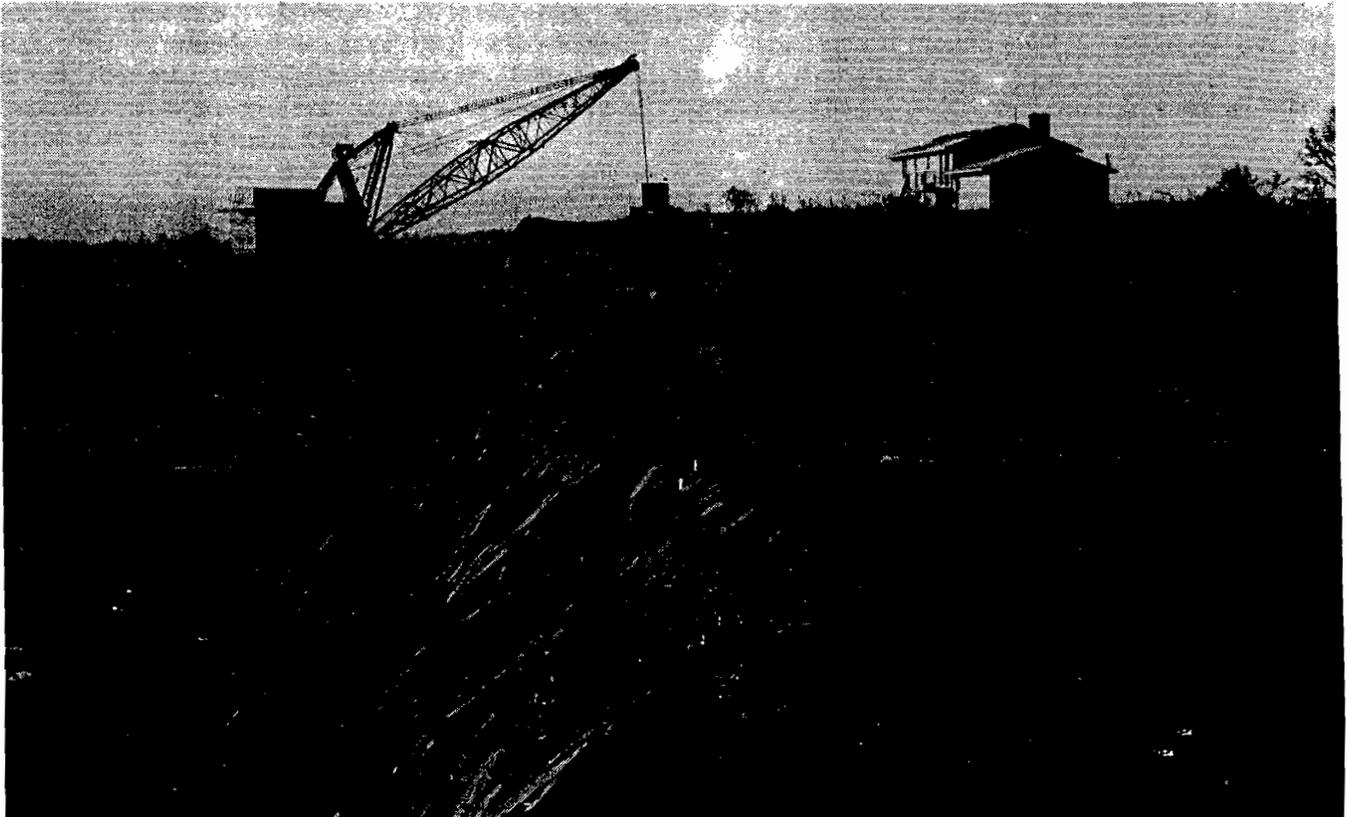
FIGURE 7. - House relationship to pit (south view).

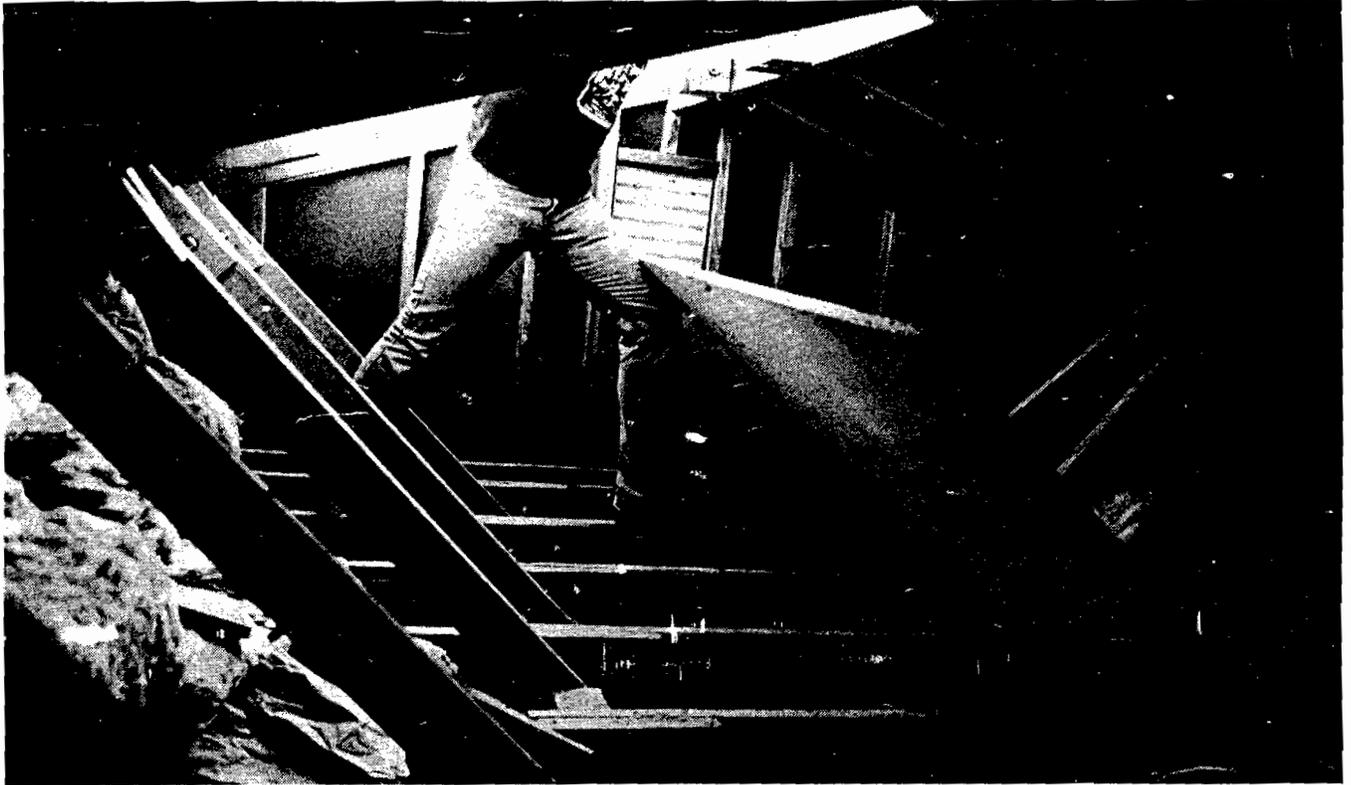
FIGURE 9. - Roof joist preparation for mechanical shaker installation.

An experimental plan had been prepared for the final series of tests, and a contract was let with ANCO Engineers, Inc., to provide and operate the mechanical shaking system. ANCO provided dual-synchronized shakers developed during a previous study of North Sea oil drilling platforms. These shakers were used in the house for accelerated fatigue tests with excitation levels based upon the structure response measured during the blasting tests. Shakers were installed on plywood bolted across the ceiling joists pictured in figure 9, at each end of the test house. Figure 10 shows the installed shaker at the south end of the test house. Table 3 presents the specifications of the shaker system. To avoid stressing the ceiling joists, the shaker weight was transmitted to the foundation by additional column supports (figs. 11 and B-7). In addition, ceiling joist and wall stud connections near the shakers

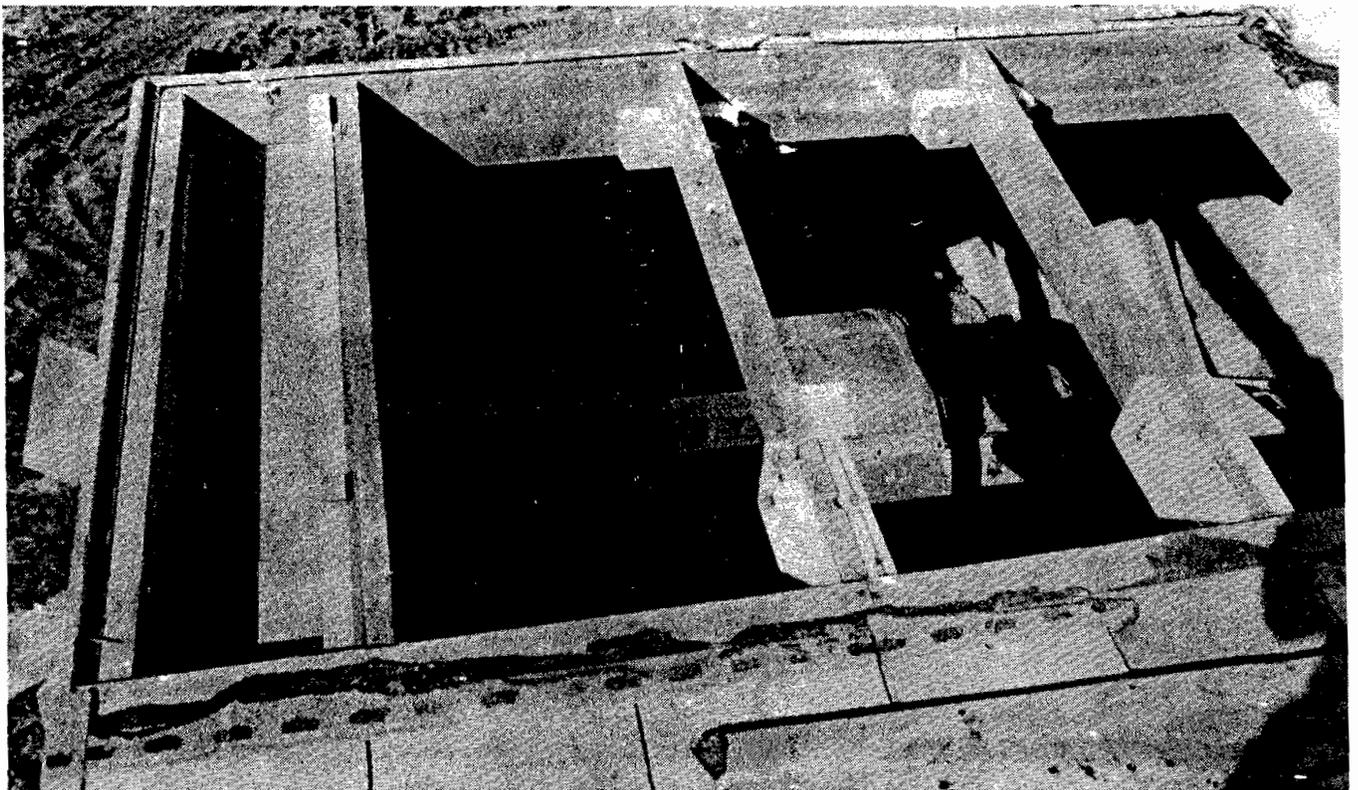
FIGURE 10. - Installed south-end shaker.

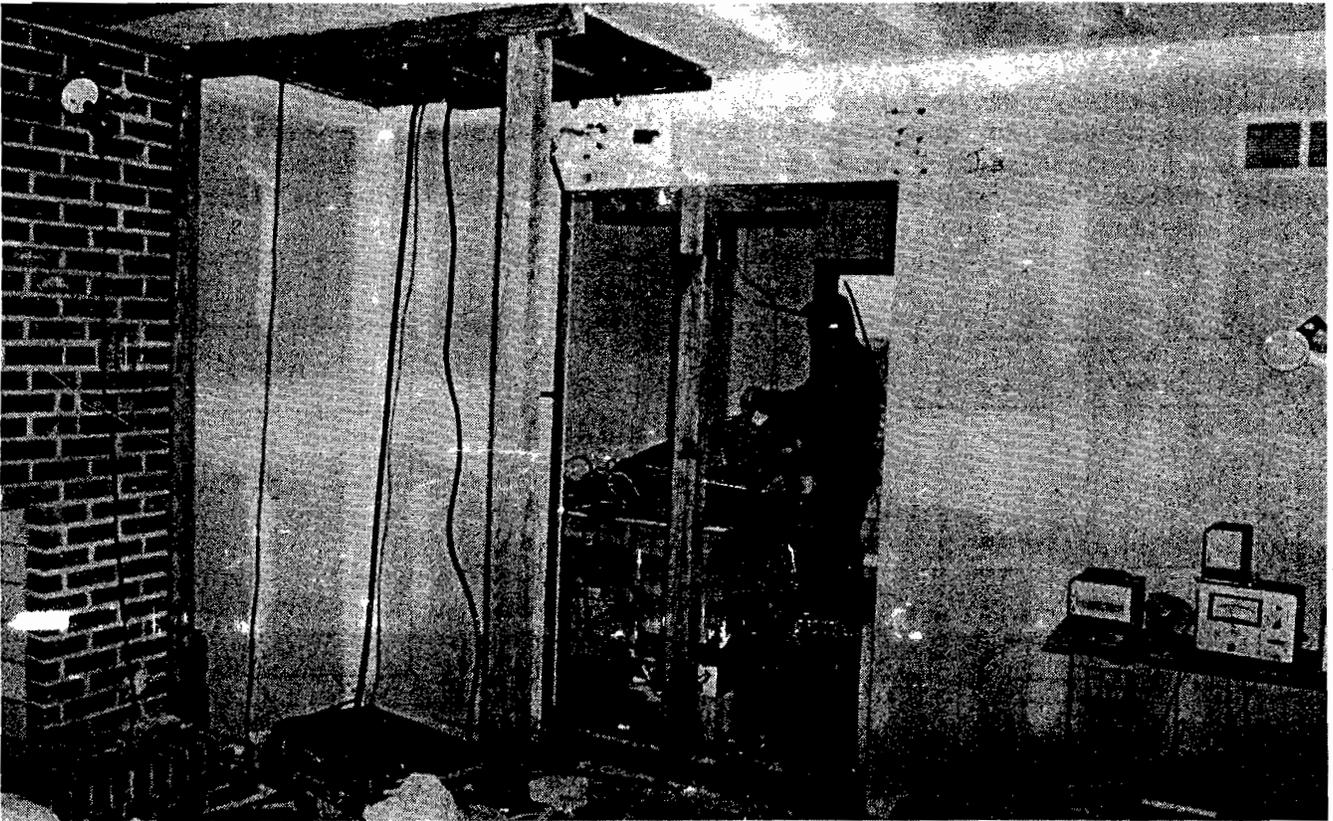
FIGURE 11. - North-end shaker support.

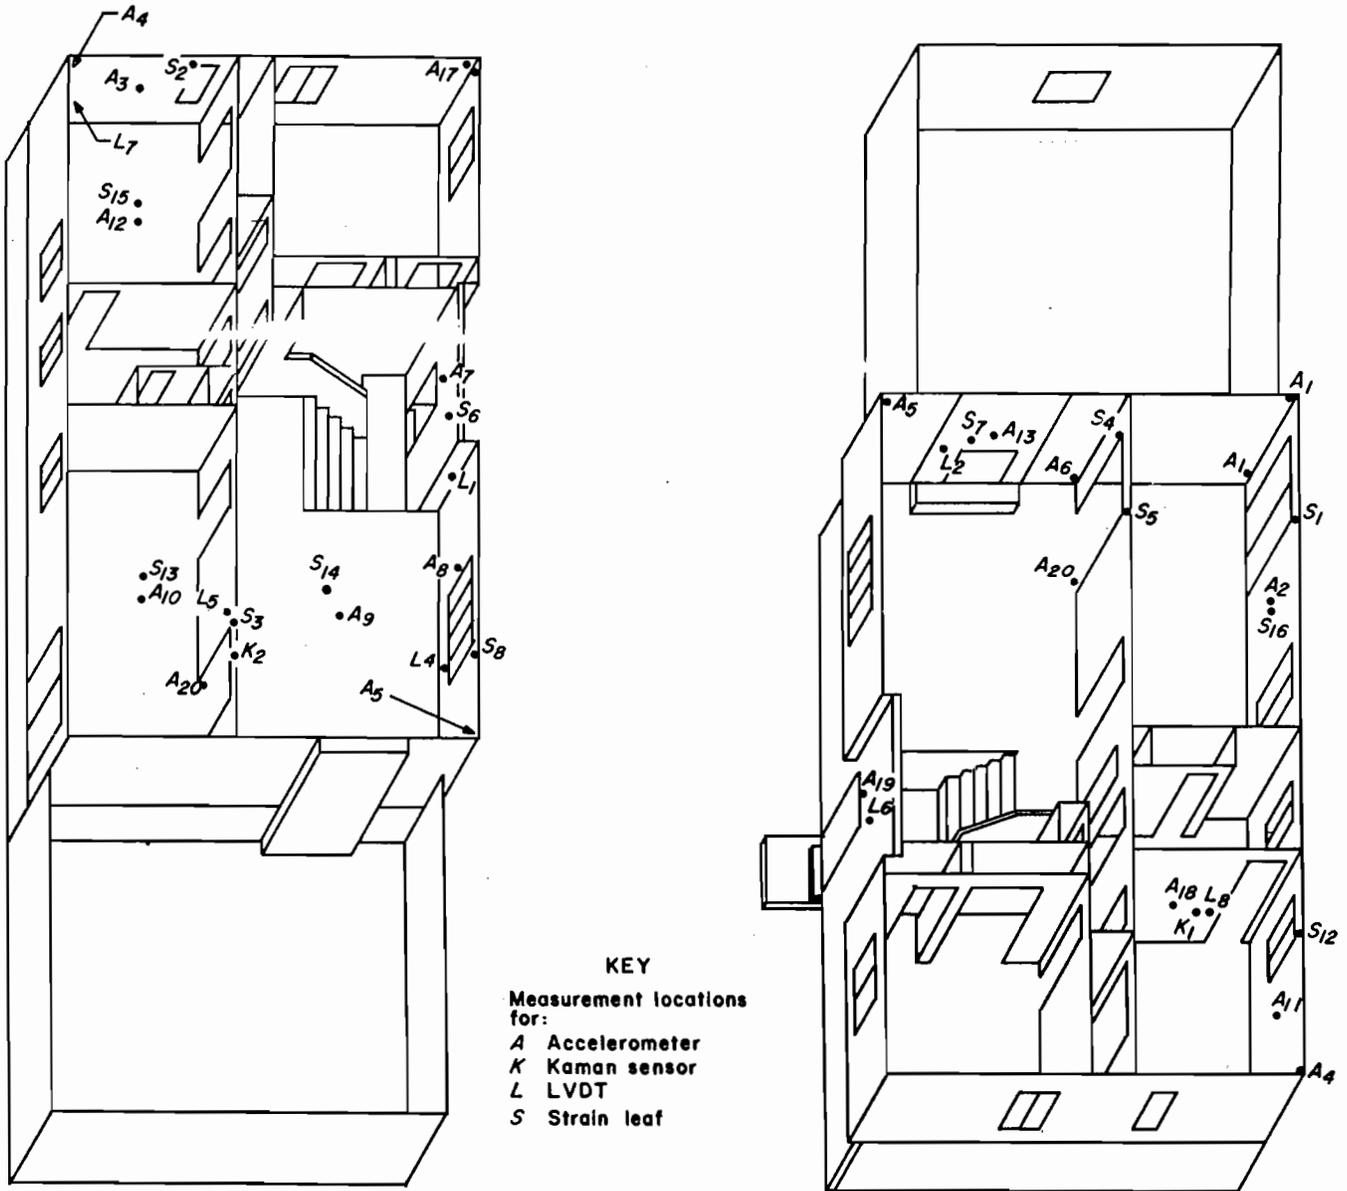
FIGURE 13. - Accelerometer and strain system measurement locations on main floor.

temperature and humidity). Table 4 summarizes the instruments used in the monitoring program. The listed accuracies represent the combined limitations of the instruments and the least division of the chart papers. Locations of all instrumentation are shown in figures 13-16.

envelope line as shown in figure 26) and on a least-squares regression-line analyses. For example, the strain recorded at location S_1 (fig. 13) by slamming the sliding door was $48.8 \mu\text{in/in}$. The equivalent ground vibration levels were read from the plot presented in figure 26, which shows strain versus peak ground vibration at site S_1 . The envelope- and regression-line equivalent blast vibration levels are 0.50 and 1.40 in/s, respectively, as indicated by the broken lines in figure 26. The 0.50-in/s value is a worst-case prediction based on strain-producing ground vibration being the independent variable. Blast vibration levels equivalent to human activities are up to 0.88, 0.59, and 0.92 in/s based on envelope analysis (worst case) of strain, structure motion, and midwall response, respectively; and similarly, up to 1.44, 0.90, and 2.16 in/s based on regression-line analysis.

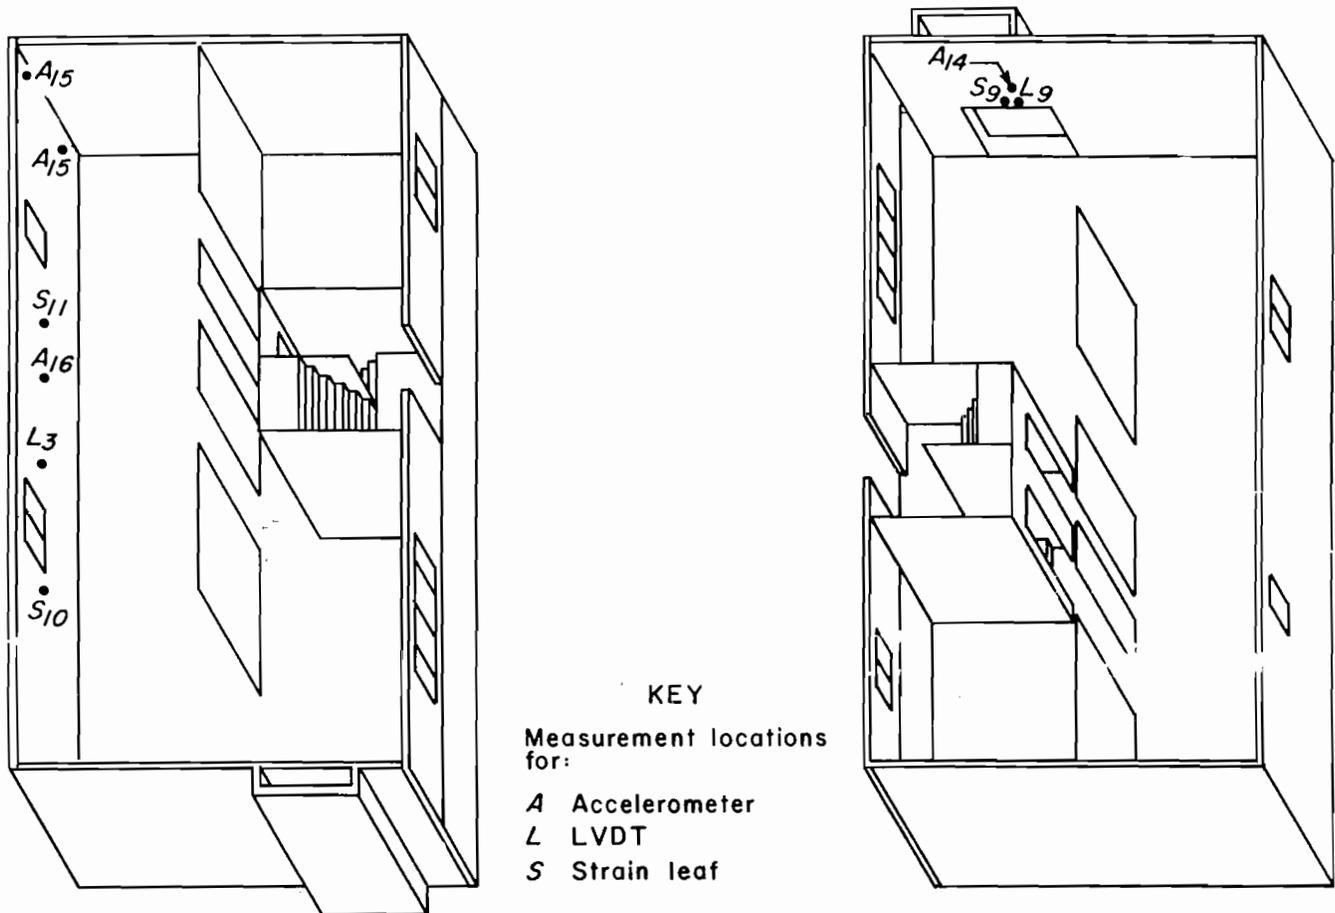
FIGURE 14. - Accelerometer and strain system measurement locations in basement.

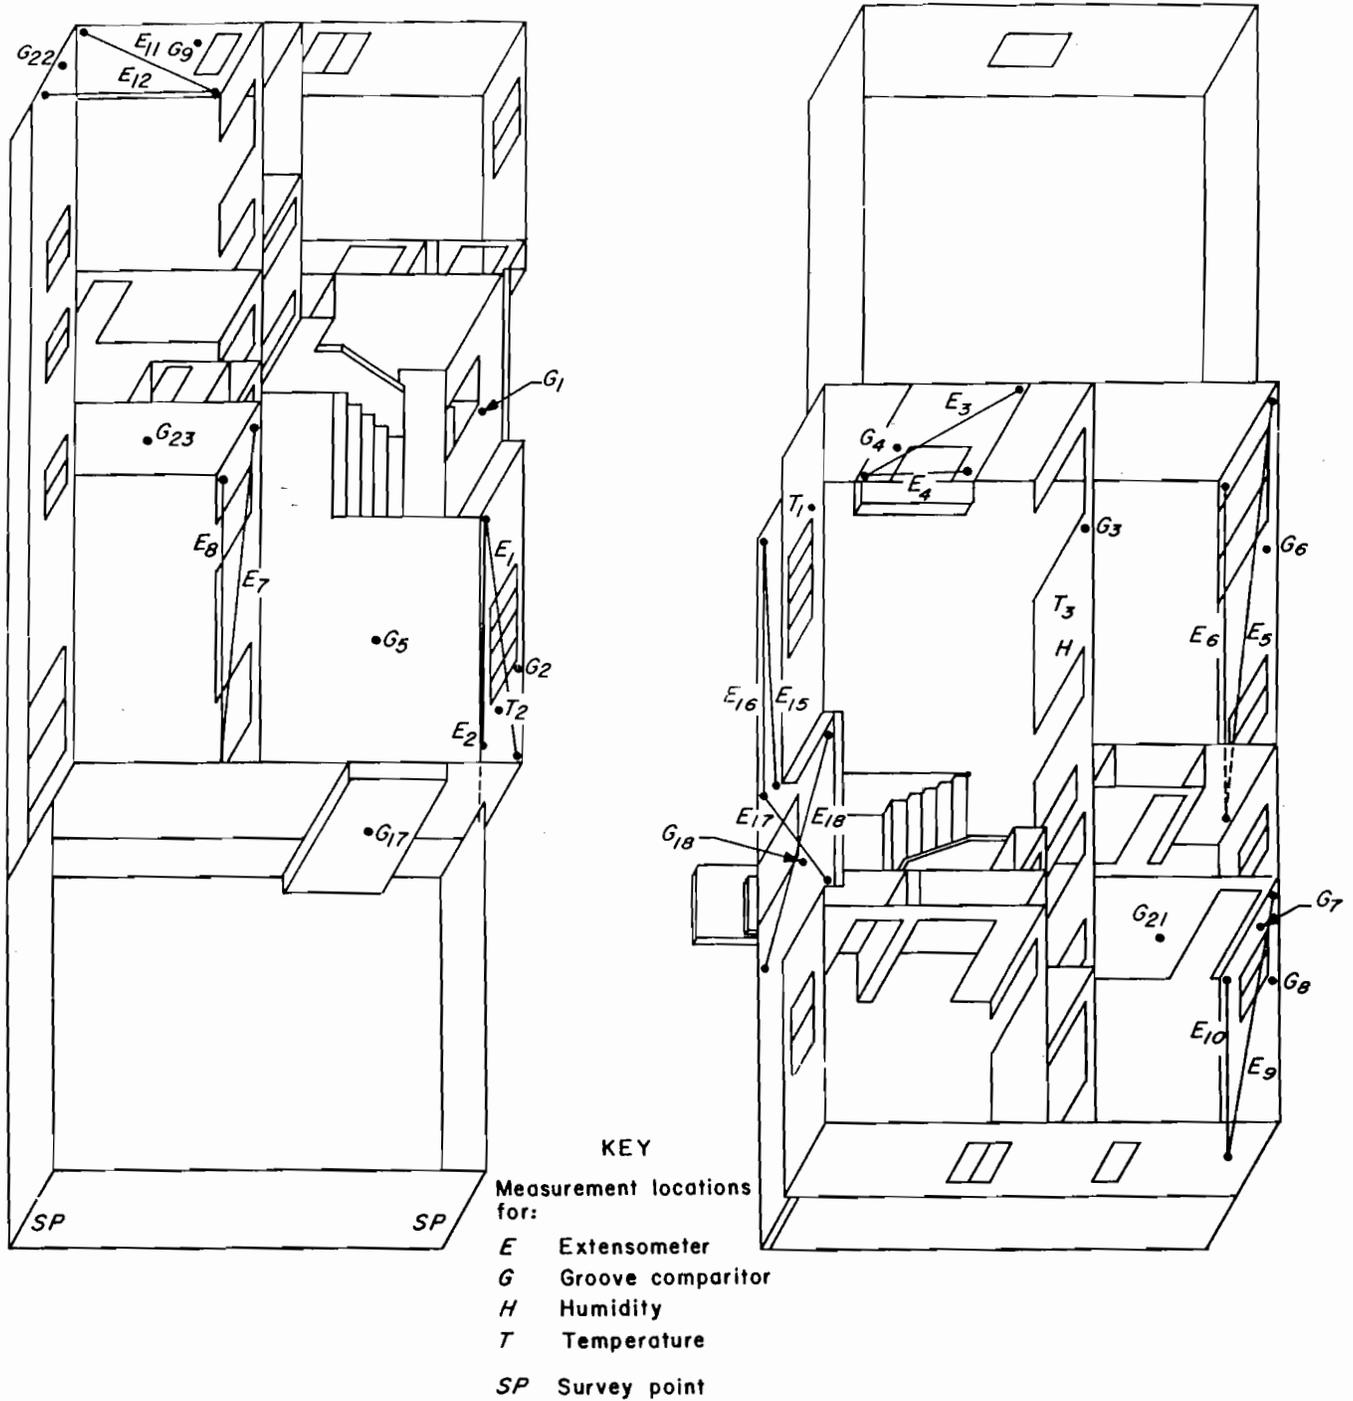
FIGURE 15. - Semimonthly strain, temperature, and humidity measurement locations, and survey points on main floor.

Differential settlement of the structure was determined by measuring elevations at the survey points (SP) shown in figures 15 and 16. The elevation rod rested on a stainless steel sphere which was welded to a stainless steel stud and grouted into the top course of the block wall. A brass bench mark obtained from the U.S. Geological Survey was installed 50 ft from the house so that each elevation survey would complete a closed loop around the house and thereby identify any differential settlement.

Monthly environmental data were collected from groove comparitor and extensometer readings but were not used in the final analysis because in some cases calculated strains should have produced cracking, and in other cases not enough data were collected to permit a valid statistical analysis. The data were ambiguous. Extensometer readings at locations E_1 and E_2 (fig. 15) gave conflicting results. For example, for strains

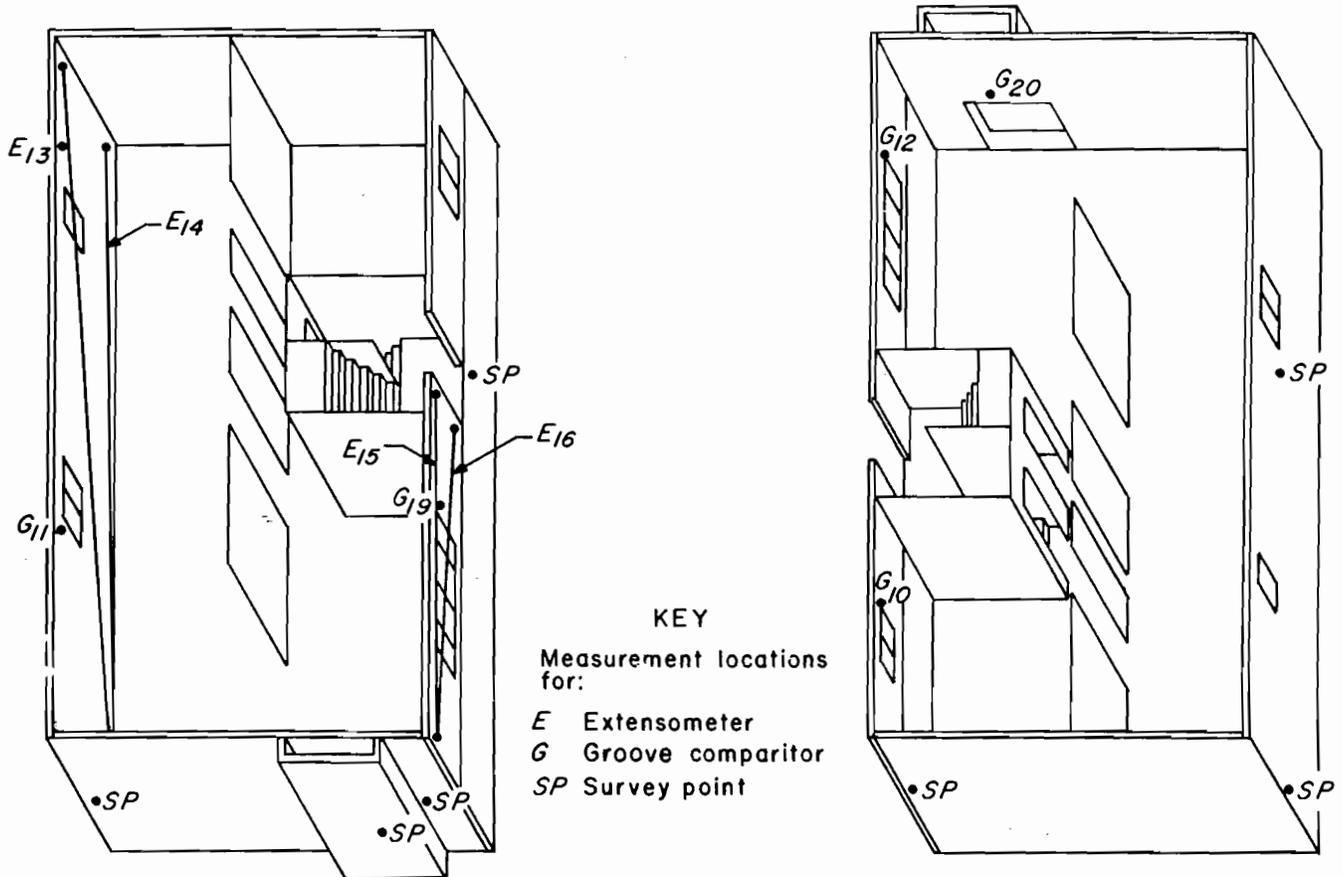
FIGURE 16. - Semimonthly strain, measurement locations, and survey points in basement.

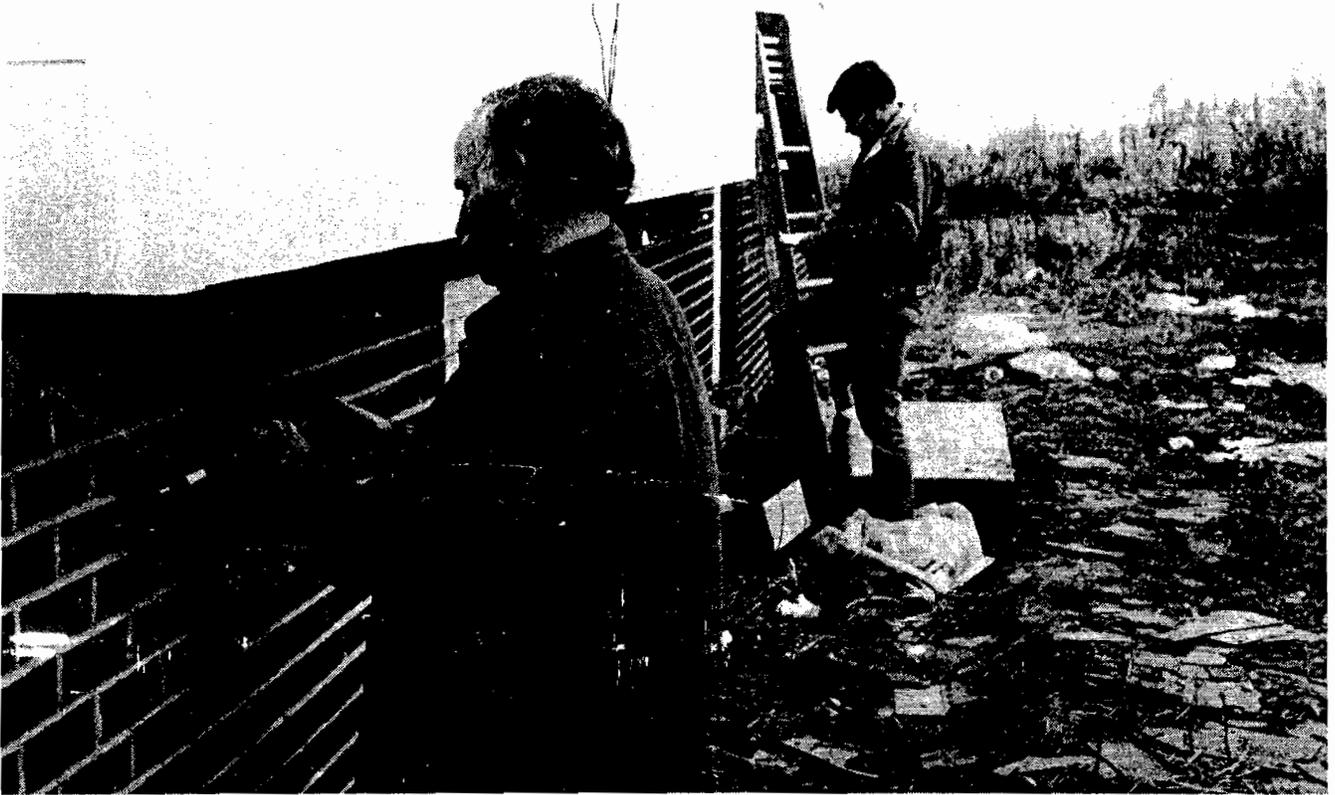
FIGURE 17. - Extensometer.

The extensometer (fig. 17) and groove comparitor (fig. 18) measured the distance between set reference points ~ 10 to 30 ft apart and ~ 3 in apart, respectively. The reference points for these two devices were permanently mounted stainless steel spheres and dimpled steel blocks. They were installed over critical areas of interest as detailed in figures 15 and 16 (points G_1, G_2, G_3 , etc.). Differences in length, between that measured initially and at any later time, were divided by the initial length to obtain the strain values. A 45° rosette was employed at each groove comparitor location on wallboard; and for masonry joints, both the vertical and horizontal axes of the block or brick were instrumented. (Sites $G_{13}-G_{16}$ (masonry locations) are not shown because the reference blocks dislodged after 2 months; however, these sites were promptly replaced by sites $G_{17}-G_{20}$. $G_{21}-G_{23}$ were additional sites instrumented during installation of the replacement sites.) In all, a total of 49 groove comparitor measurements and 17 extensometer measurements were made each semimonthly data collection period. (Use of site E_{14} was discontinued after 3 months due to loosening of the reference sphere.) Readings were corrected for temperature differences as determined with Invar-bar standards.

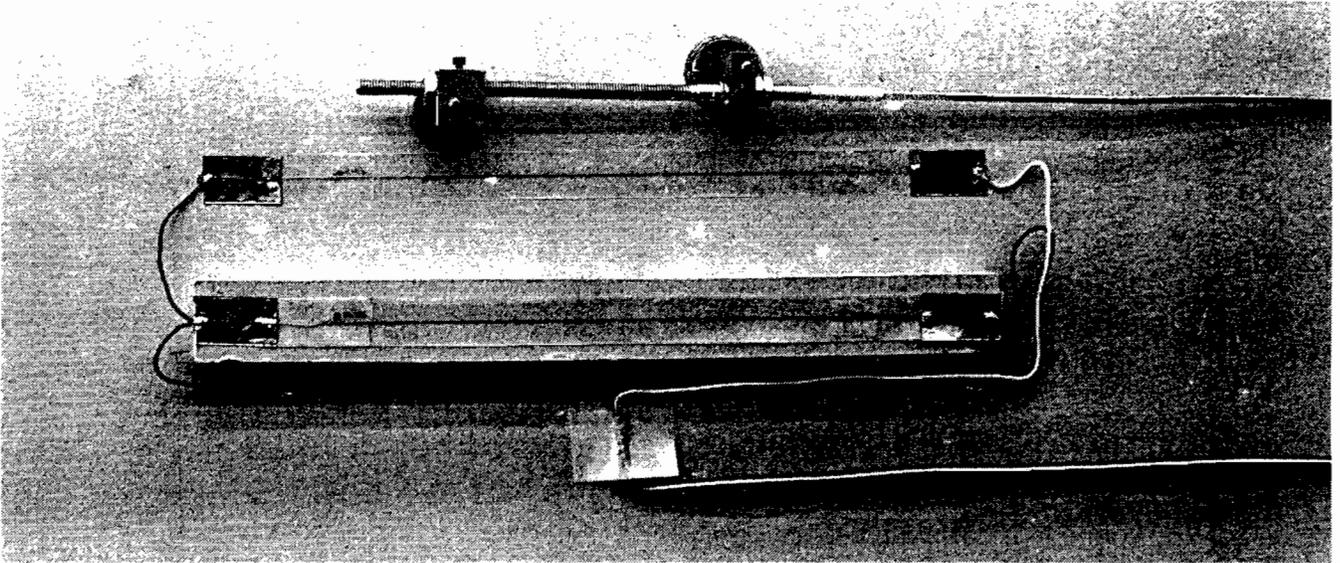
FIGURE 19. - Kaman displacement system (top) and 124-mm strain gauge.

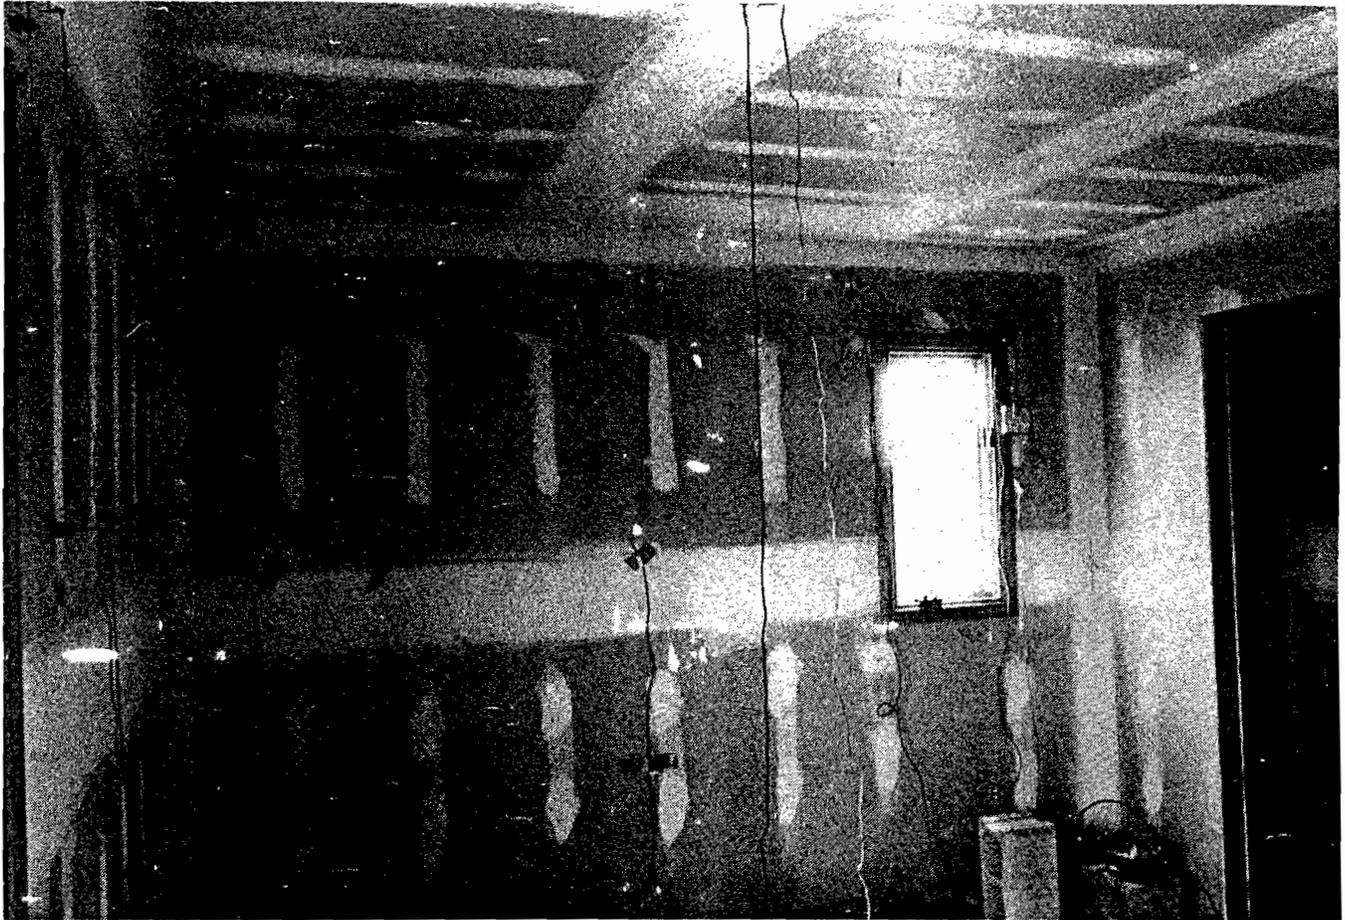
FIGURE 22. - Measurement systems in master bedroom.

Of the 50 FM channels available for recording dynamic data, 27 were usually used for recording strain time histories (16 strain leaf, 9 LVDT, and 2 Kaman). A variety of gauges installed in the master bedroom is shown in figure 22. Before and after the study, a frequency response calibration, from 2 to 100 Hz, was performed on all systems using the Bureau's 300-lbf shaker system, as described in RI 8506 (29).
