Report of Investigations 8896

Effects of Repeated Blasting on a Wood-Frame House

By Mark S. Stagg, David E. Siskind,
Michael G. Stevens, and Charles H. Dowding

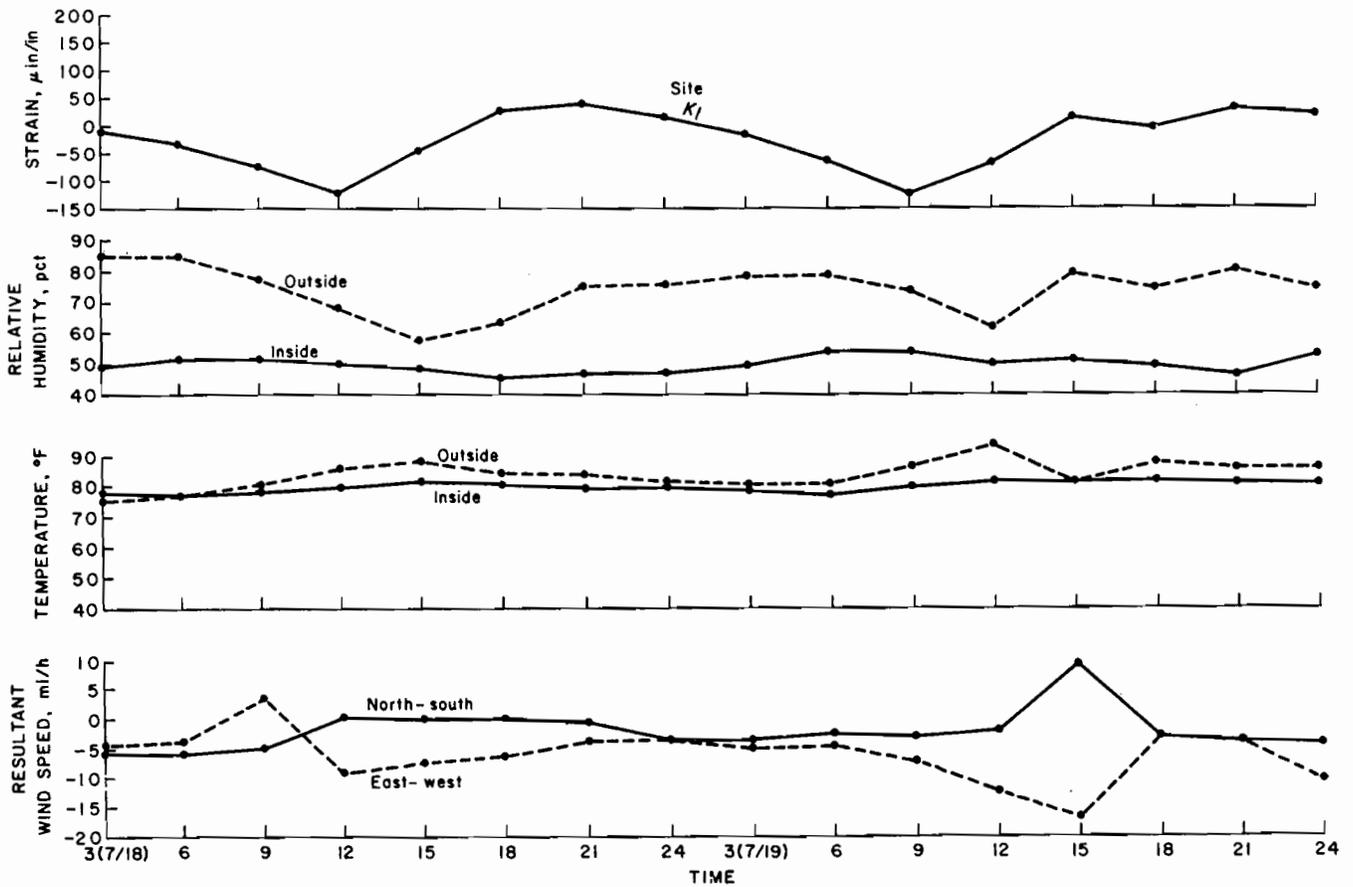
FIGURE 23. - Strain and environmental factors versus time, site K_1 .

Readings were taken in 3-h increments. Figures 23 and 24 display the data for a 2-day period. Because the strain was produced by at least four environmental factors, multiple linear regression analysis was used to quantify the factors.

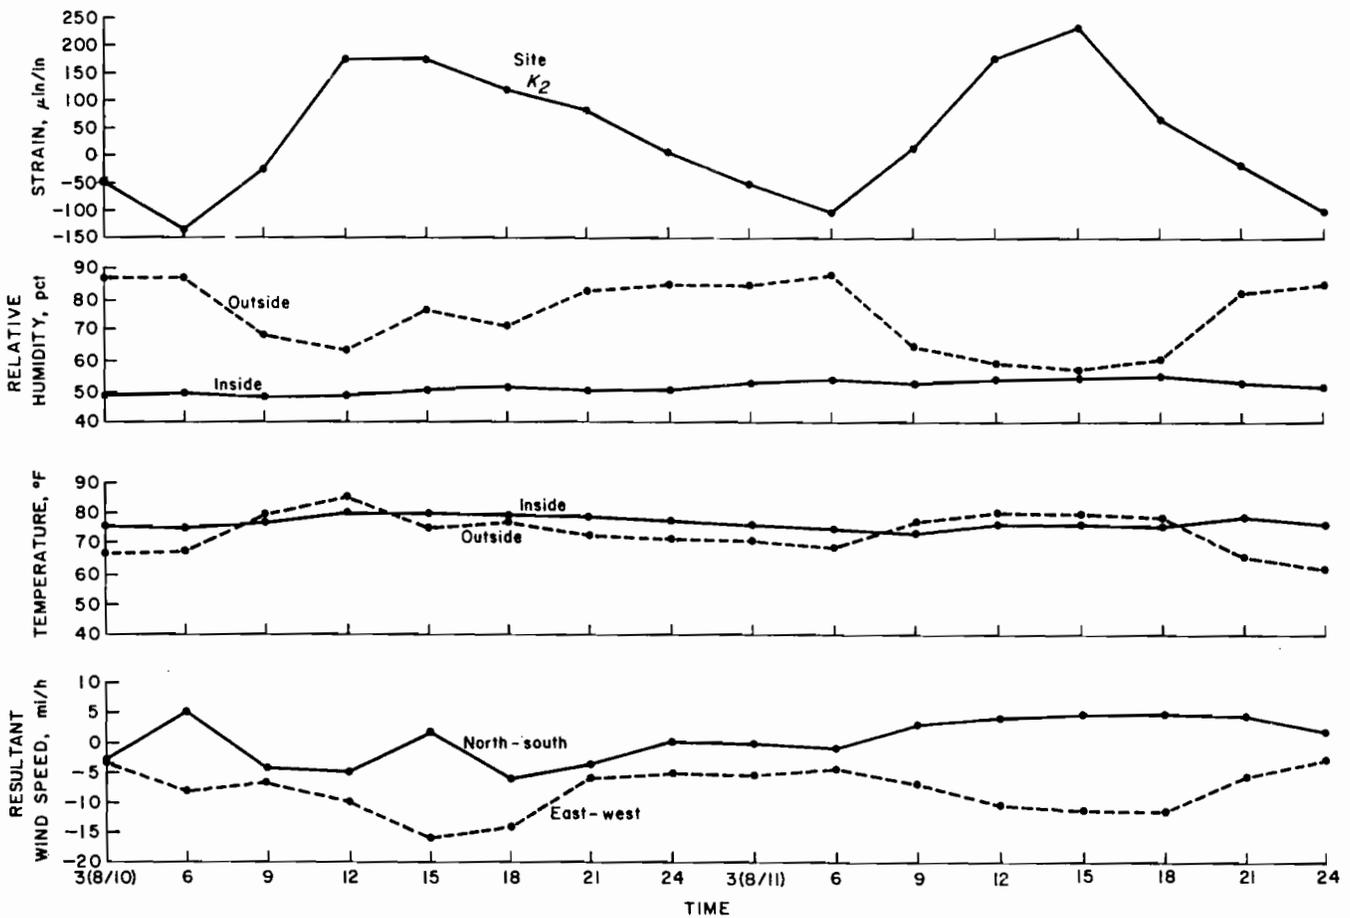
FIGURE 24. - Strain and environmental factors versus time, site K_2 .

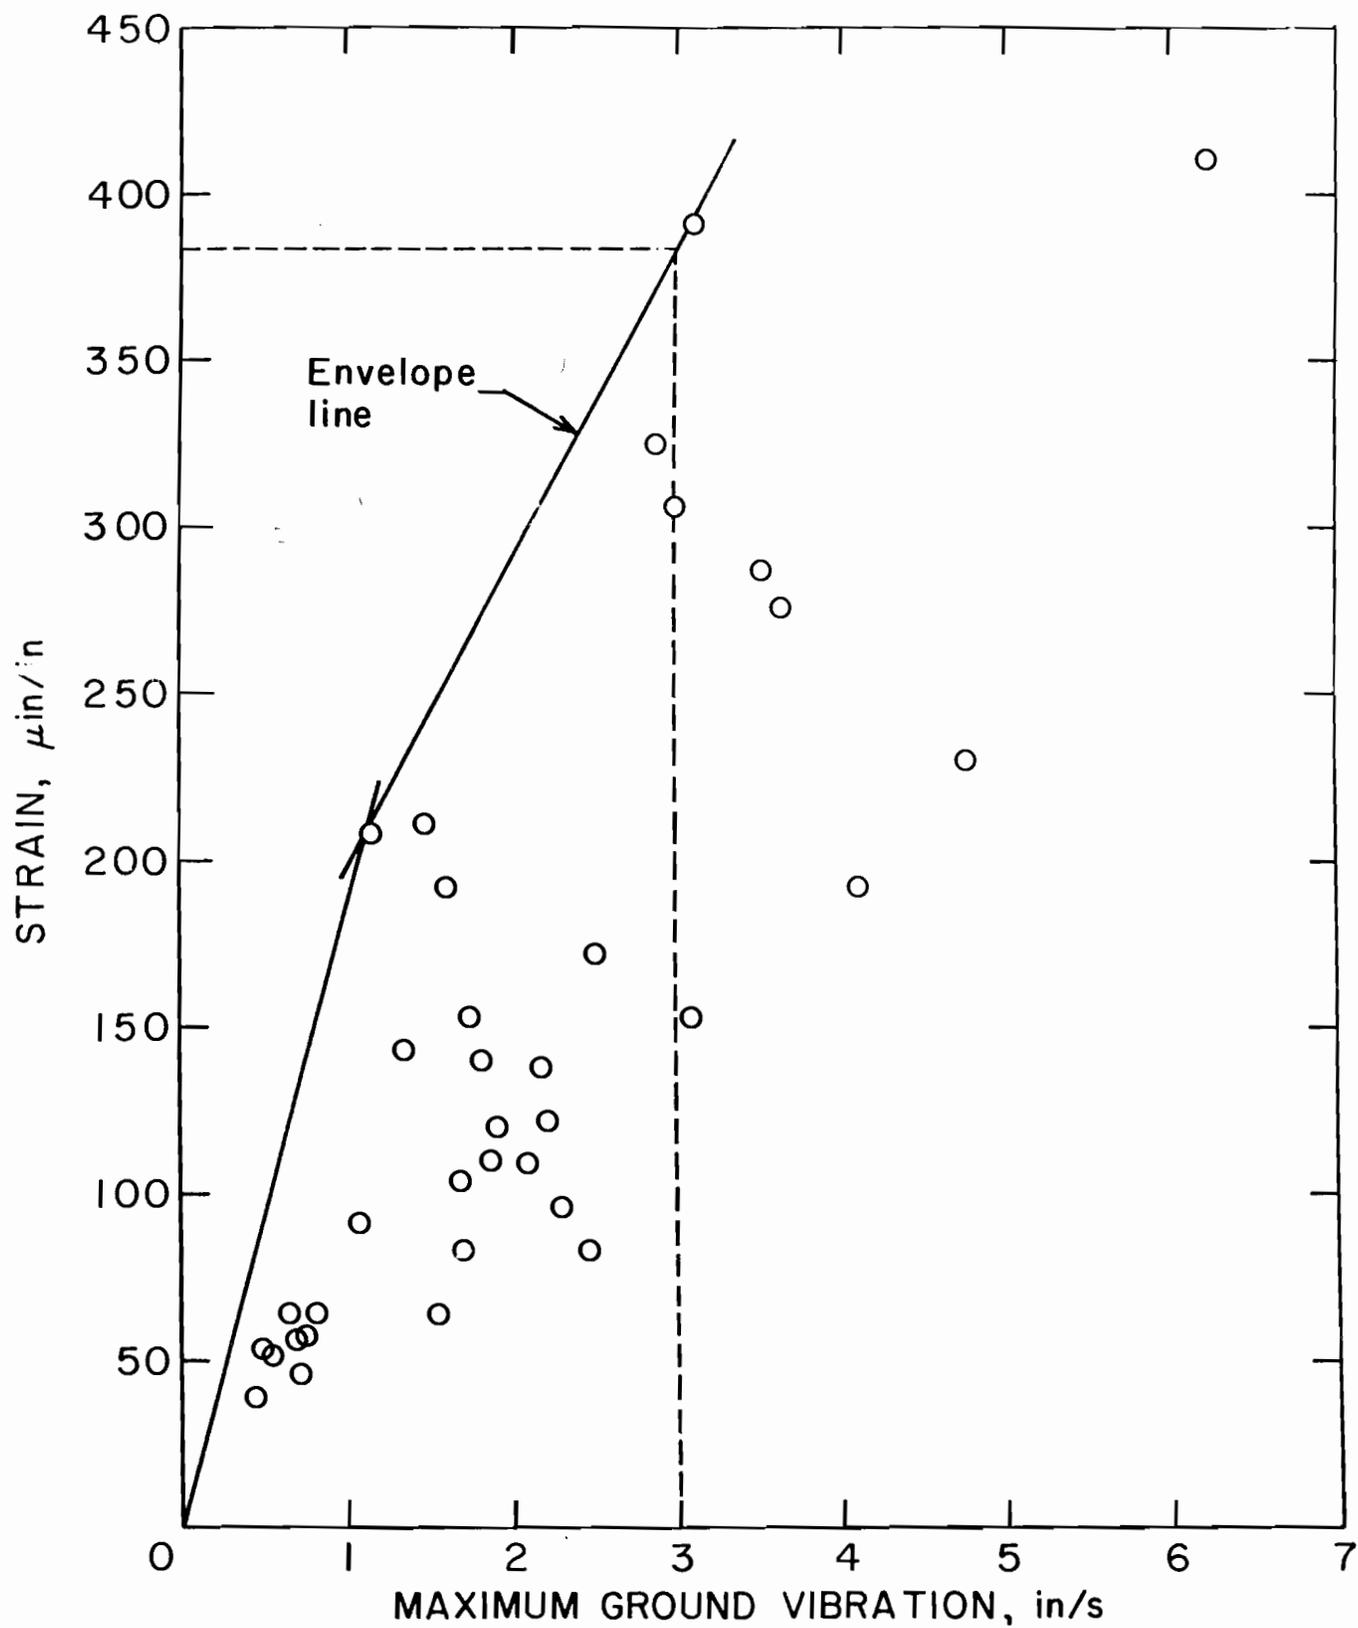
FIGURE 25. - Strain versus maximum ground vibration level, site K_2 .

Minimum blast vibrations of 1.2 and 3.0 in/s would be needed to produce the 149- and 385- $\mu\text{in/in}$ microstrains observed at sites K_1 and K_2 , respectively. For example, the K_2 equivalency can be found from the envelope line for the strain versus maximum ground vibration at K_2 as plotted in figure 25.

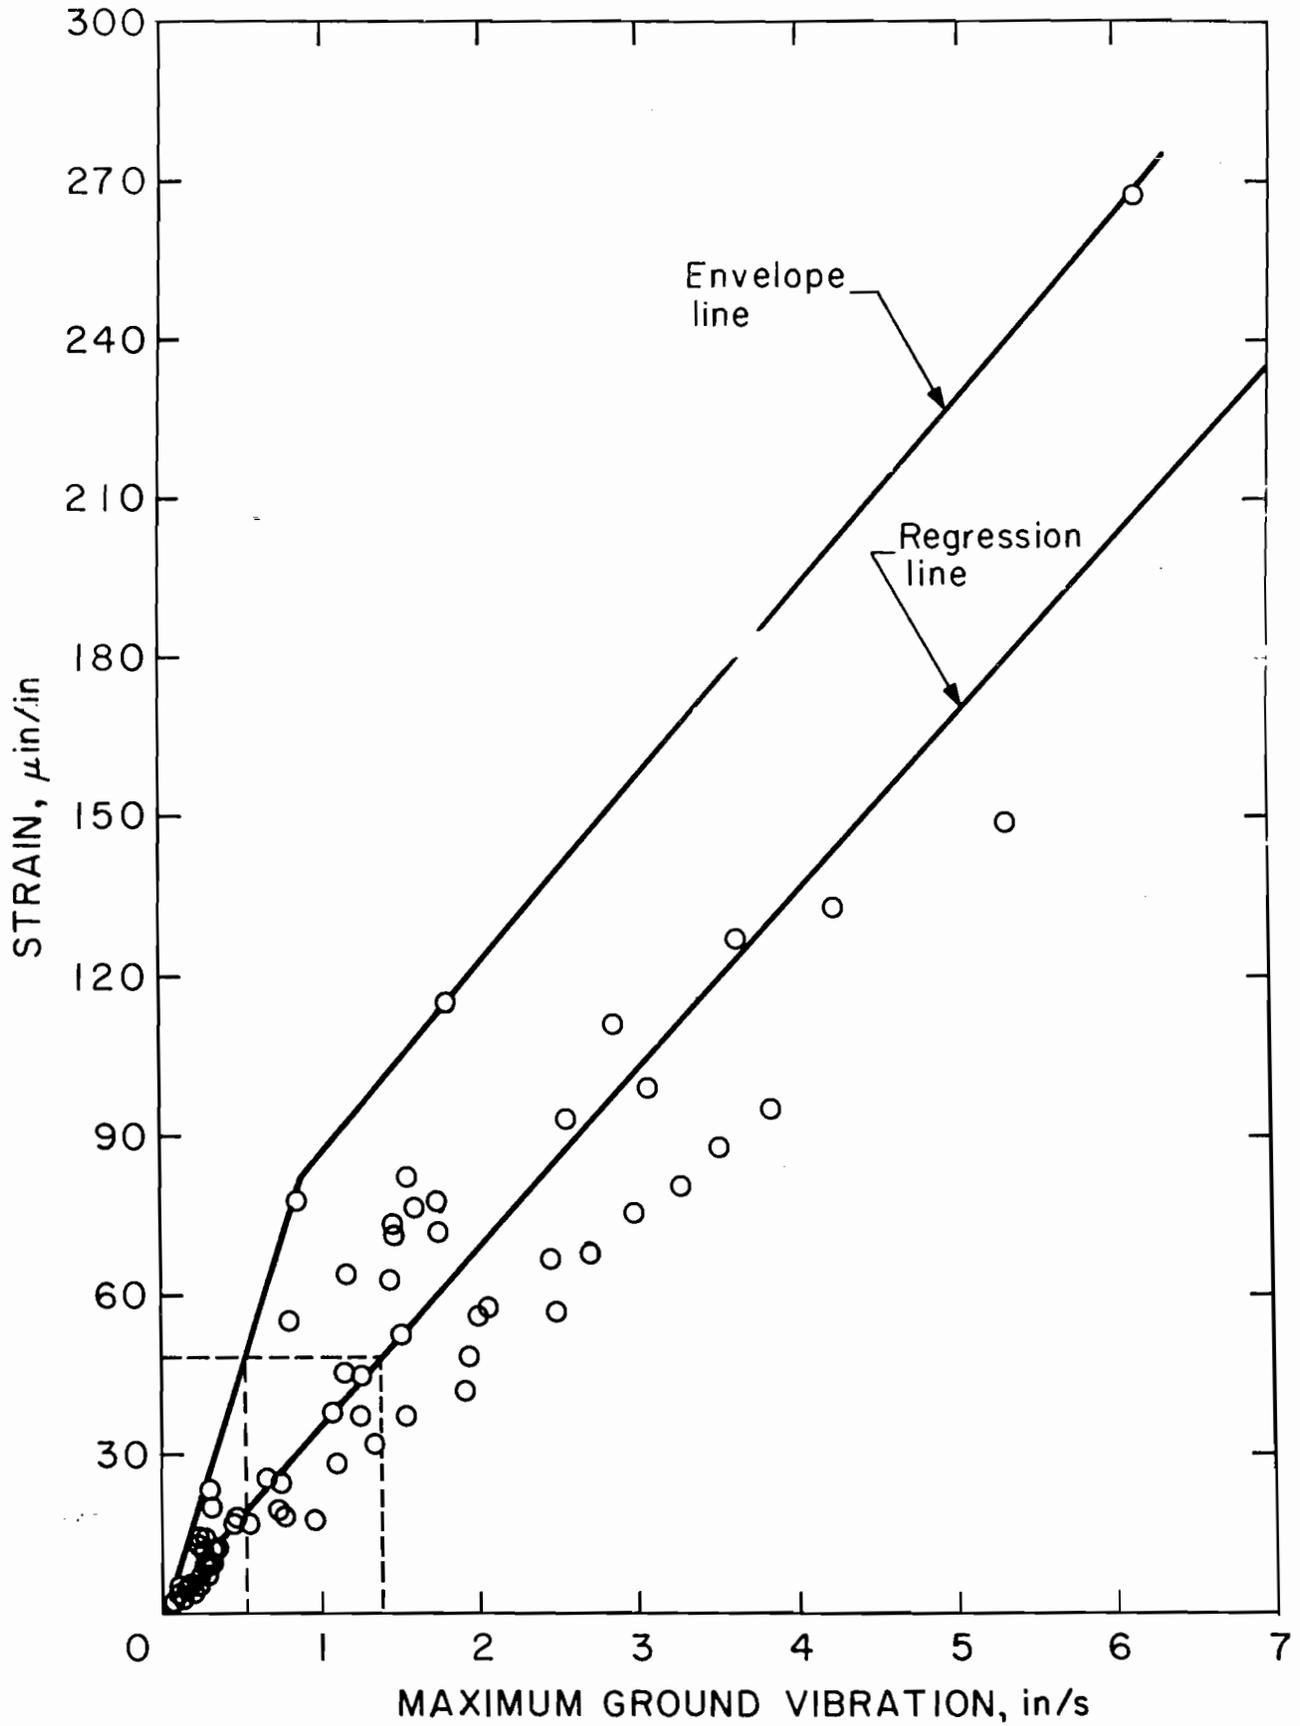
FIGURE 26. - Strain versus maximum ground vibration level, site S_1 .

envelope line as shown in figure 26) and on a least-squares regression-line analyses. For example, the strain recorded at location S_1 (fig. 13) by slamming the sliding door was $48.8 \mu\text{in/in}$. The equivalent ground vibration levels were read from the plot presented in figure 26, which shows strain versus peak ground vibration at site S_1 . The envelope- and regression-line equivalent blast vibration levels are 0.50 and 1.40 in/s, respectively, as indicated by the broken lines in figure 26. The 0.50-in/s value is a worst-case prediction based on strain-producing ground vibration being the independent variable. Blast vibration levels equivalent to human activities are up to 0.88, 0.59, and 0.92 in/s based on envelope analysis (worst case) of strain, structure motion, and midwall response, respectively; and similarly, up to 1.44, 0.90, and 2.16 in/s based on regression-line analysis.

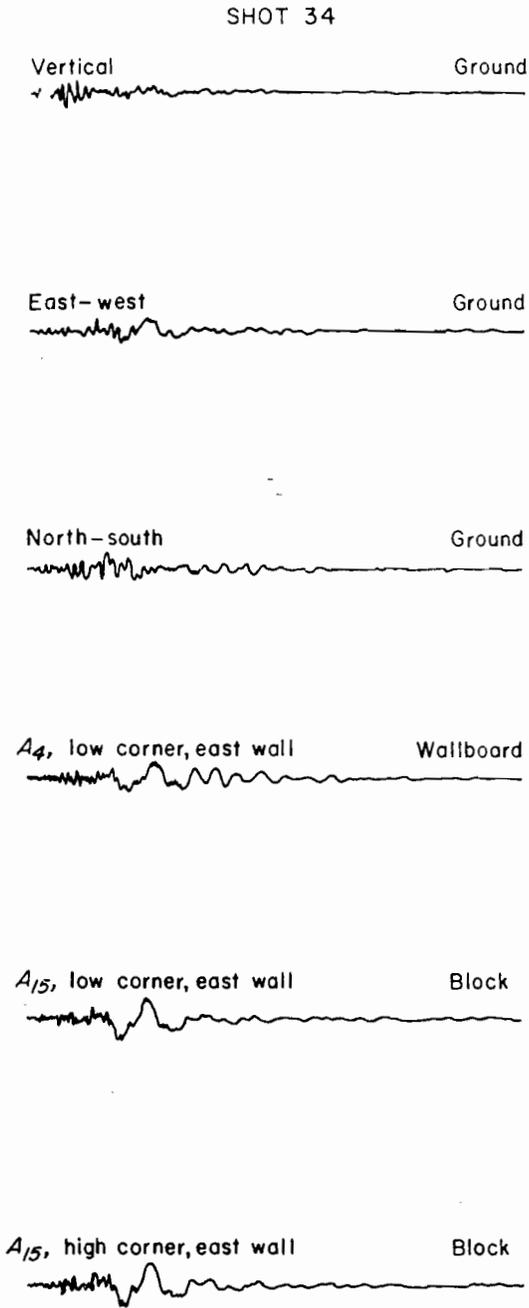
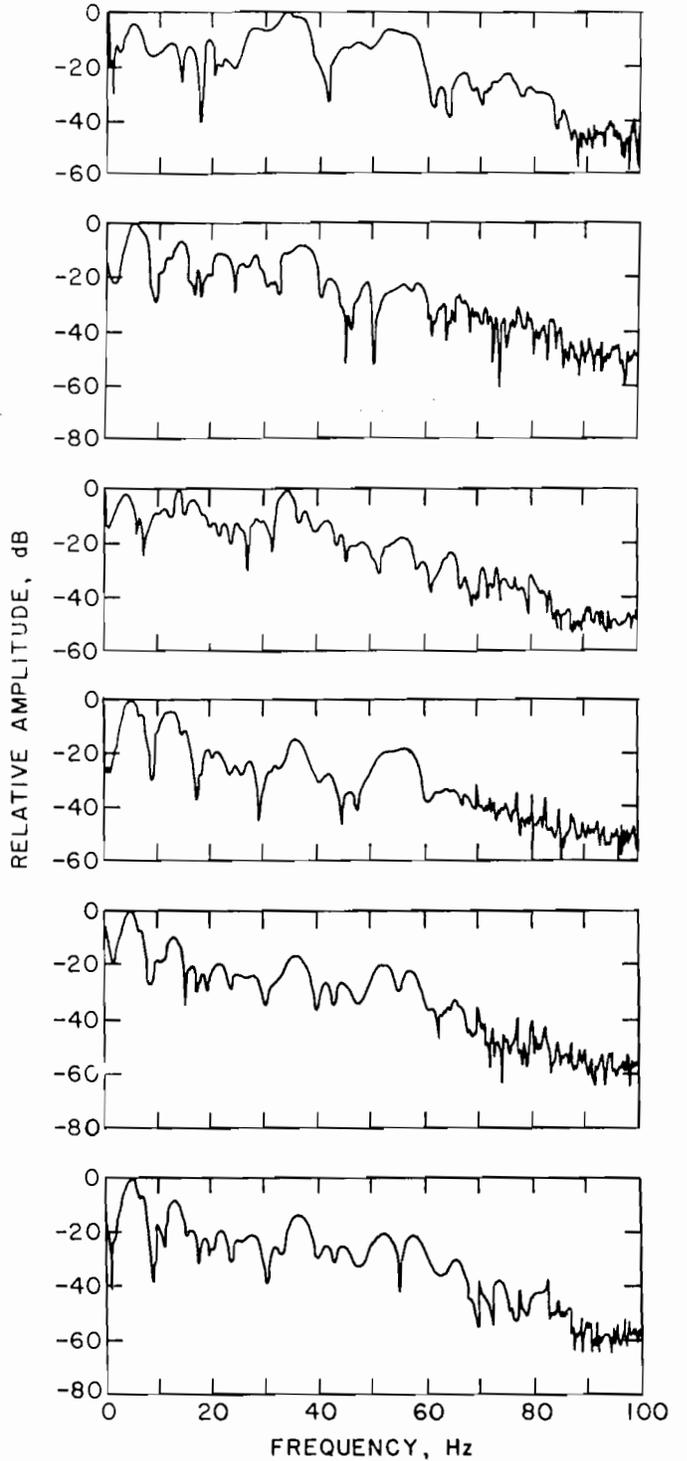
FIGURE 27. - Typical ground vibration and structure response waveforms for shot 34 with corresponding spectra. (Designations such as A_4 correspond to locations shown in figures 13 and 14.)

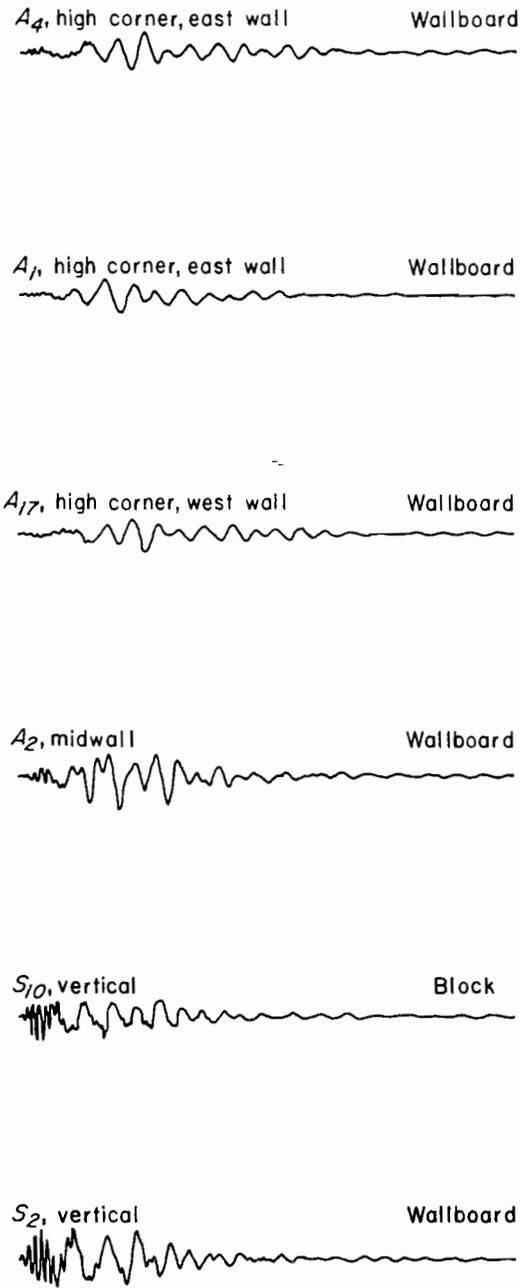
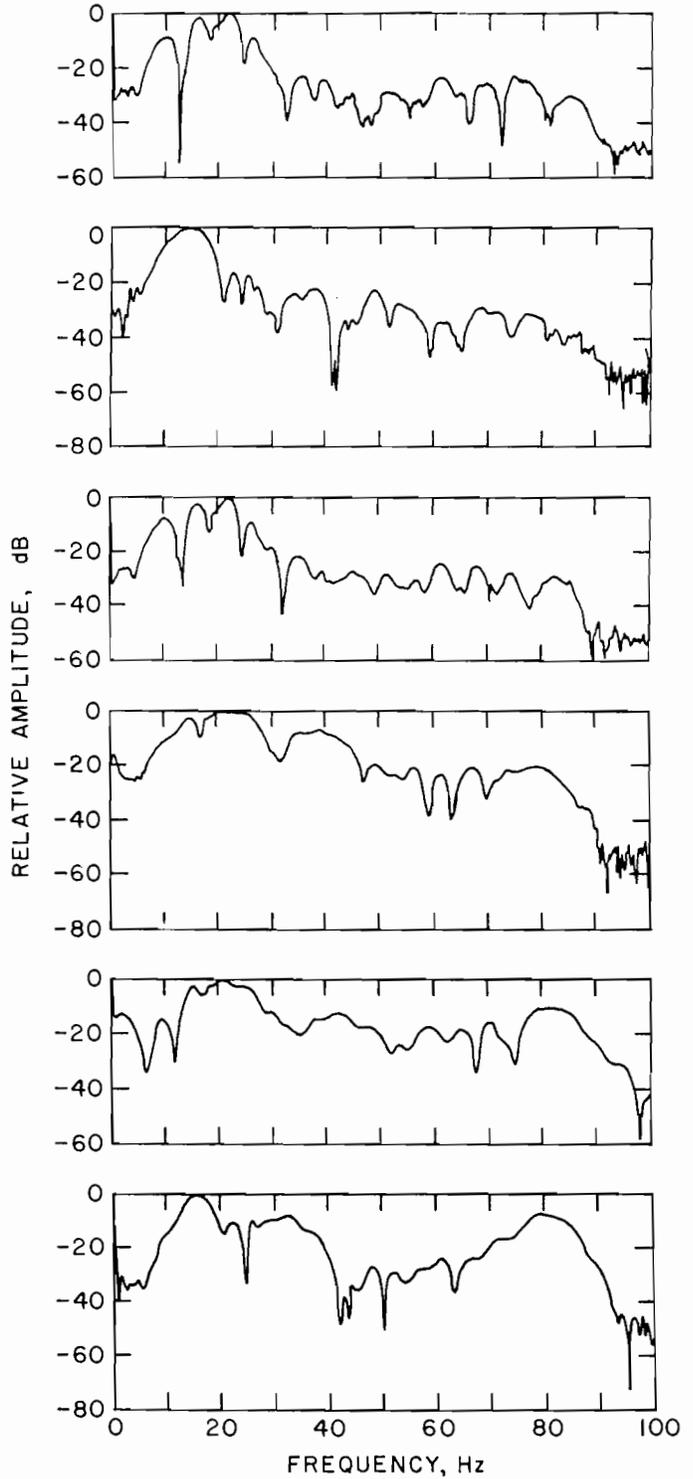
SHOT 123

FIGURE 28. - Typical ground vibration and structure response waveforms for shot 123 with corresponding spectra. (Designations such as A_4 correspond to locations shown in figures 13 and 14.)

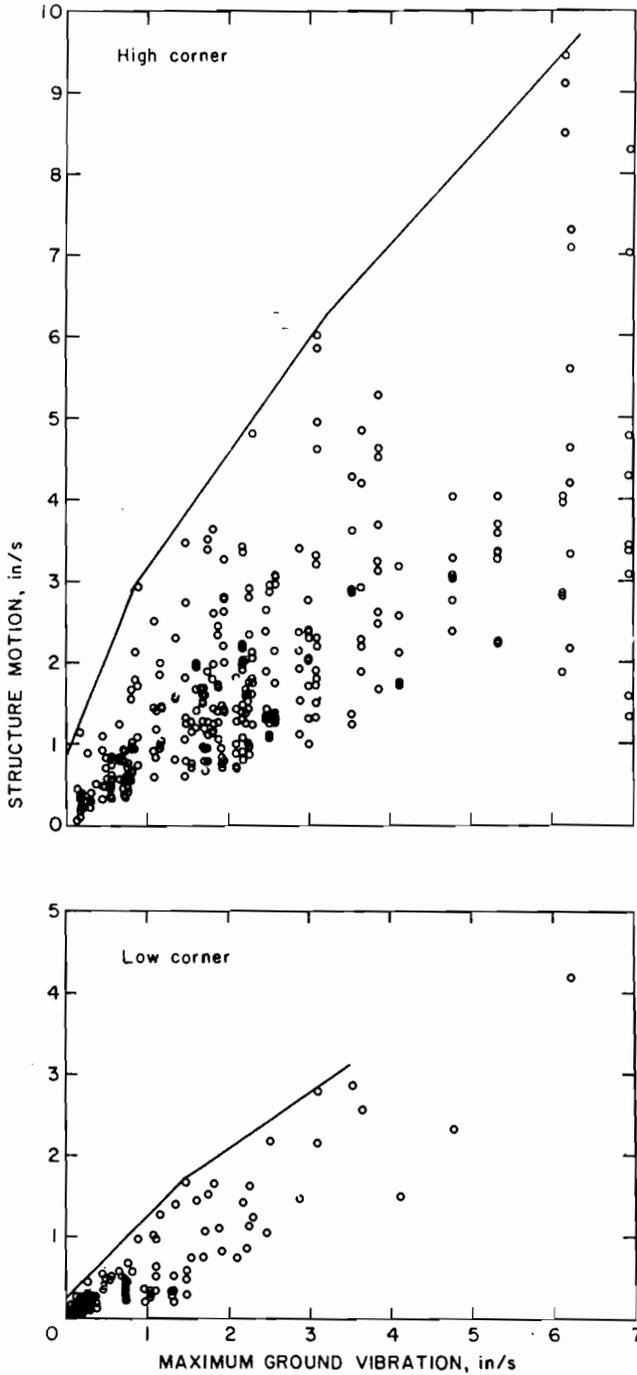
FIGURE 29. - Low- and high-corner responses versus maximum ground vibration.

Low- and high-corner responses are plotted against maximum ground vibration (ground peak particle velocity) in figure 29. A large difference exists in the slopes of the envelopes of the high- and

low-corner responses and in the scatter of data. The slope of the envelope of structure motion versus maximum ground vibration is a good approximation of the maximum amplification factor. Structure response depends on the frequency of the excitation. The large scatter of data in figure 29 resulted from the wide variation in excitation frequencies, which resulted in different amounts of amplification. The effect of excitation frequency on amplification factors is shown in figure 30.

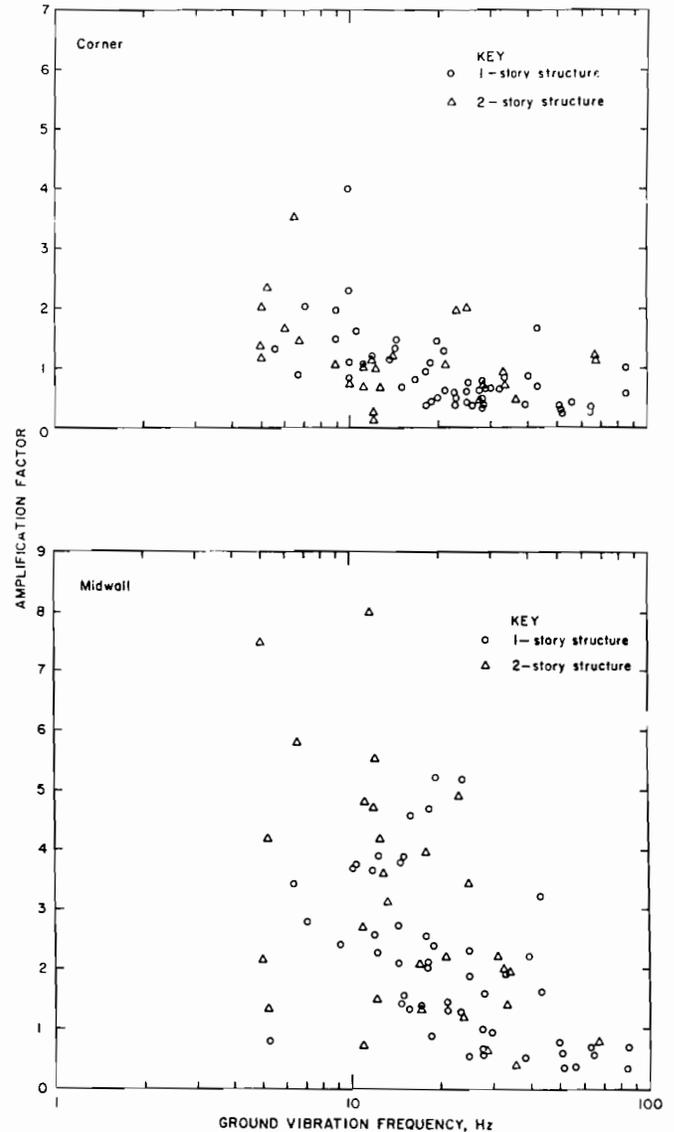
FIGURE 30. - Corner and midwall amplification factors (2).

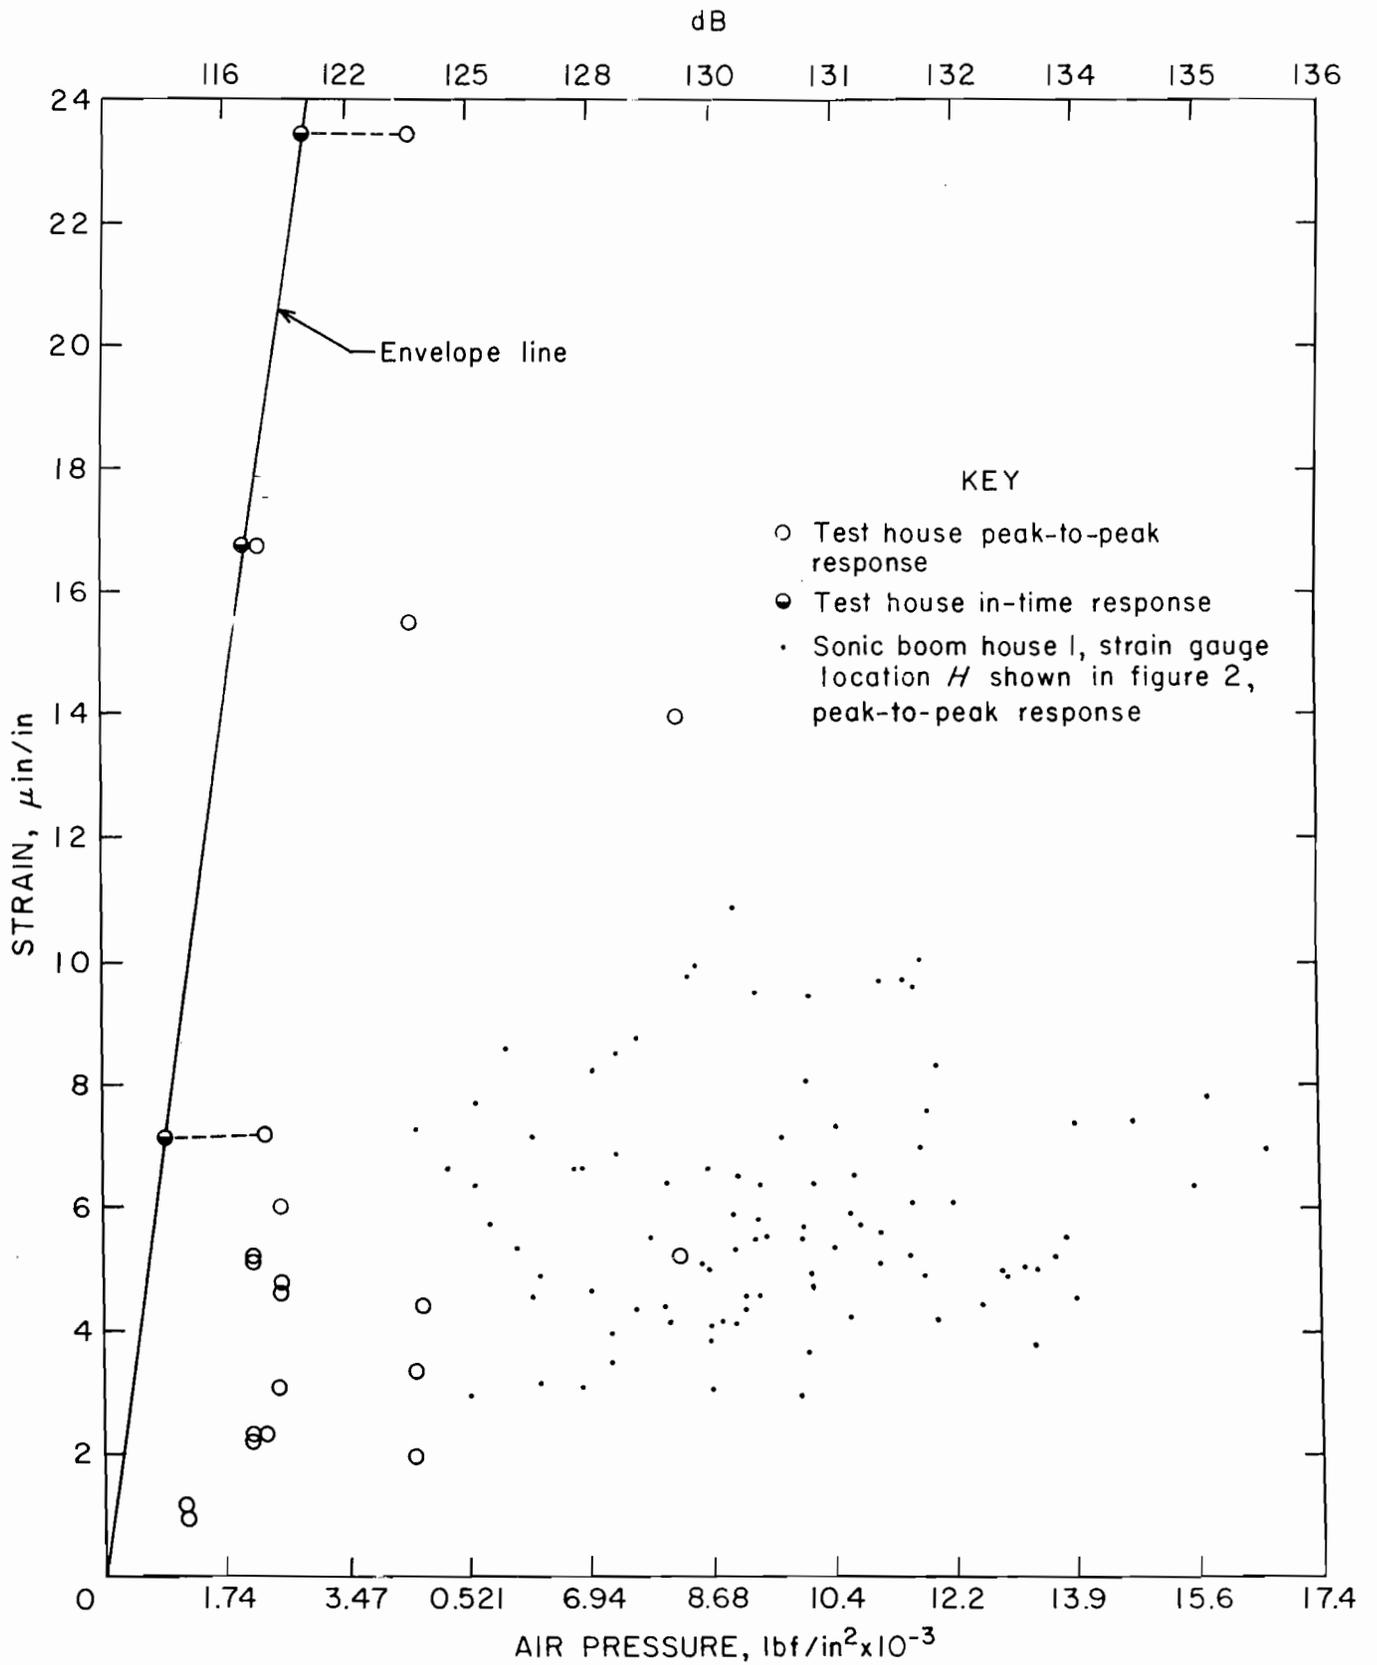
FIGURE 31. - Wallboard strain versus airblast level at test house, with comparison to sonic boom response.

Strains in walls from airblast are shown in figure 31. Based on the worst-case envelopes of airblast and ground vibration versus strain, an airblast of ~ 132 dB produces the same wall strains as a ground vibration of 1 in/s. This equality applies only to airblasts whose peak amplitudes occur at frequencies within the range of the frequencies of the structure's midwalls. Otherwise, typical airblasts in these tests induced strains of less than 25 $\mu\text{in/in}$, even for airblasts approaching 132 dB. The measured strains were equivalent to those produced by a ground vibration of 0.25 in/s. In the time histories, the maximum strain responses usually coincided with the arrival of frequencies near the structure's natural frequency. Figure 31 also includes the induced strains recorded in one of the houses in the previously discussed sonic-boom study (3). The larger structure response from the mine blasts is the result of a better match of the frequency content of the confined blasts to the natural frequency of the wall panels.

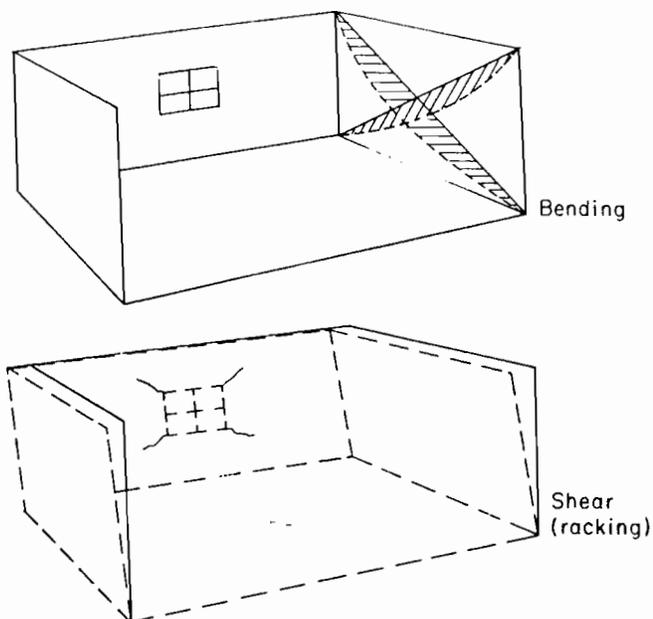
FIGURE 32. - Shear and bending of walls (2).

As illustrated in figure 32, strain response is a combination of both shear and flexural deformation of the walls. Plots of strain versus maximum ground vibration are shown for wallboard and plaster, wallboard tape joints, block joints, and brick veneer, and fireplace brick joints in figures 33-37, respectively. The graph of peak wallboard and plaster strain (fig. 33) shows a large scatter of data again (as in figure 29) due to differences in excitation frequency and mode at the same maximum vibration level, or peak particle velocity. Wallboard and taped joints were exposed to maximum strains of 250 to 550 $\mu\text{in/in}$, which is considerably below the 1,000 $\mu\text{in/in}$ necessary for visible cracking. However, these are dynamic strains, and they do not include prestrains. Since no cracks were observed in the wallboard, the prestrains were probably less than 500 $\mu\text{in/in}$.

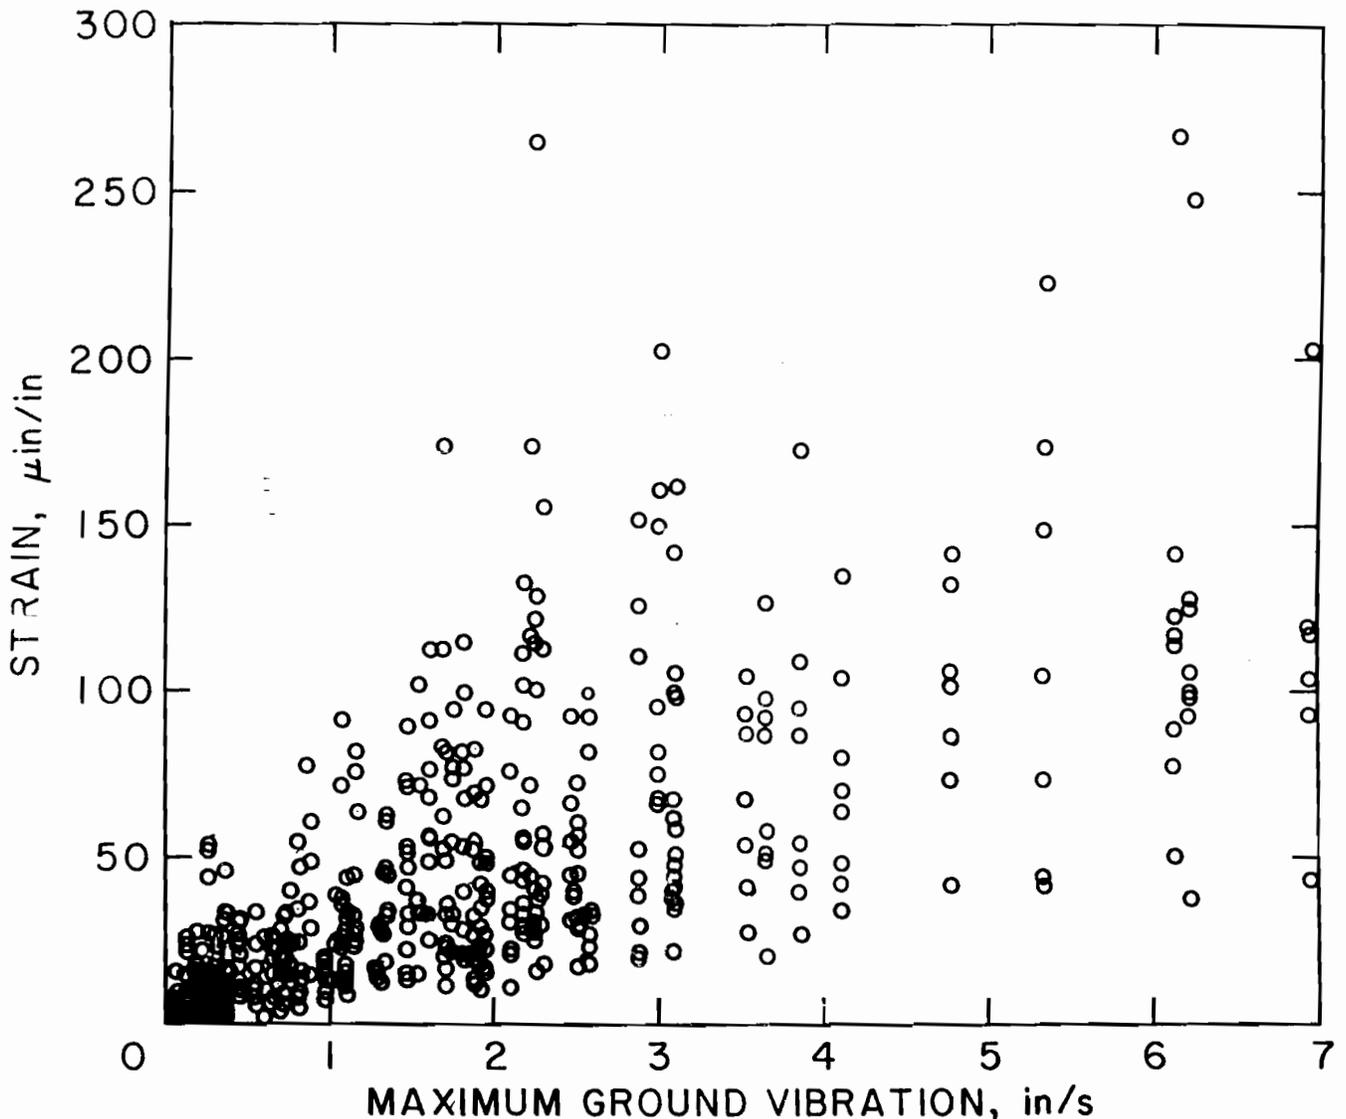
FIGURE 33. - Wallboard and plaster strain versus maximum ground vibration.

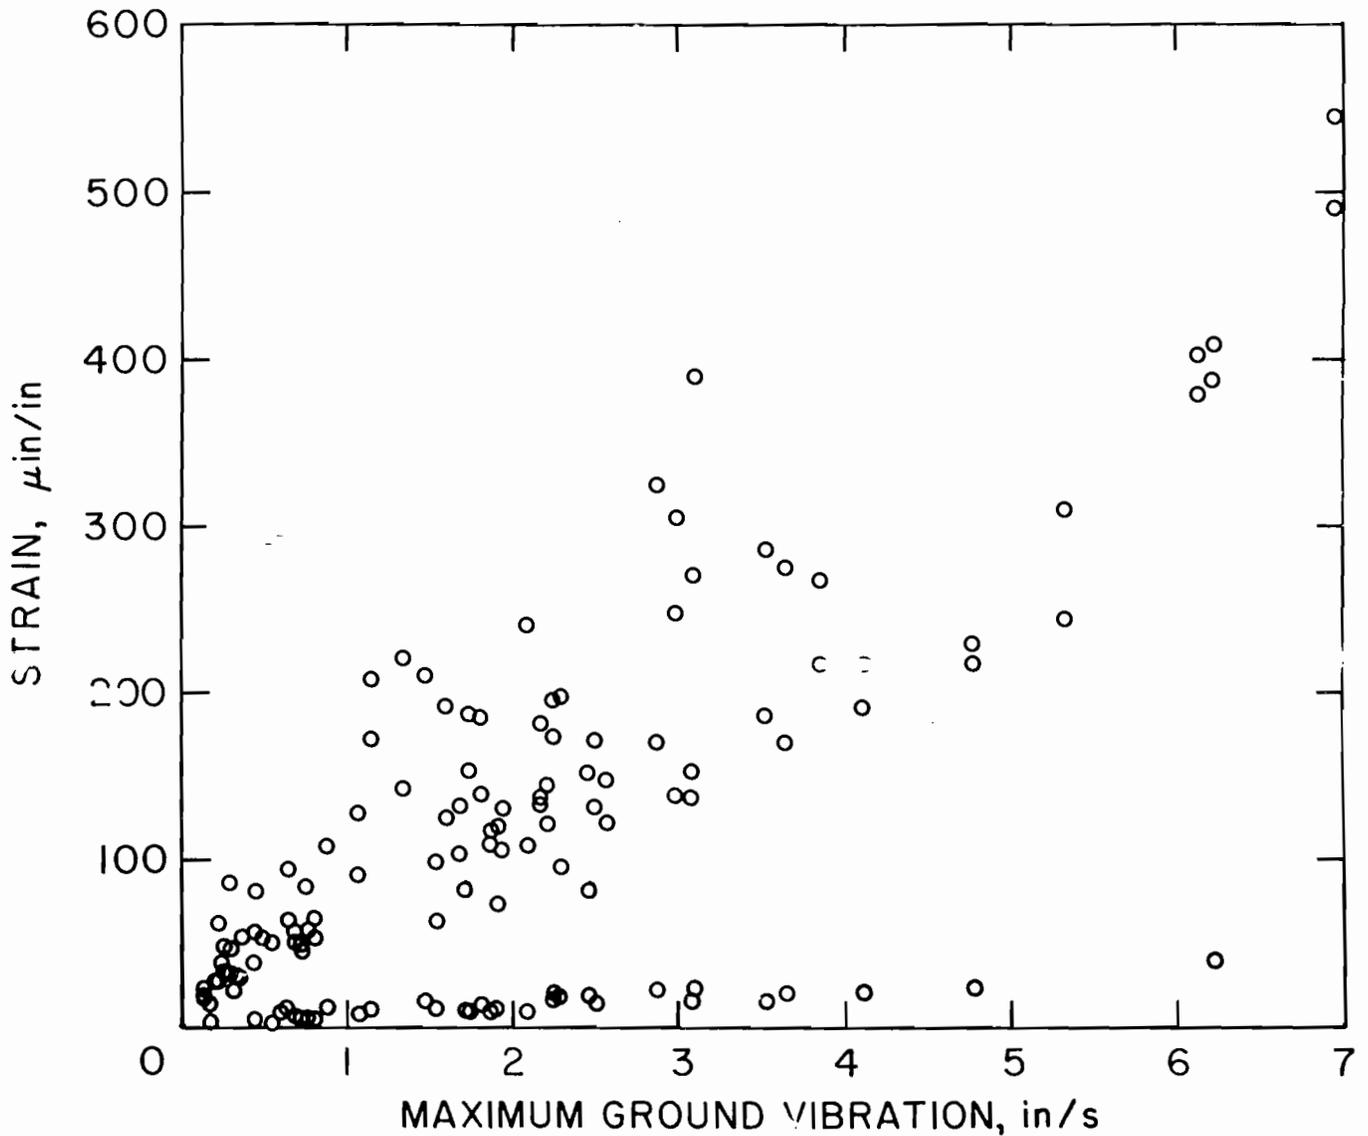
FIGURE 34. - Wallboard tape joint strain versus maximum ground vibration.

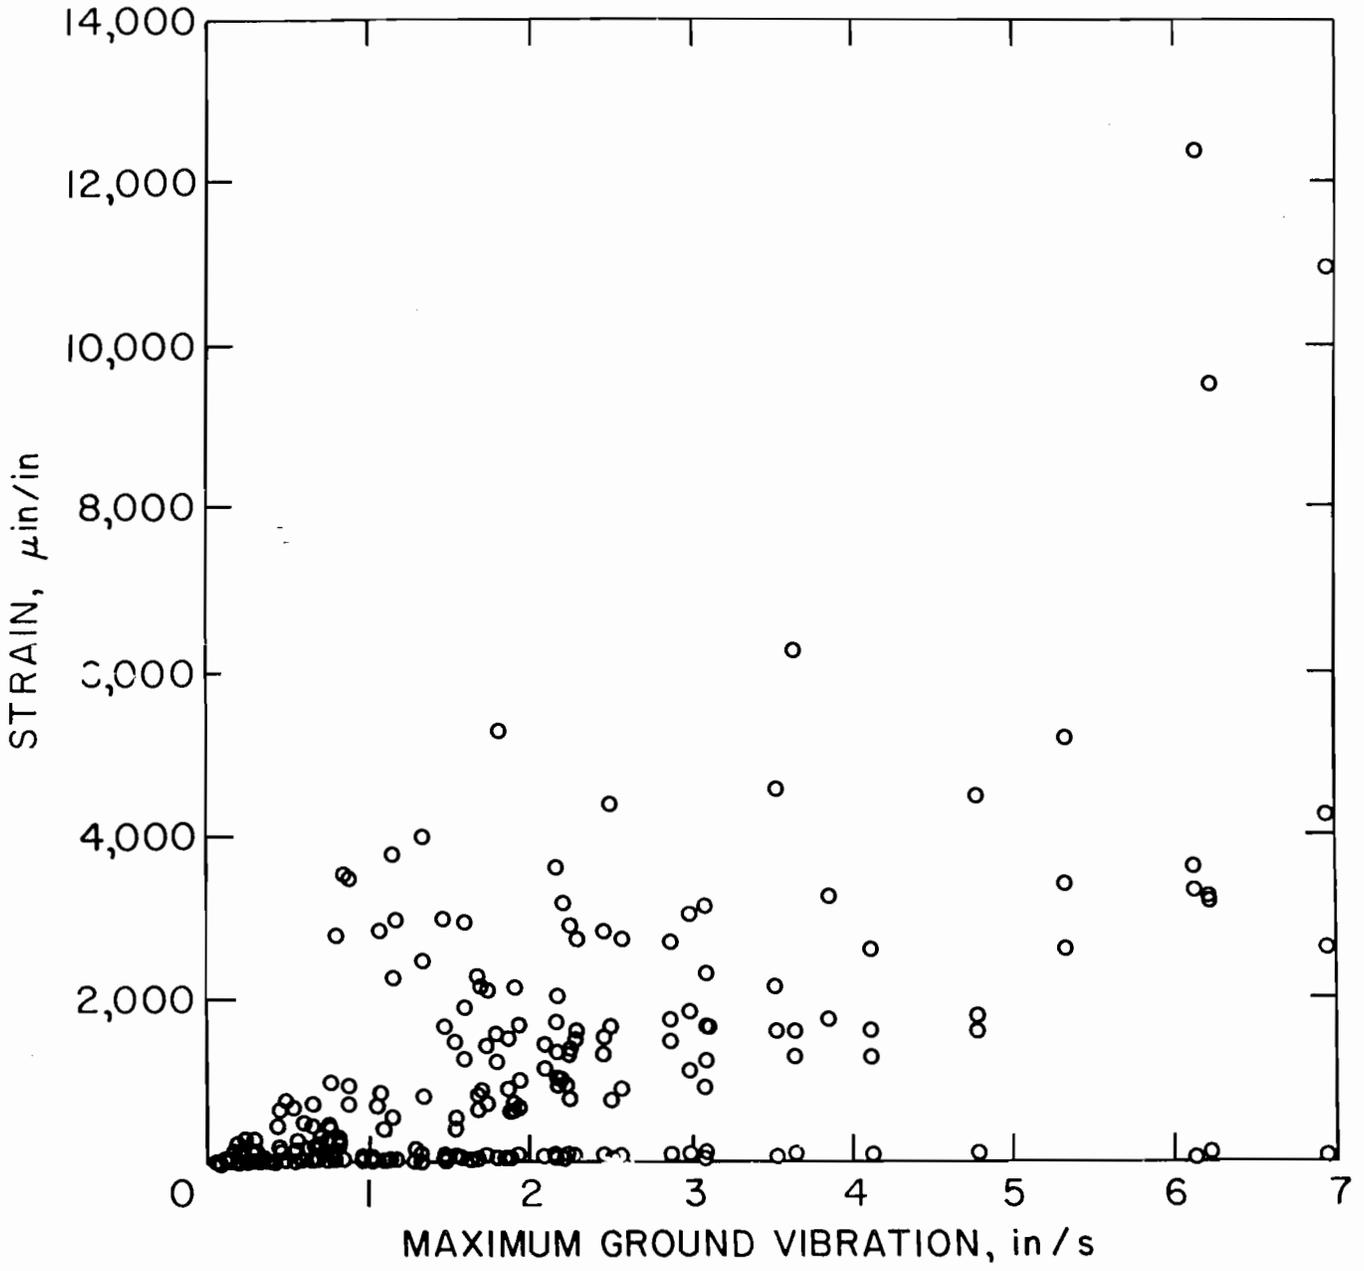
FIGURE 35. - Block joint strain versus maximum ground vibration.
