Report of Investigations 8896

Effects of Repeated Blasting on a Wood-Frame House

By Mark S. Stagg, David E. Siskind,
Michael G. Stevens, and Charles H. Dowding

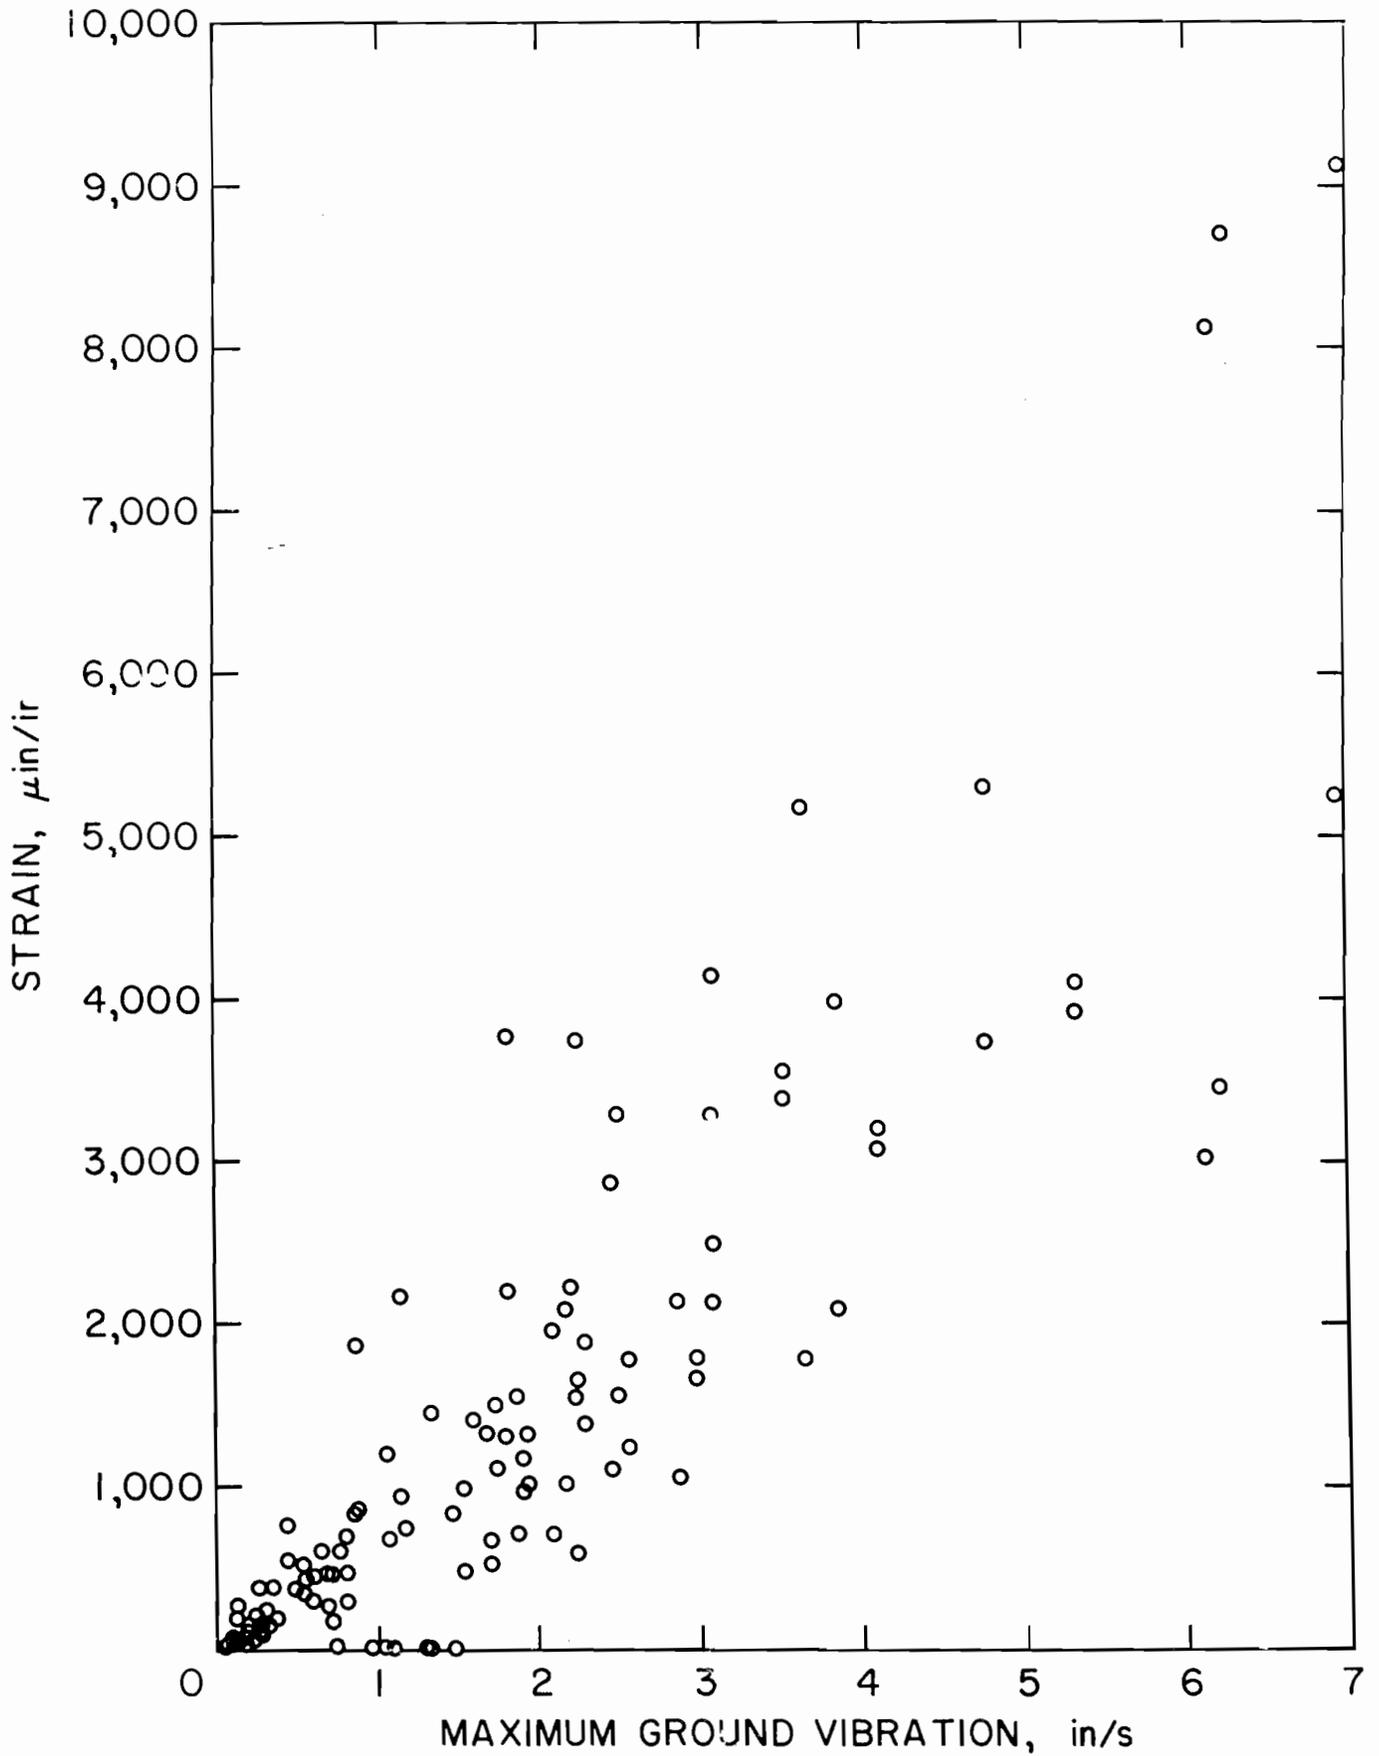
FIGURE 36. - Brick veneer joint strain versus maximum ground vibration.

As illustrated in figure 32, strain response is a combination of both shear and flexural deformation of the walls. Plots of strain versus maximum ground vibration are shown for wallboard and plaster, wallboard tape joints, block joints, and brick veneer, and fireplace brick joints in figures 33-37, respectively. The graph of peak wallboard and plaster strain (fig. 33) shows a large scatter of data again (as in figure 29) due to differences in excitation frequency and mode at the same maximum vibration level, or peak particle velocity. Wallboard and taped joints were exposed to maximum strains of 250 to 550 $\mu\text{in/in}$, which is considerably below the 1,000 $\mu\text{in/in}$ necessary for visible cracking. However, these are dynamic strains, and they do not include prestrains. Since no cracks were observed in the wallboard, the prestrains were probably less than 500 $\mu\text{in/in}$.

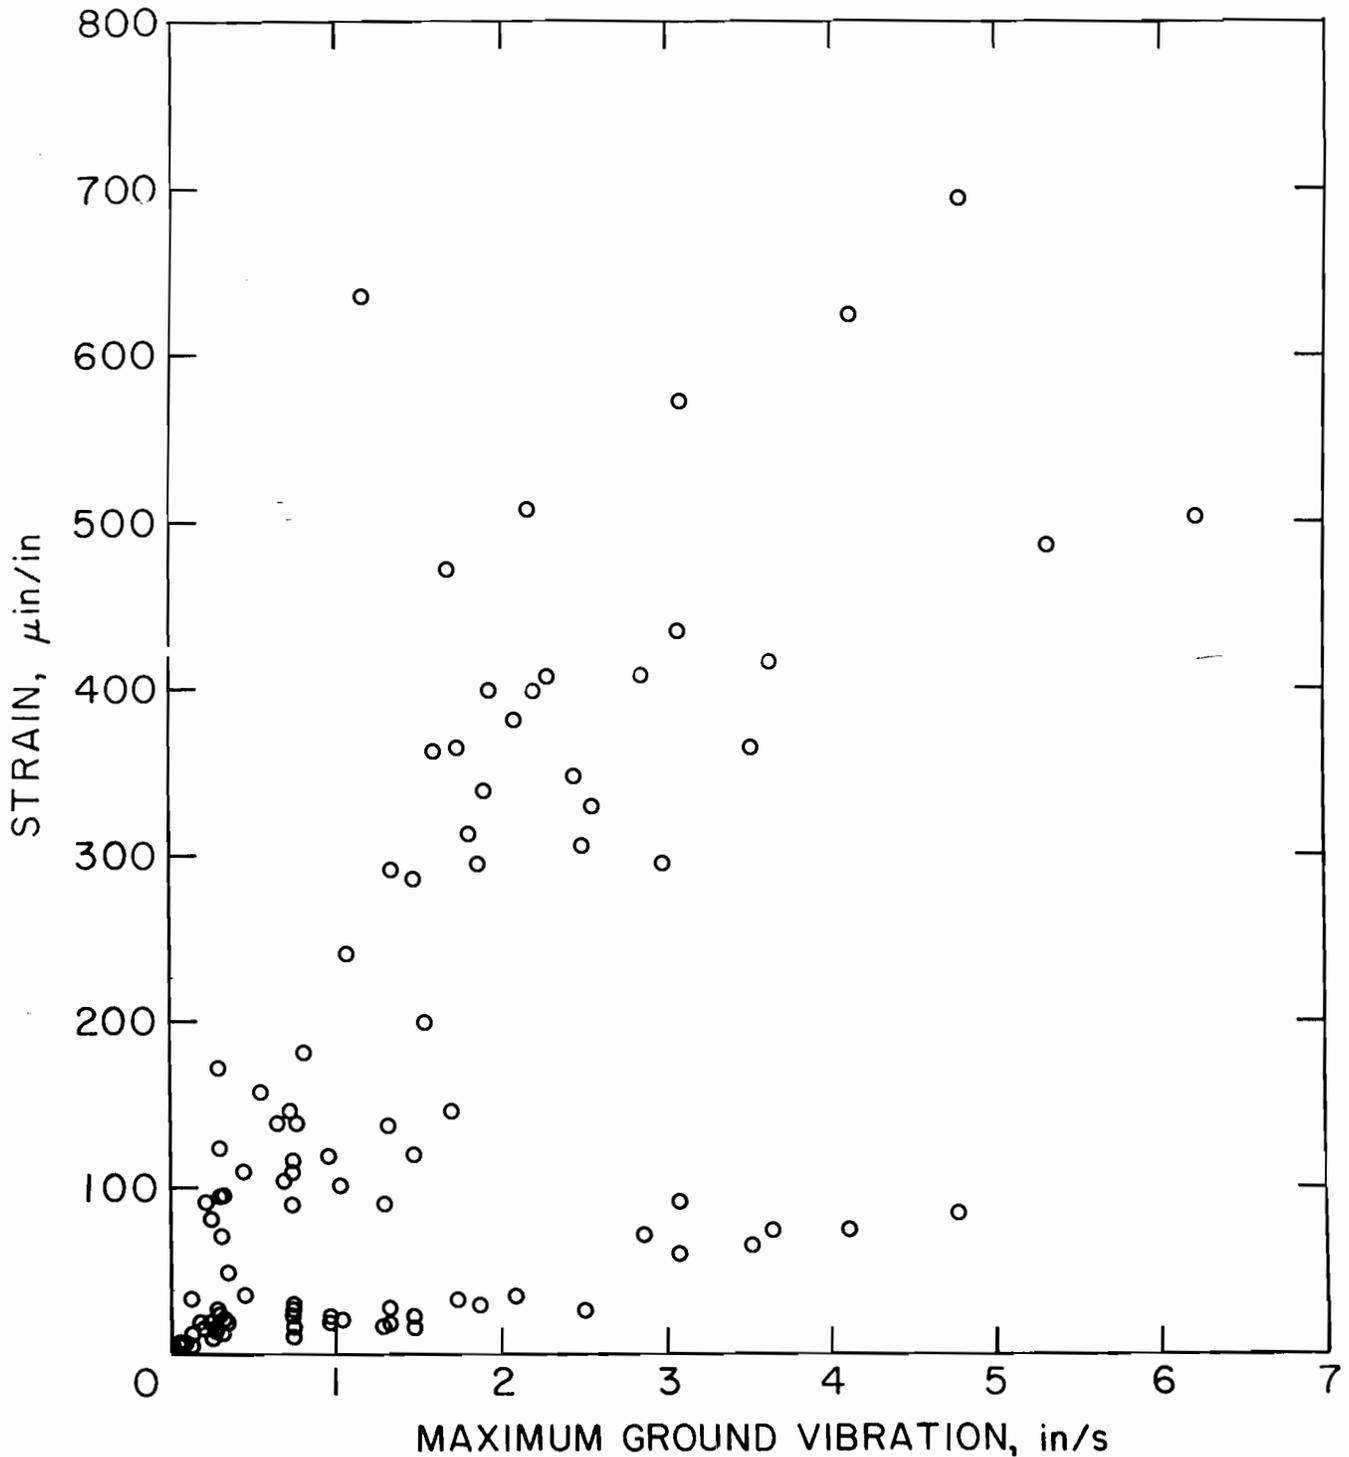
FIGURE 37. - Fireplace brick joint strain versus maximum ground vibration.

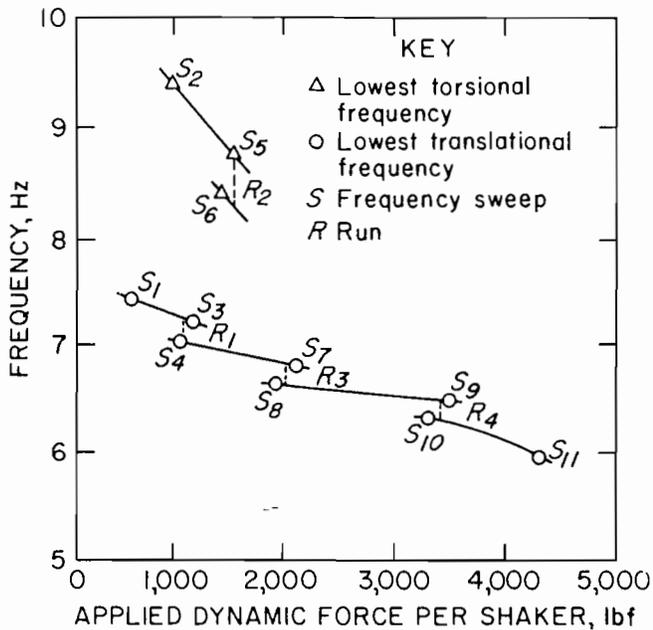
FIGURE 38. • Resonance frequencies versus applied dynamic force during shaker tests.

The superstructure decreased in stiffness, as shown by the drop in natural frequency plotted in figure 38. In addition, flexure was observed at the small

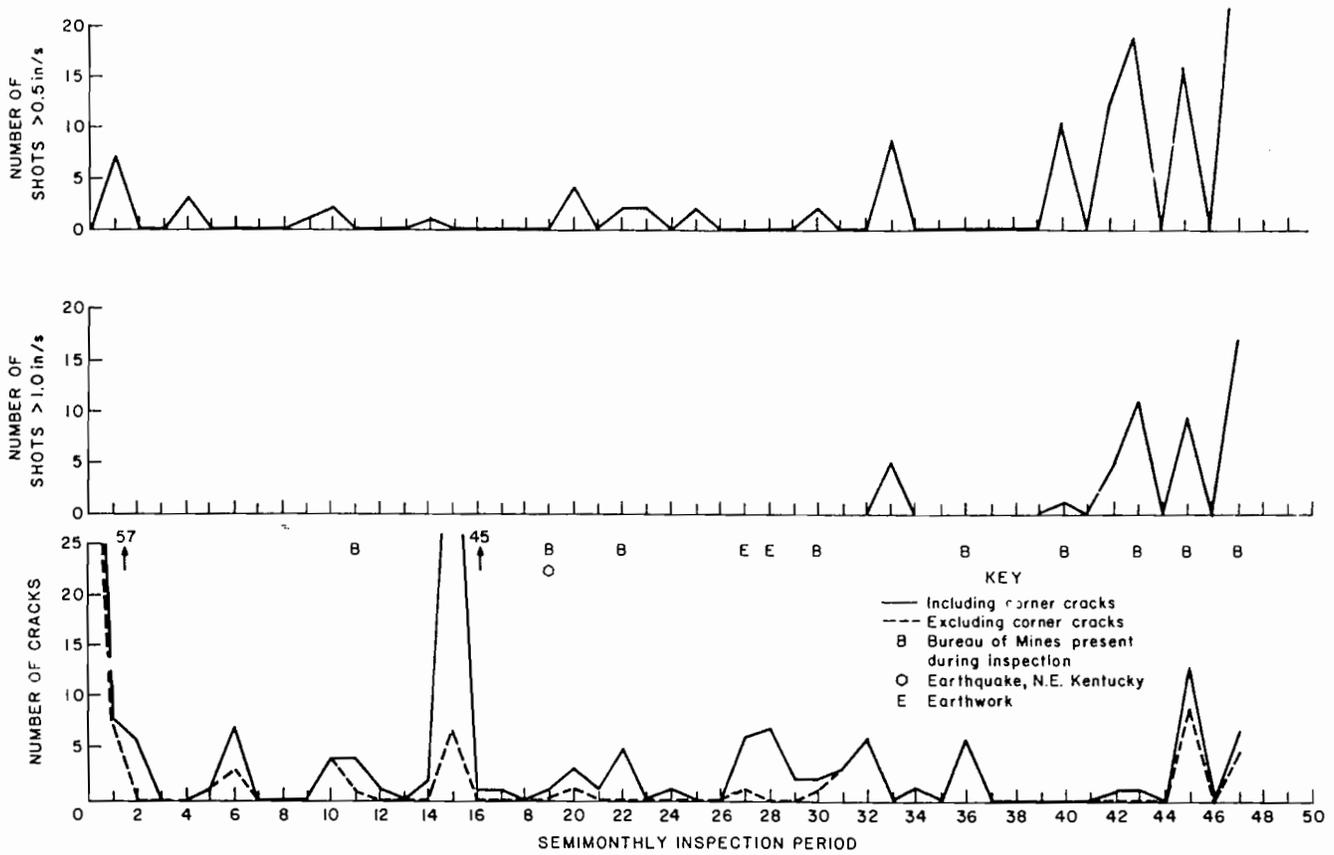
FIGURE 39. - Number of cracks and blasts >0.50 in/s and >1.0 in/s versus inspection period.

ground vibrations >0.50 in/s and >1.0 in/s, is shown in figure 39. The histogram of all peak ground vibration levels is shown in figure 40. The ground vibration levels were either recorded by the self-triggering equipment or back calculated using propagation equations in the 0.01- to 0.10-in/s range. (Of the 475 vibration levels in this range, 250 were calculated.)

Some of the crack rates shown in figure 39 include small hairline corner cracks, and some do not. The majority of corner cracks occurred in the first 8 months. Cracks were found in nearly every corner in the house, but were ignored up to inspection period 15. Then it was decided to rigorously observe them despite their miniscule size. Corner cracks are an inevitable consequence of the curing of the tape compound and are enhanced by dynamic strains induced by human activity.

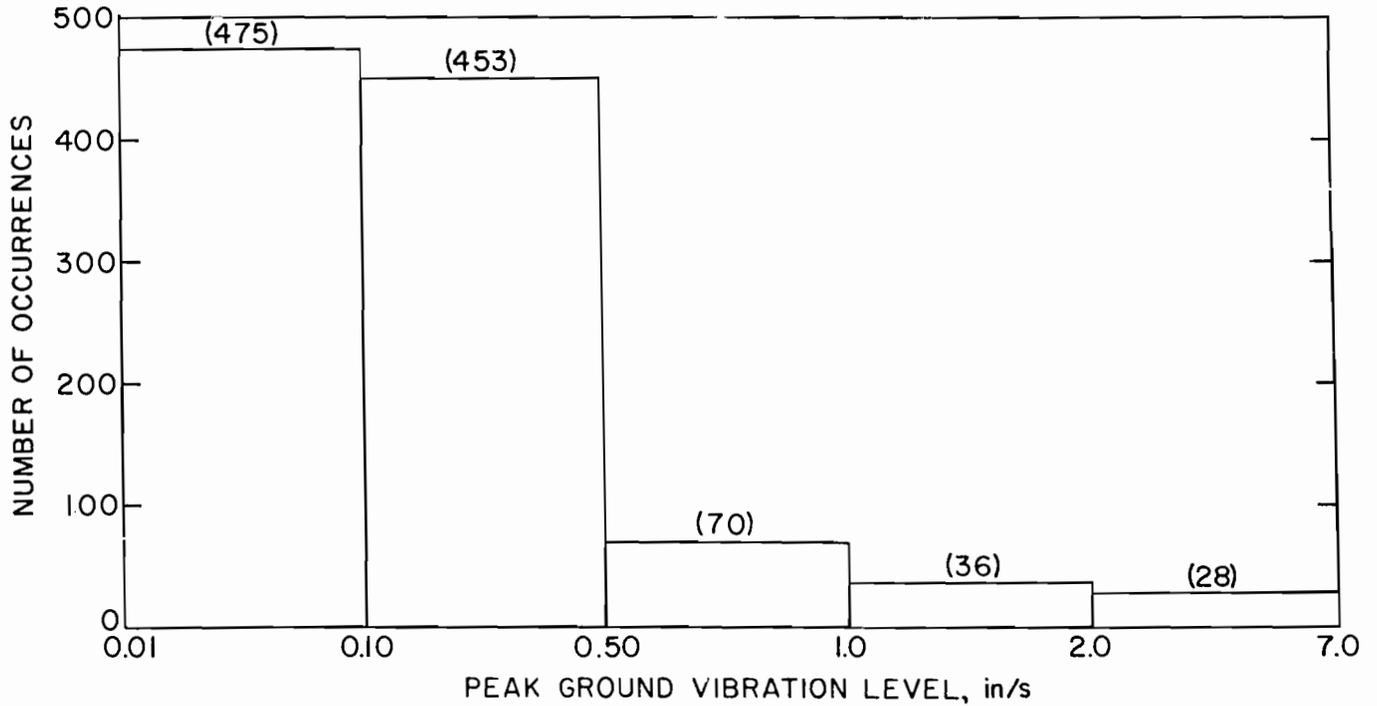
FIGURE 40. - Histogram of peak ground vibration levels recorded at test house.

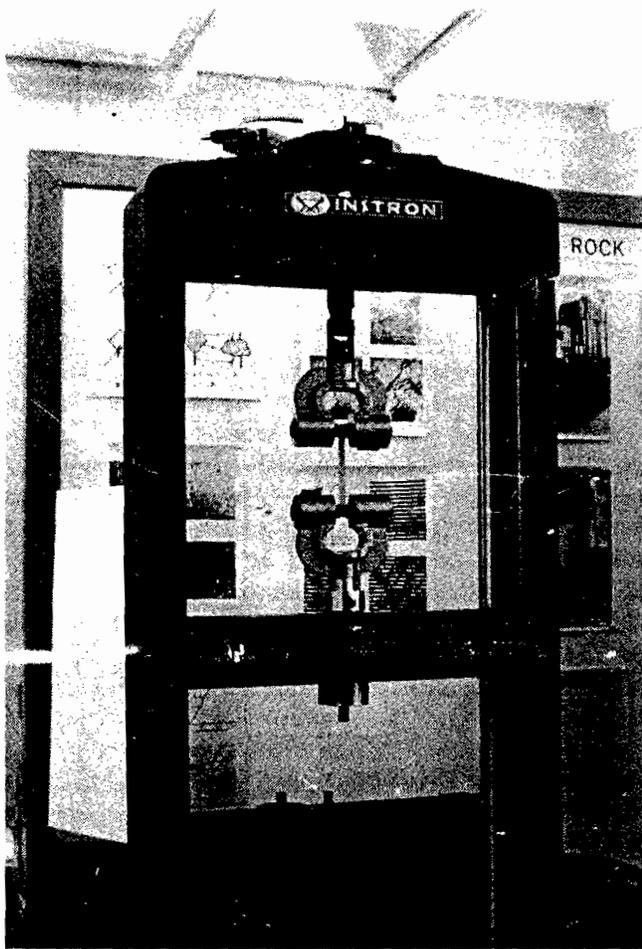
FIGURE A-1. - Instron TM 100-kg universal testing machine with test specimen.

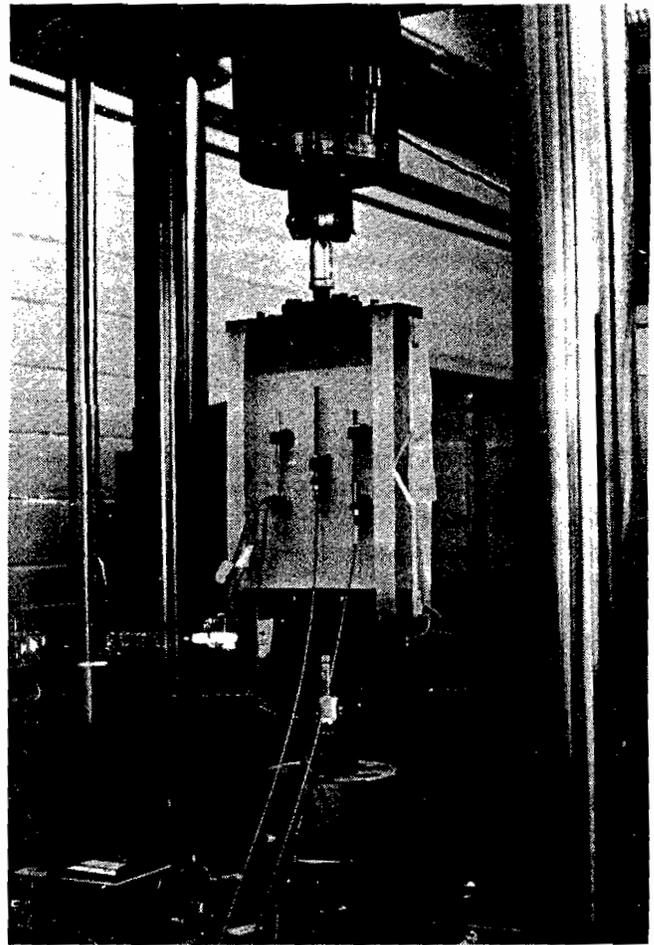
FIGURE A-2. - MTS 250-lbf electro-hydraulic loading frame with test specimen.

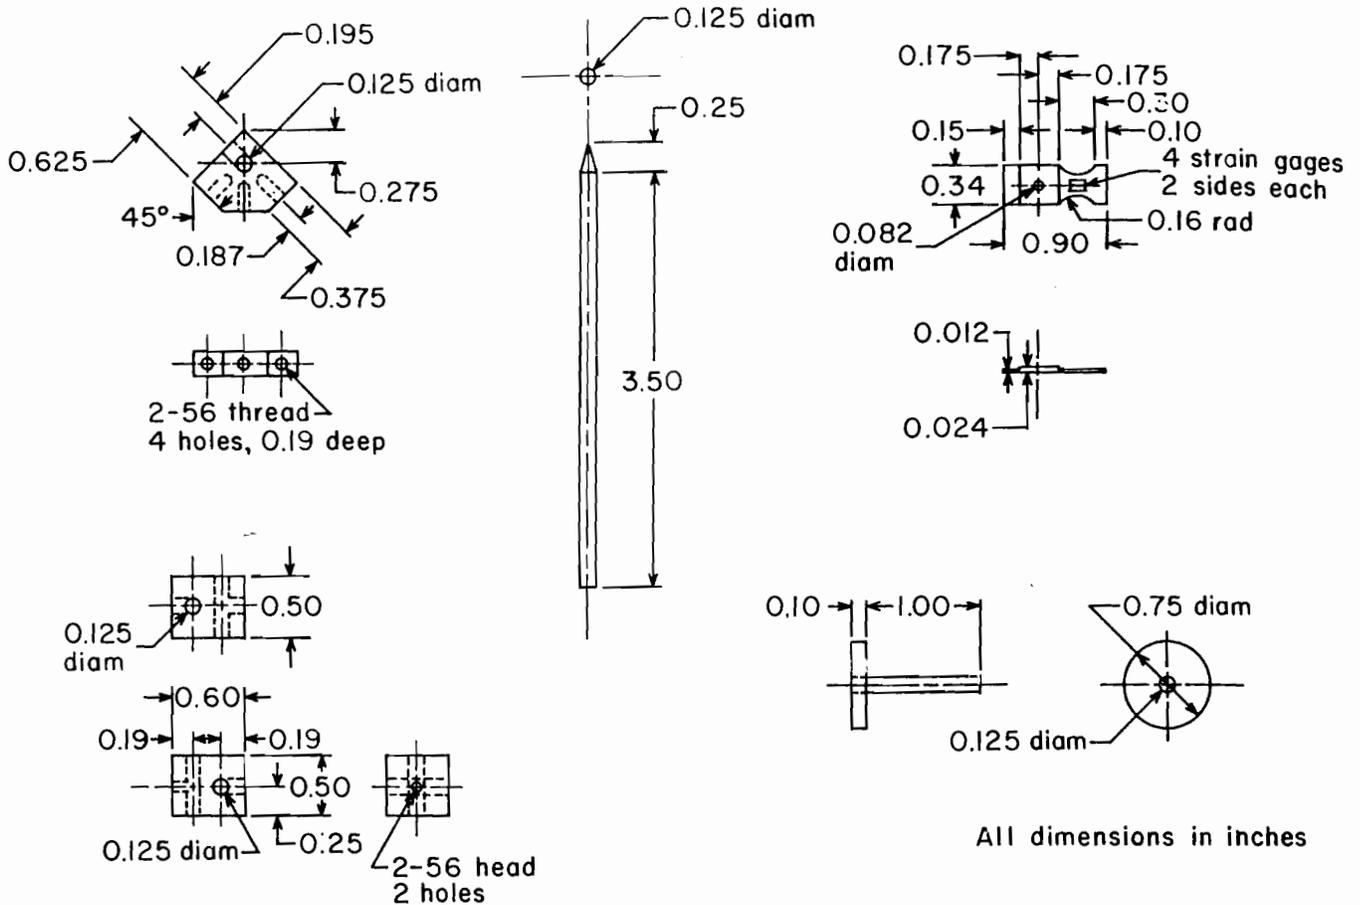
FIGURE A-4. - Details of post-mounted strain system.

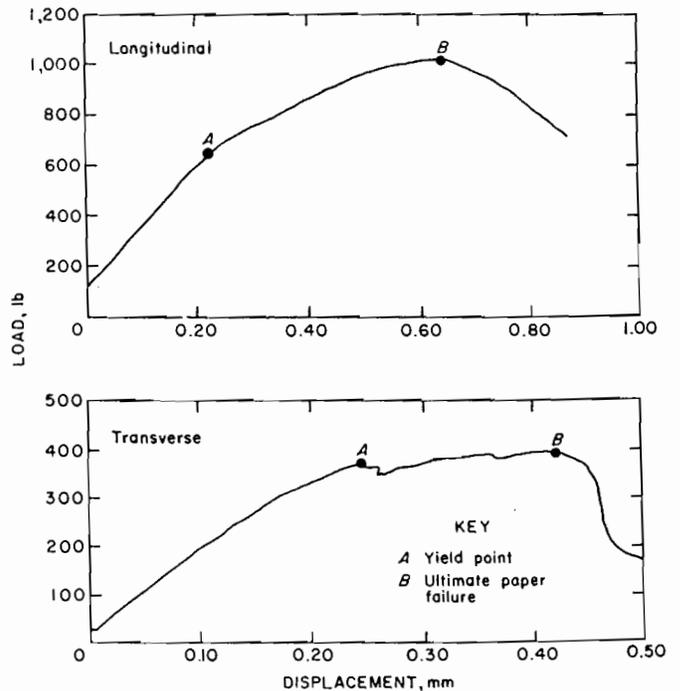
FIGURE A-5. - Effect of paper orientation on tensile failure curves for 1/2-in-thick wallboard.

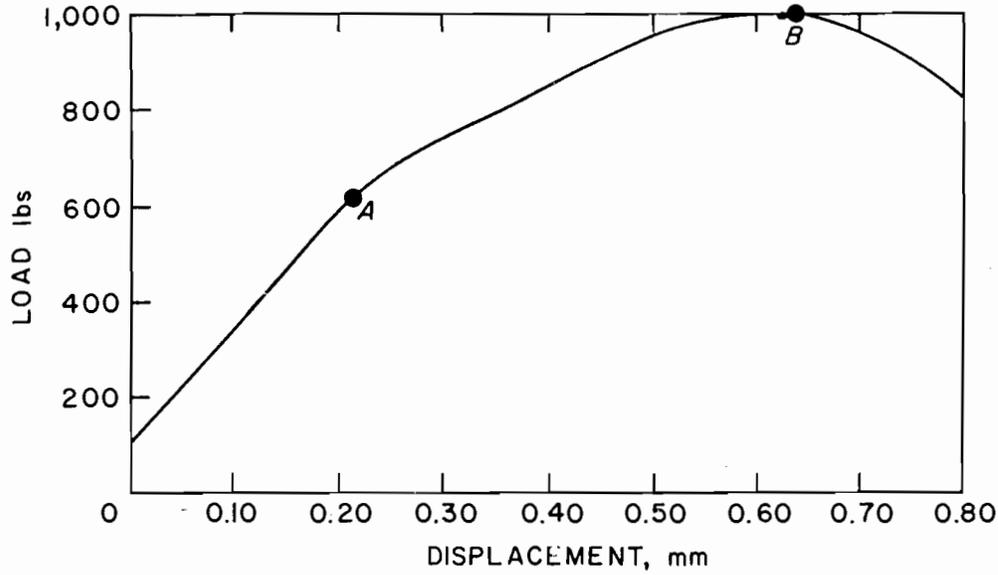
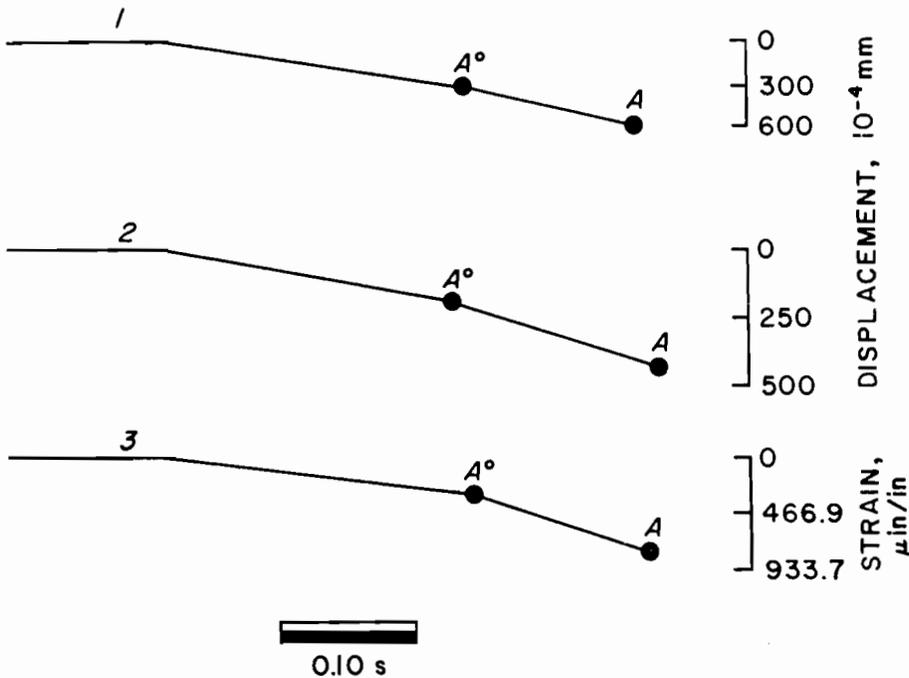
- A Yield point
- B Ultimate paper failure
- A° Core failure
- 1 Strain-leaf system
- 2 Kaman system
- 3 Strain gauge

FIGURE A-6. • Comparison of tensile failure displacement data for 1/2-in-thick wallboard.

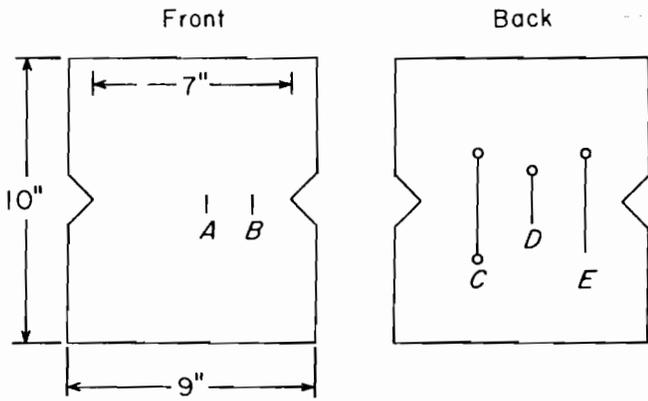
- A Strain gauge
- B Strain gauge
- C Strain-leaf system
- D Kaman system
- E Kaman system

FIGURE A-7. - Wallboard specimen and strain systems tested under load control.

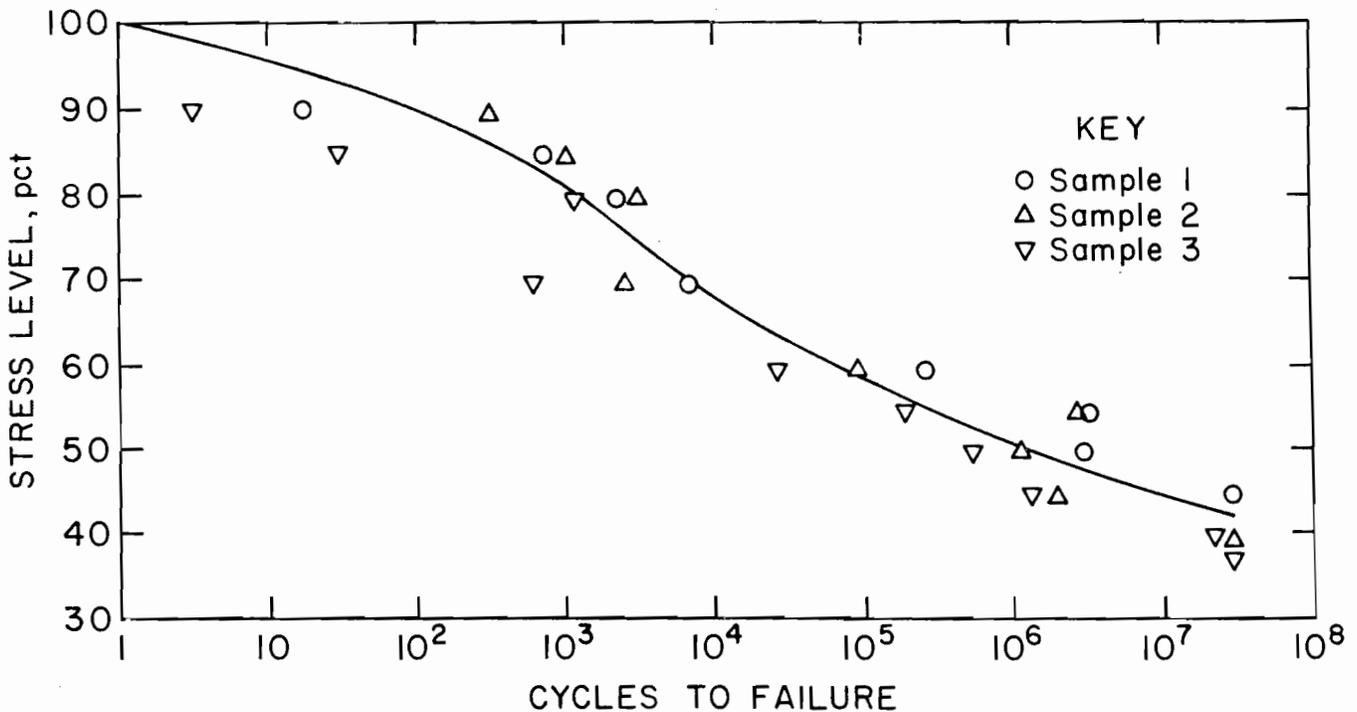
FIGURE A-8. - Stress level versus number of cycles to failure for 1/4-in-thick hardboard in tension (10).

Fatigue assessment was limited to a cursory look at the hardboard data presented in table A-1 and a limited fatigue test. Table A-2 displays the results for cyclic tests of wallboard under displacement control. As cyclic strain data were sought, strain systems were balanced to zero out baseline shift due to system drift and paper creep. Absolute displacement was not available. Load control was then utilized. Figure A-7 shows a wallboard test specimen, and the test results are listed in table A-6. System response on load control limited strain output to about 50 $\mu\text{in/in}$ at an upper frequency of 2 Hz. The test was stopped at 66 h, after 475,000 cycles. Since the apparatus limited further tests, hardboard creep and fatigue data are presented, in table A-1, as a generalization of the response of wood products to cyclic and long term loads (10). Load versus number of cycles to failure (fatigue) is plotted in figure A-8, and load versus

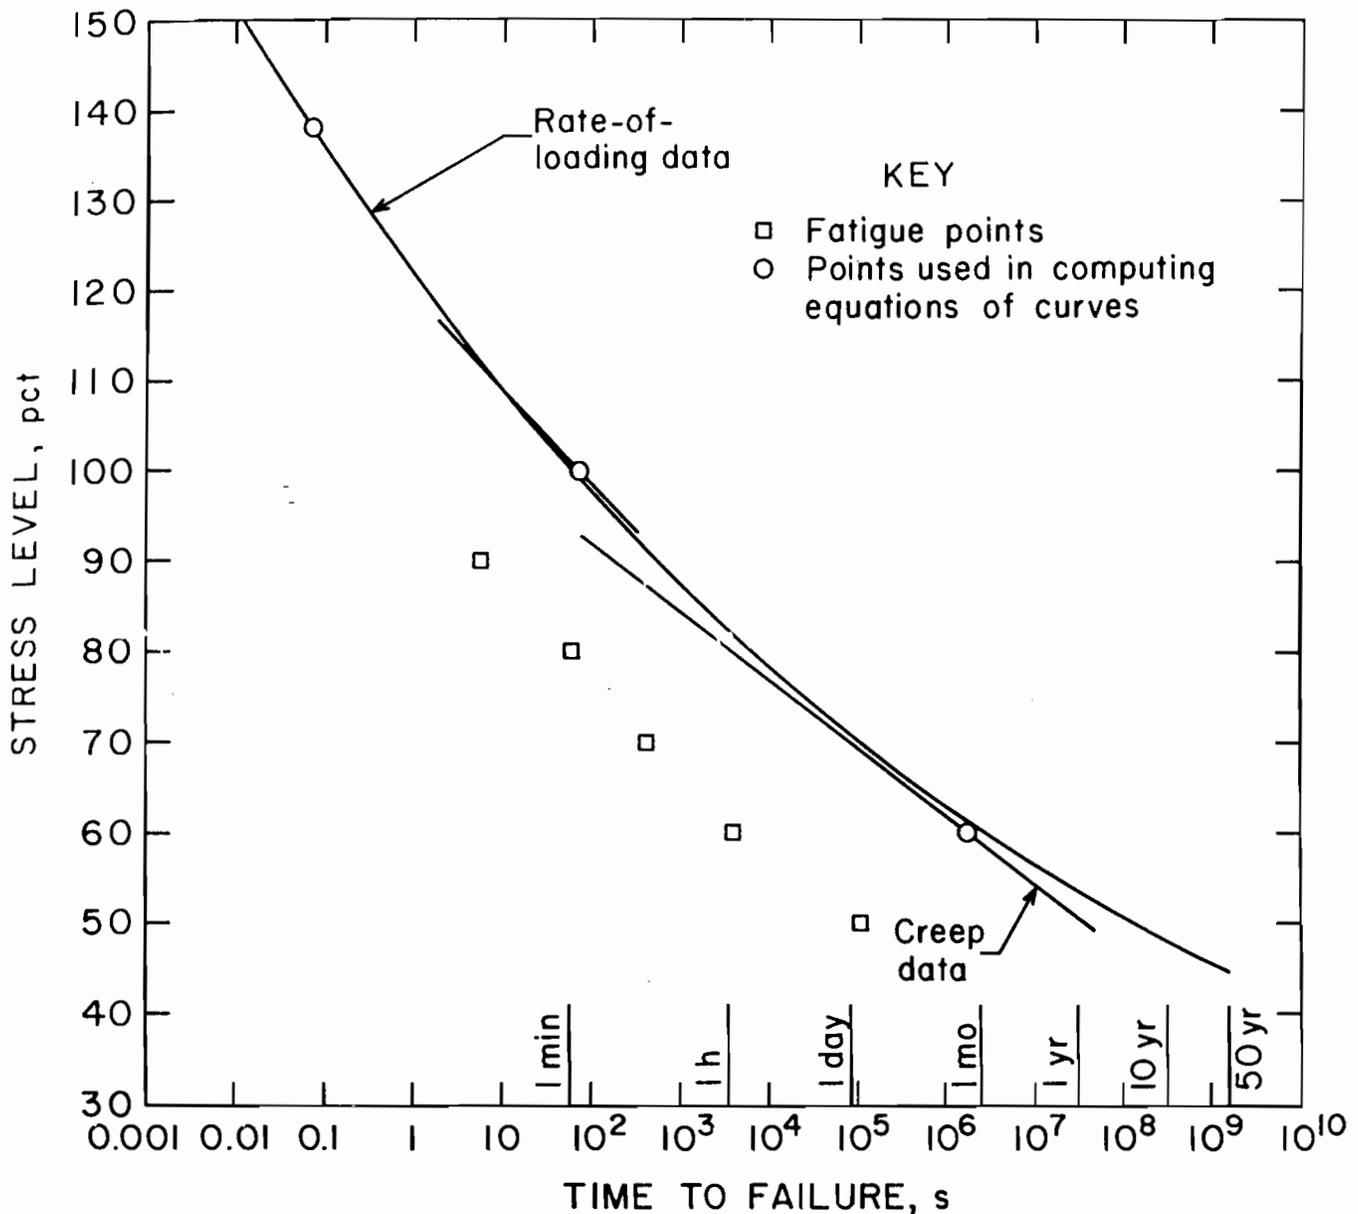
FIGURE A-9. - Stress level versus time to failure for 1/4-in-thick hardboard (10).

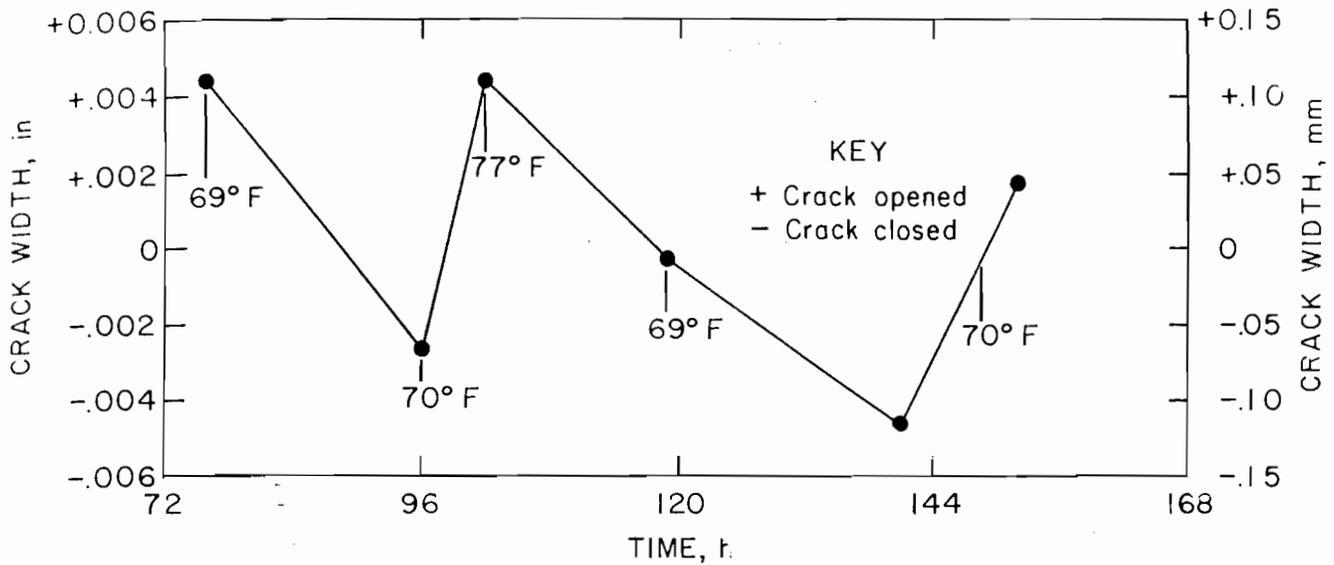
FIGURE A-10. - Response of wallboard during a period of nonblasting (35).

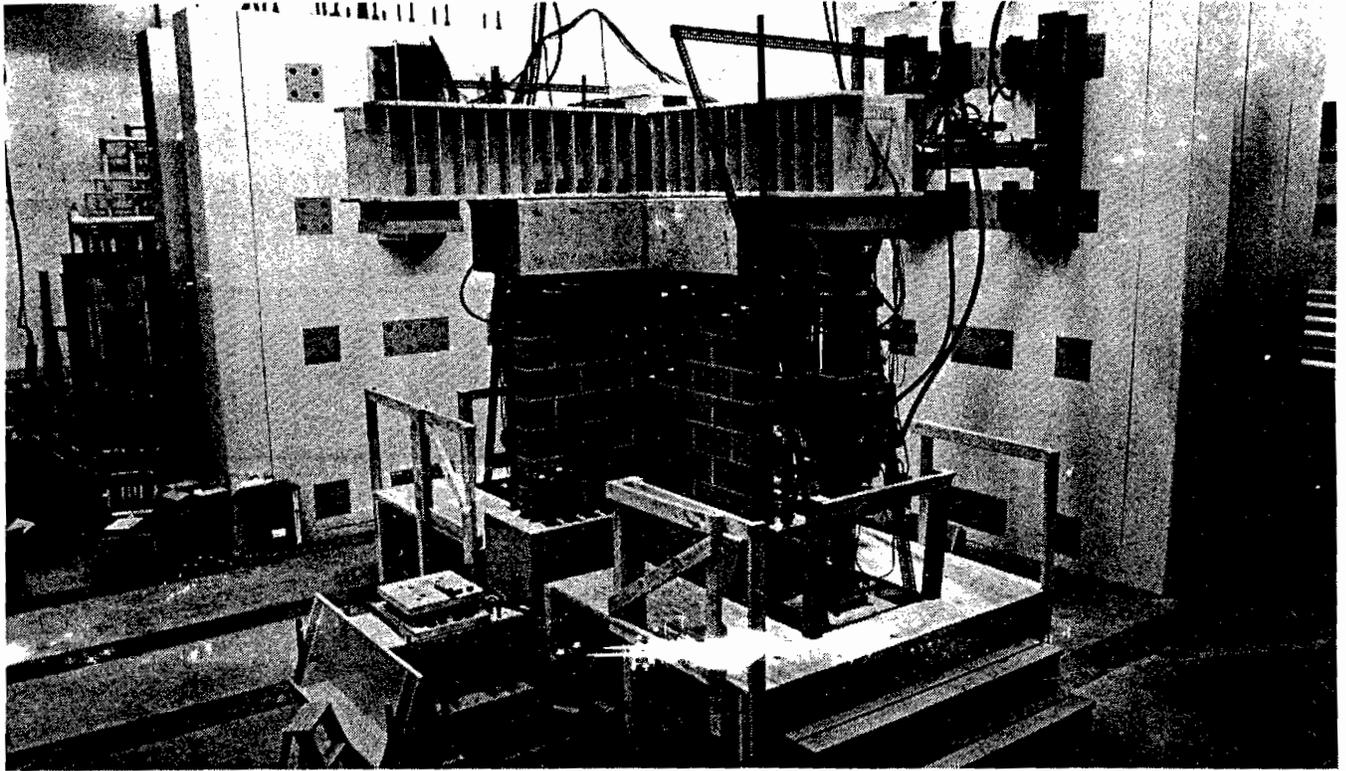
FIGURE A-12. - In-place angle wall with 4-ft-long legs at NBS Tridirectional Test Facility.

(fig. A-12). Both figures show an epoxied in-place wall. Walls were laid in running bond,¹ and standard ASTM tests

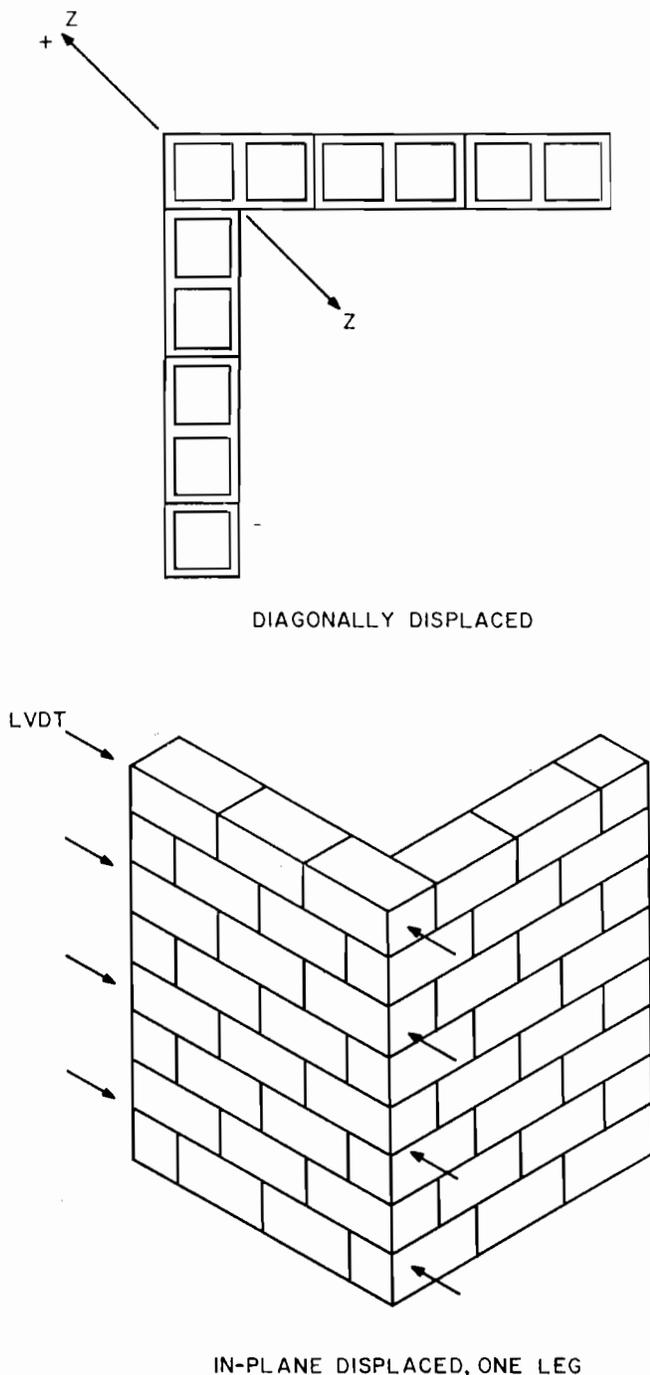
FIGURE A-14. - Loading orientations of angle wall along the diagonal and in-plane (one leg).

- The walls were epoxied in place to the upper and lower footing by lowering the upper crosshead on the bedded epoxy until a load of 500 to 1,500 lbf was sensed. The initial set took 1 h, and no tests were run until it had hardened at least 16 h. Loading was applied by the upper crosshead in the direction of the LVDT arrows in figures A-13 and A-14.

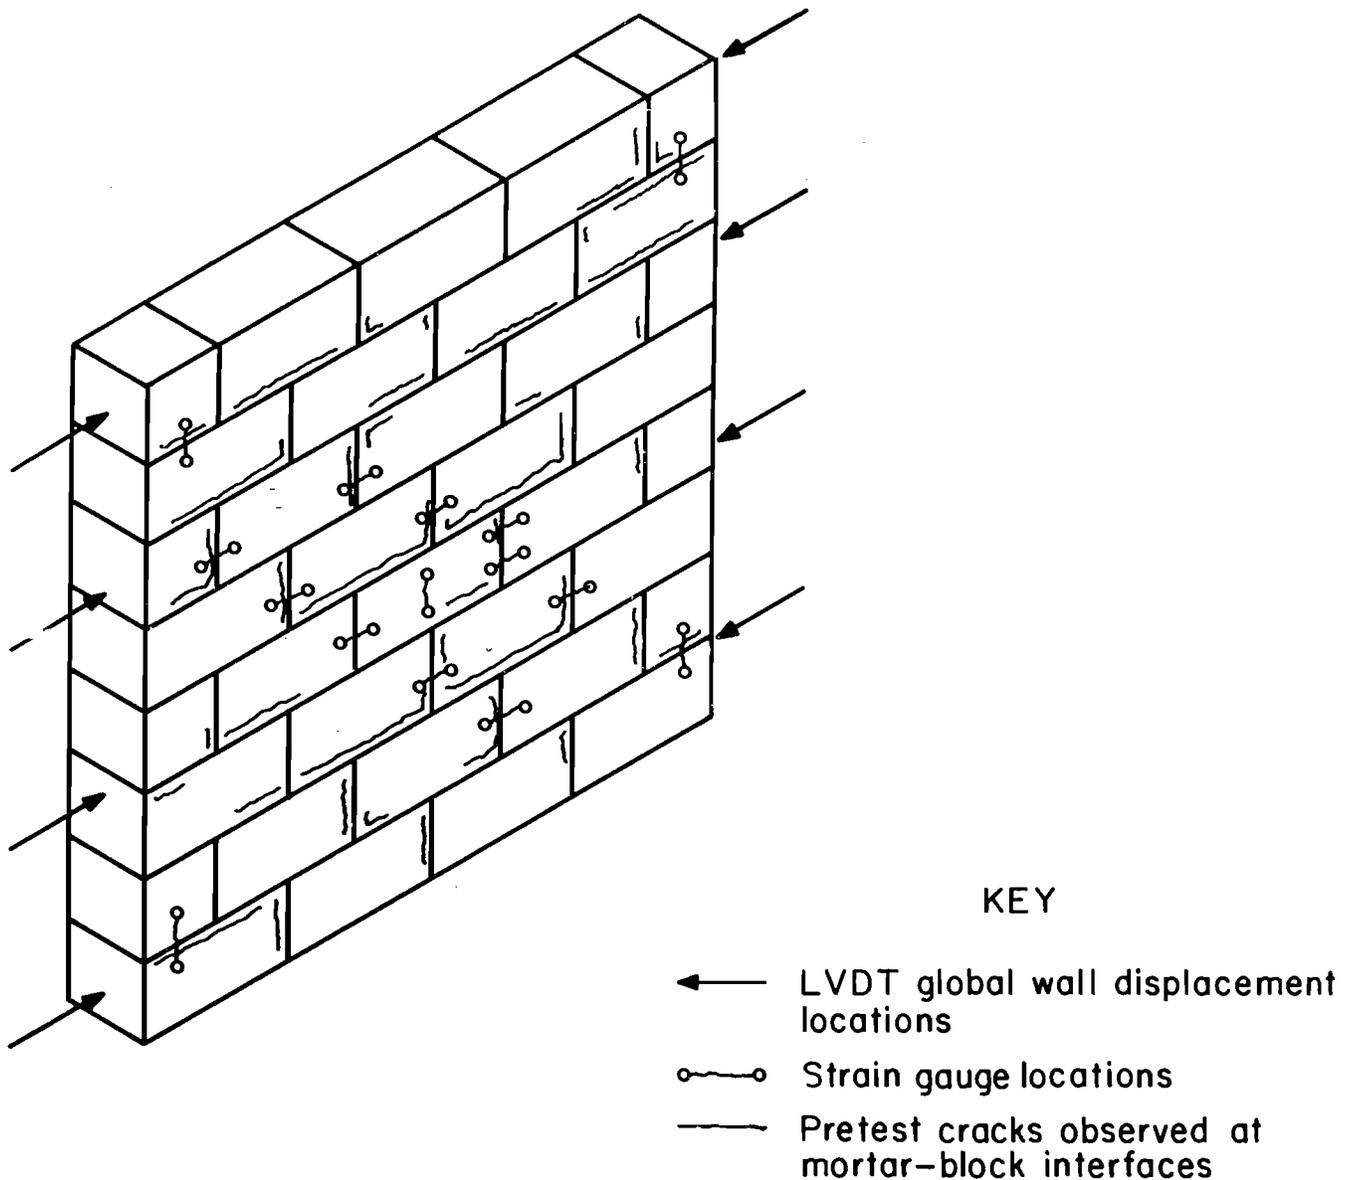
FIGURE A-13. - Typical LVDT global displacement and strain gauge locations with pretest crack observations.

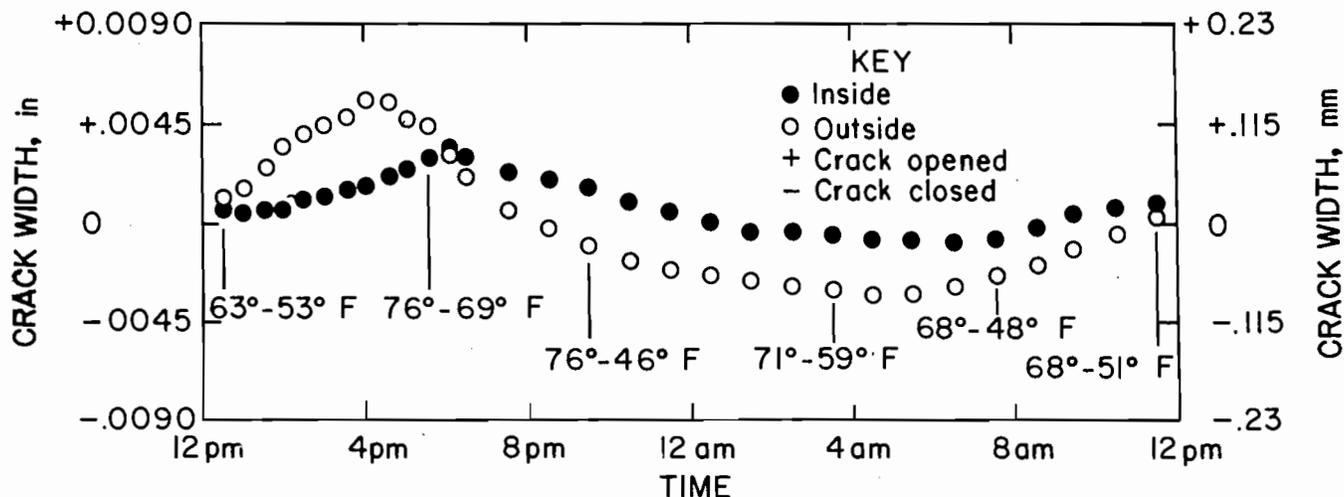
FIGURE A-15. - Response of concrete block crack widths to environmental factors (28).

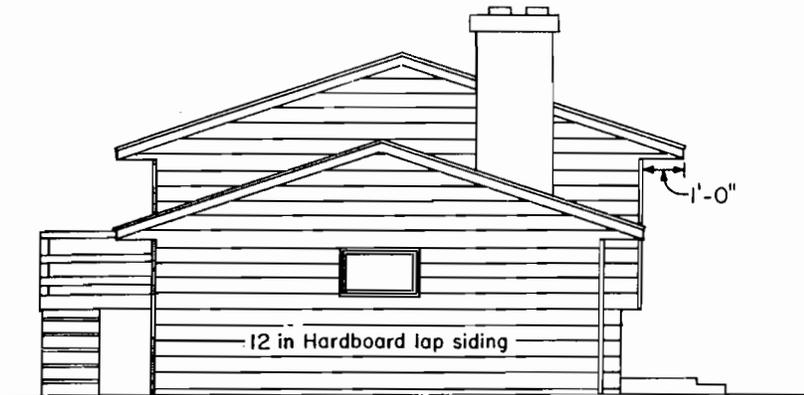
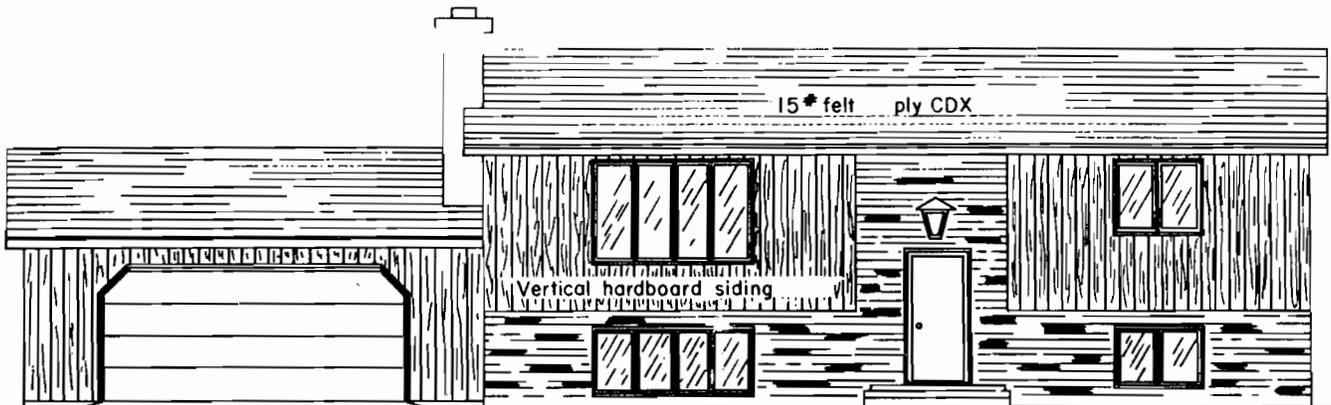
NORTH ELEVATION

WEST ELEVATION

FIGURE B-1. - North and west side elevation views (architect's drawing).

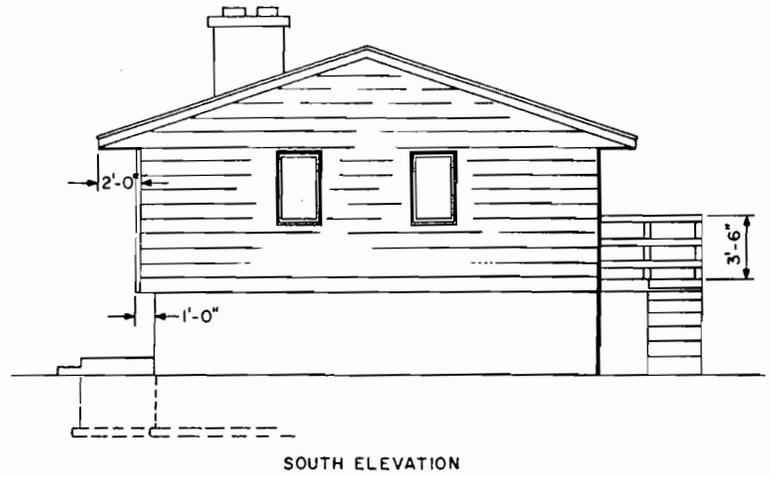
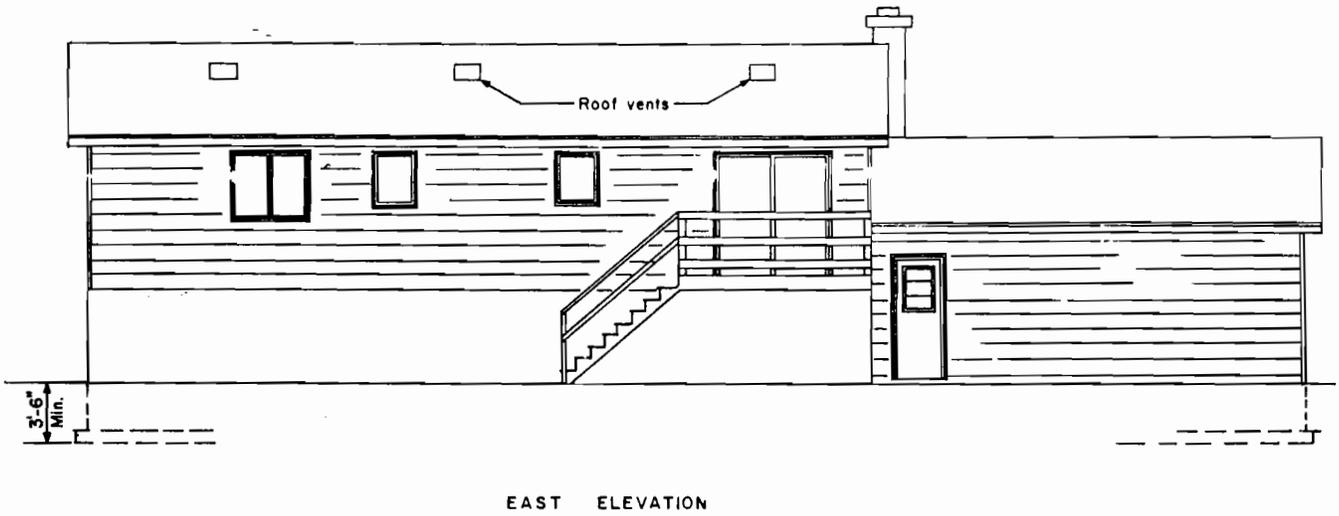
FIGURE B-2. - South and east side elevation views.

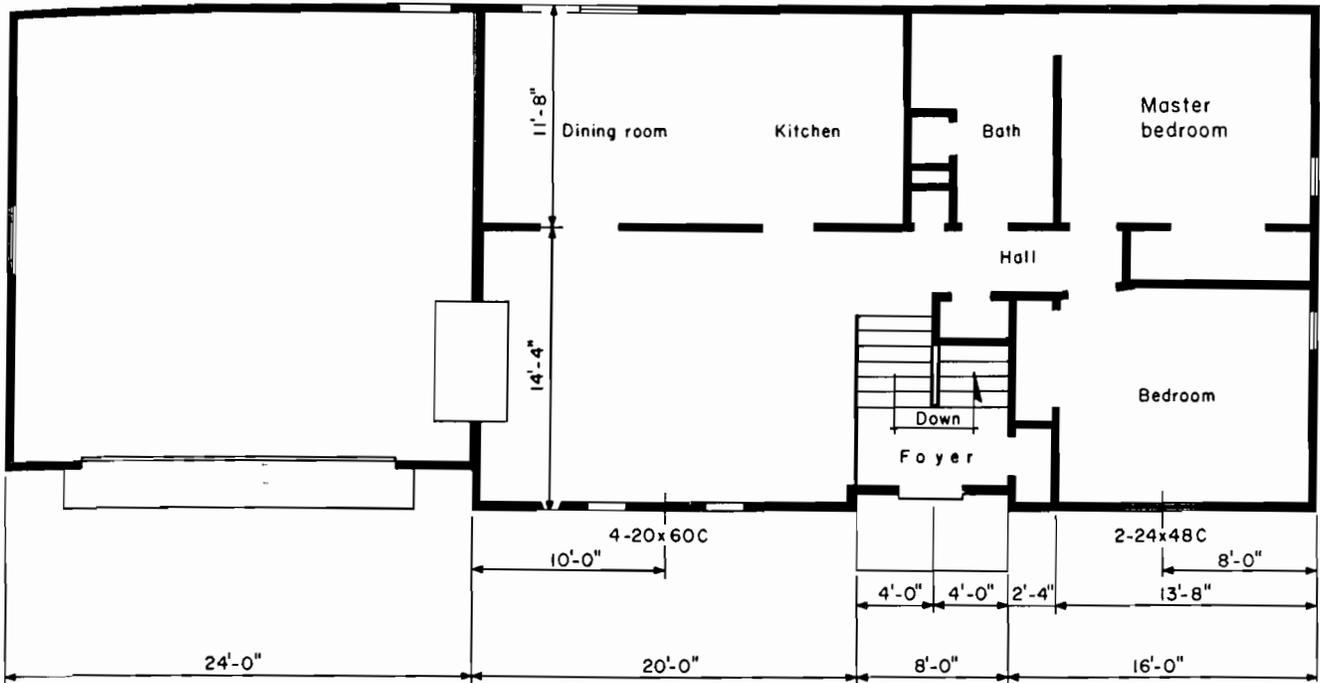
FIGURE B-3. - Main floor plan.
