Report of Investigations 8896

Effects of Repeated Blasting on a Wood-Frame House

By Mark S. Stagg, David E. Siskind,
Michael G. Stevens, and Charles H. Dowding

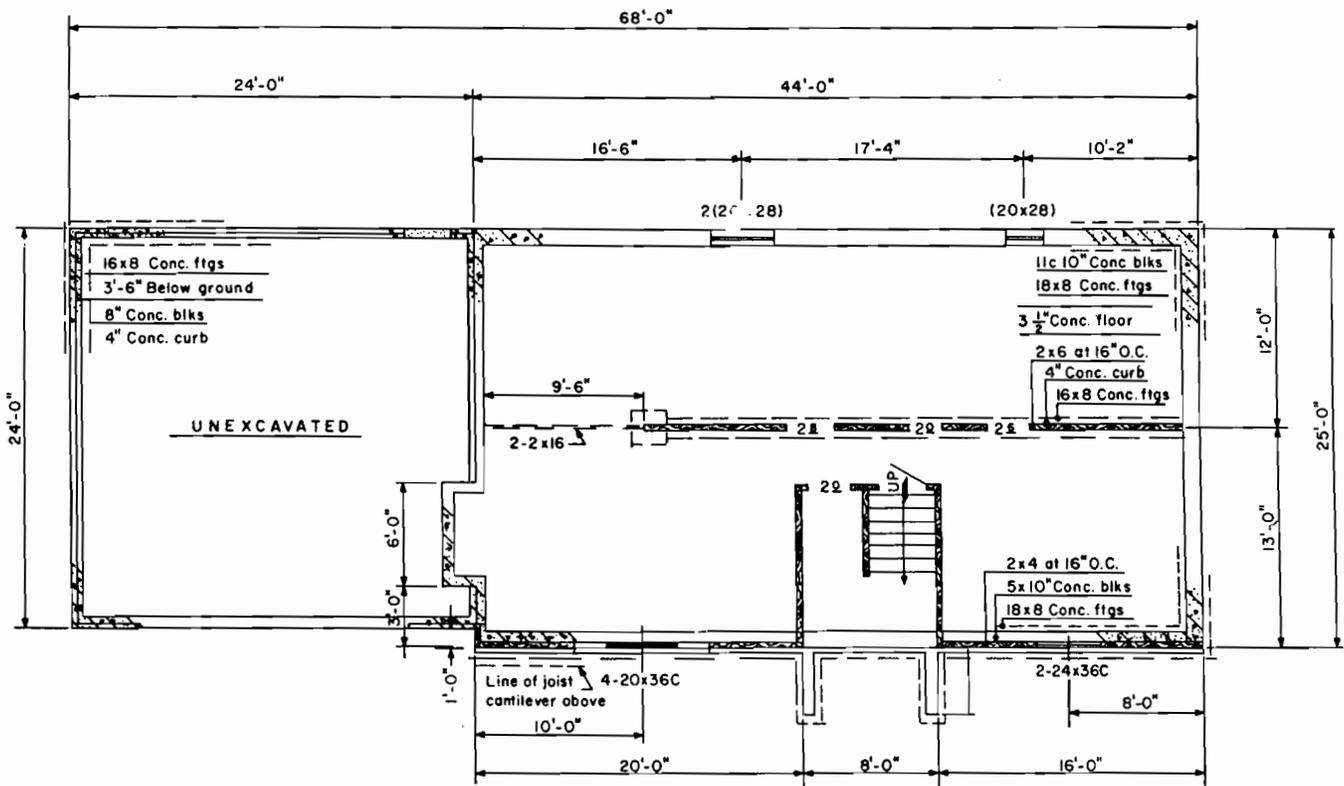
FIGURE B-4. - Basement floor plan.

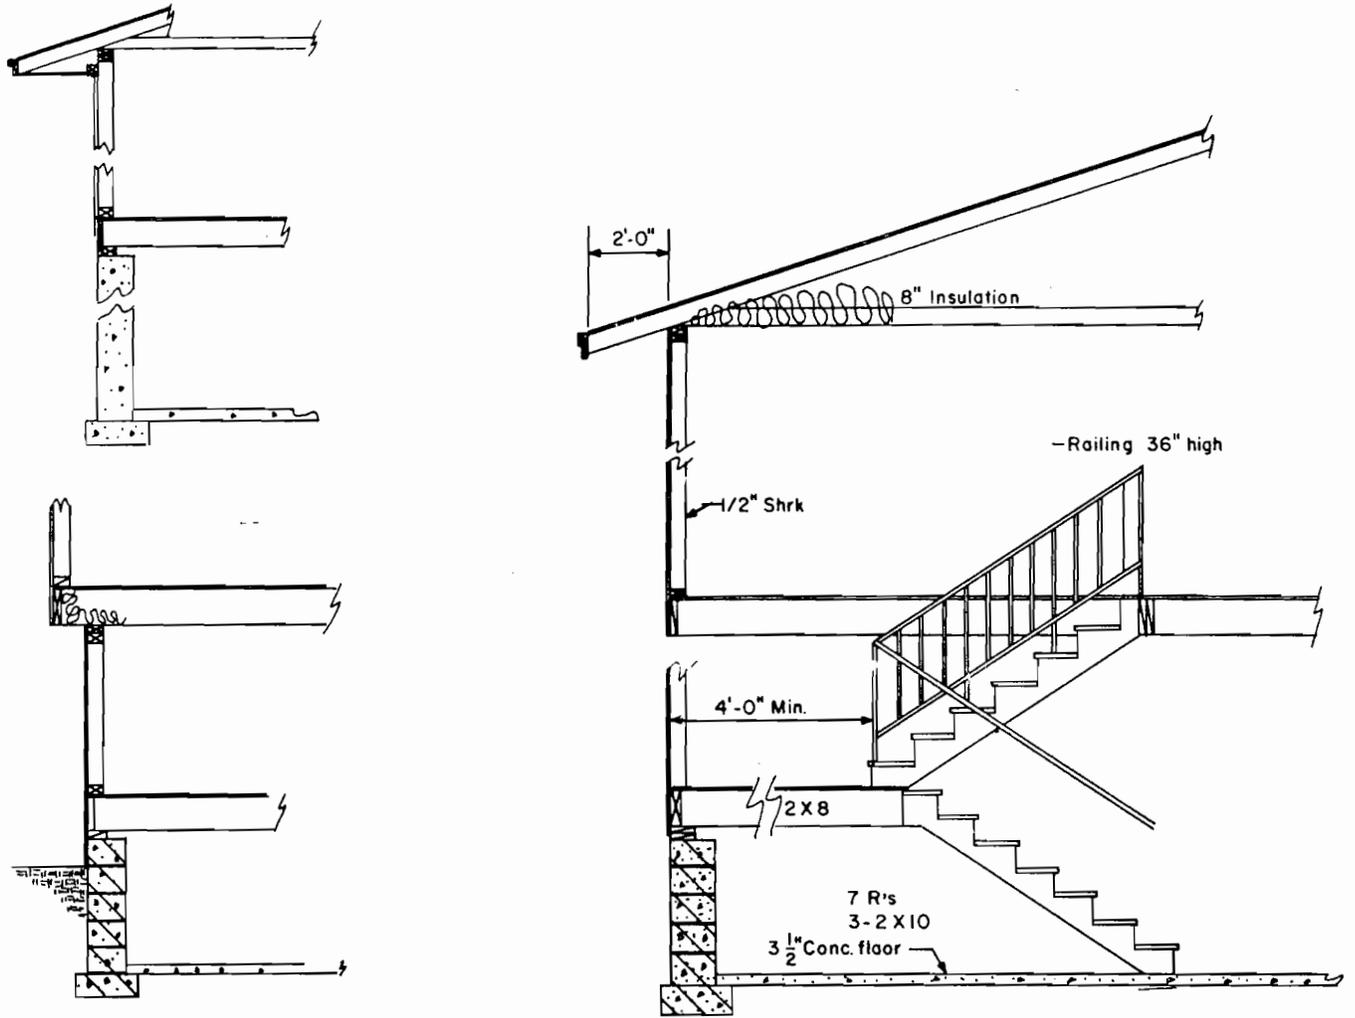
FIGURE B-5. - Design details.

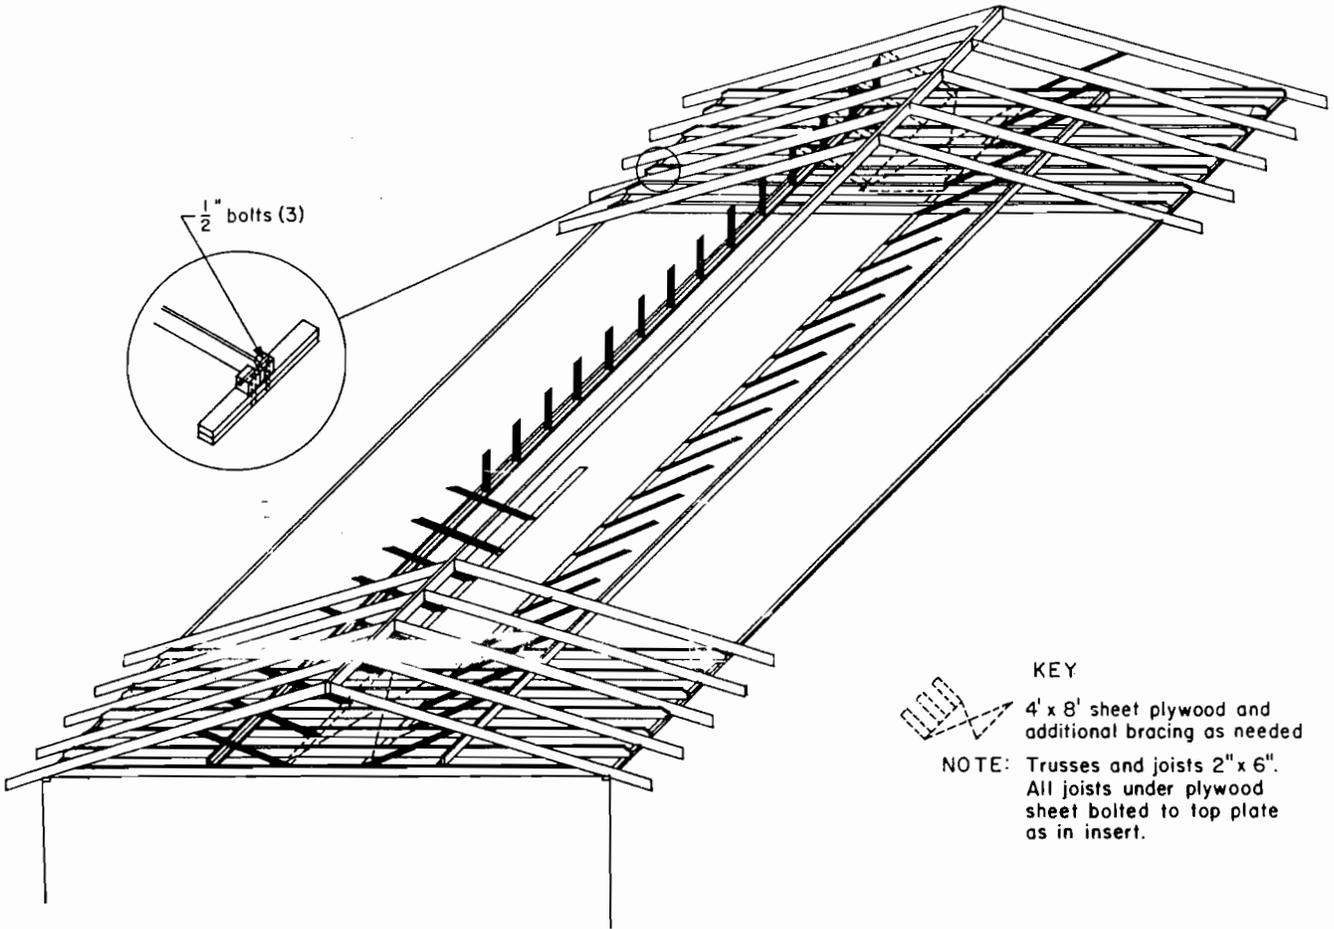
FIGURE B-6. - Roof framing after modifications.

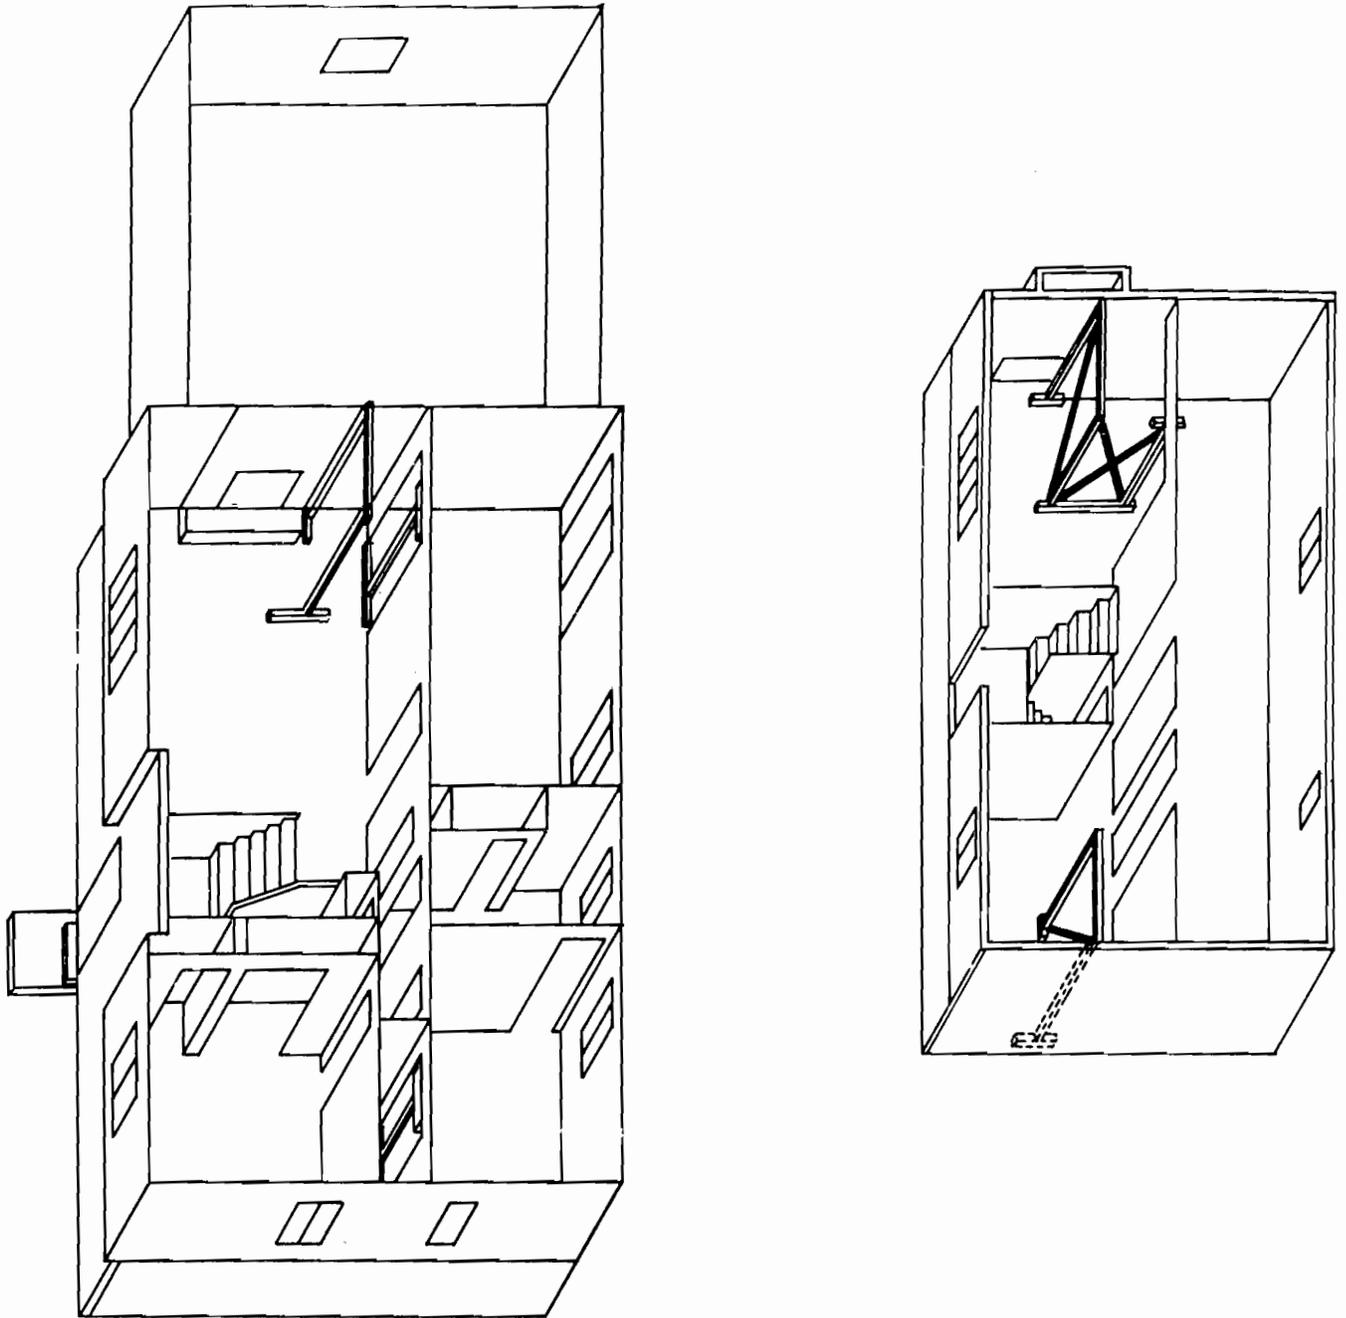
FIGURE B-7. - Structural modifications of main floor and basement to accept shakers. (Modifications shown as darkened features.)
