**Report of Investigations 9008**

# **Delayed Blasting Tests To Improve Highwall Stability—A Final Report**

**By Virgil J. Stachura, Larry R. Fletcher,  
and Michael A. Peltier**

**BUREAU OF MINES**  
**Robert C. Horton, Director**

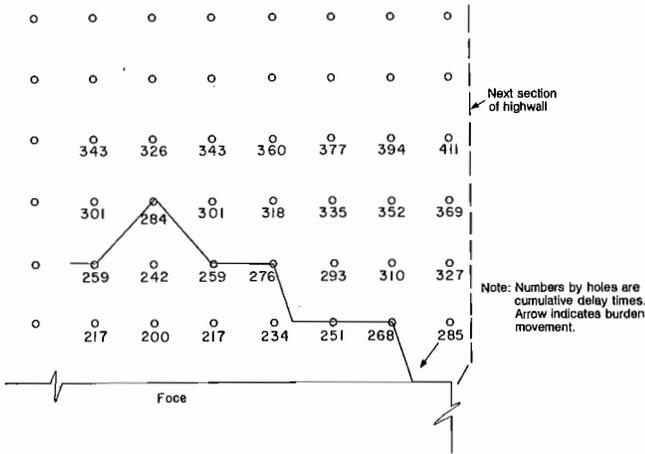
FIGURE 1. - Break line prior to 285 ms with 200-ms in-the-hole delays throughout.

The blast design used by the mine and the Bureau's first two alternative designs were previously described in detail in RI 8916. Briefly, design 1 (the pattern used by the mine) was a flat V with surface delays of 17 ms between holes, 42 ms between rows, and 200-ms in-the-hole delays. Designs 2 and 3 were the same as design 1 except that in-the-hole delays of 250 and 300 ms, respectively, were used in the highwall holes. Design 4 was the same as design 1 except that 300-ms in-the-hole delays were used in the highwall holes and 250-ms in-the-hole delays were used in the second row of holes from the highwall. The four designs and the cumulative delay times for each blast hole are shown in figures 1 through 4. Each plan view (figs. 1-4) includes an arrow that indicates the observed direction of burden movement. In figures 2 through 4, this direction is perpendicular to the plane of the highwall, a sign of improved relief over that illustrated in figure 1. Design 4 was tried because of reports of overbreak extending far beyond a distance equal to one burden (7-8). It was anticipated that the additional delay in the second row of holes from the highwall would provide additional relief, reducing the damage to the highwall.

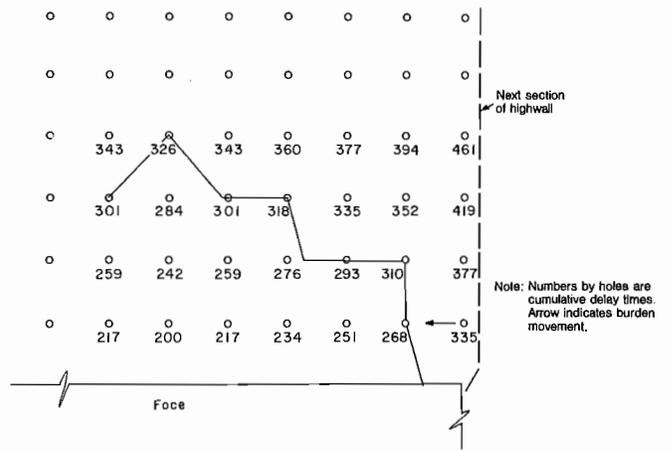
FIGURE 2. - Break line prior to 335 ms with 250-ms in-the-hole delays in highwall holes and 200-ms in-the-hole delays in remaining holes.

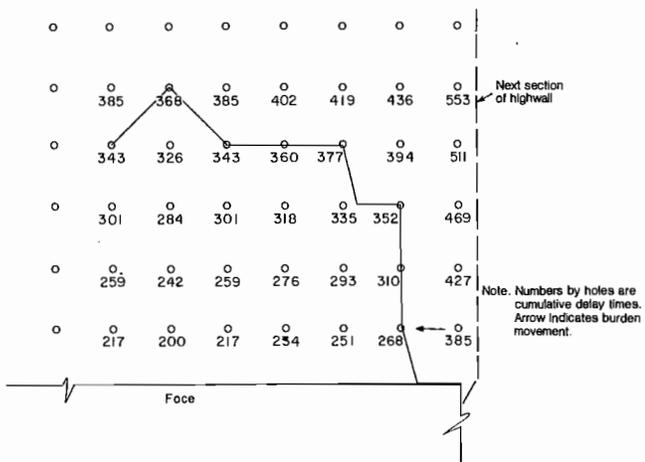
FIGURE 3. - Break line prior to 385 ms with 300-ms in-the-hole delays in highwall holes and 200-ms in-the-hole delays in remaining holes.

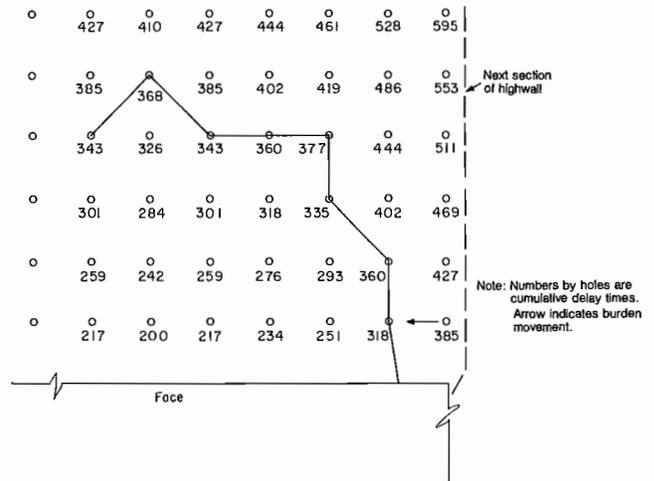
FIGURE 4. - Break line prior to 385 ms with 250- and 300-ms in-the-hole delays in two rows of holes nearest to the highwall and 200-ms in-the-hole delays in remaining holes.

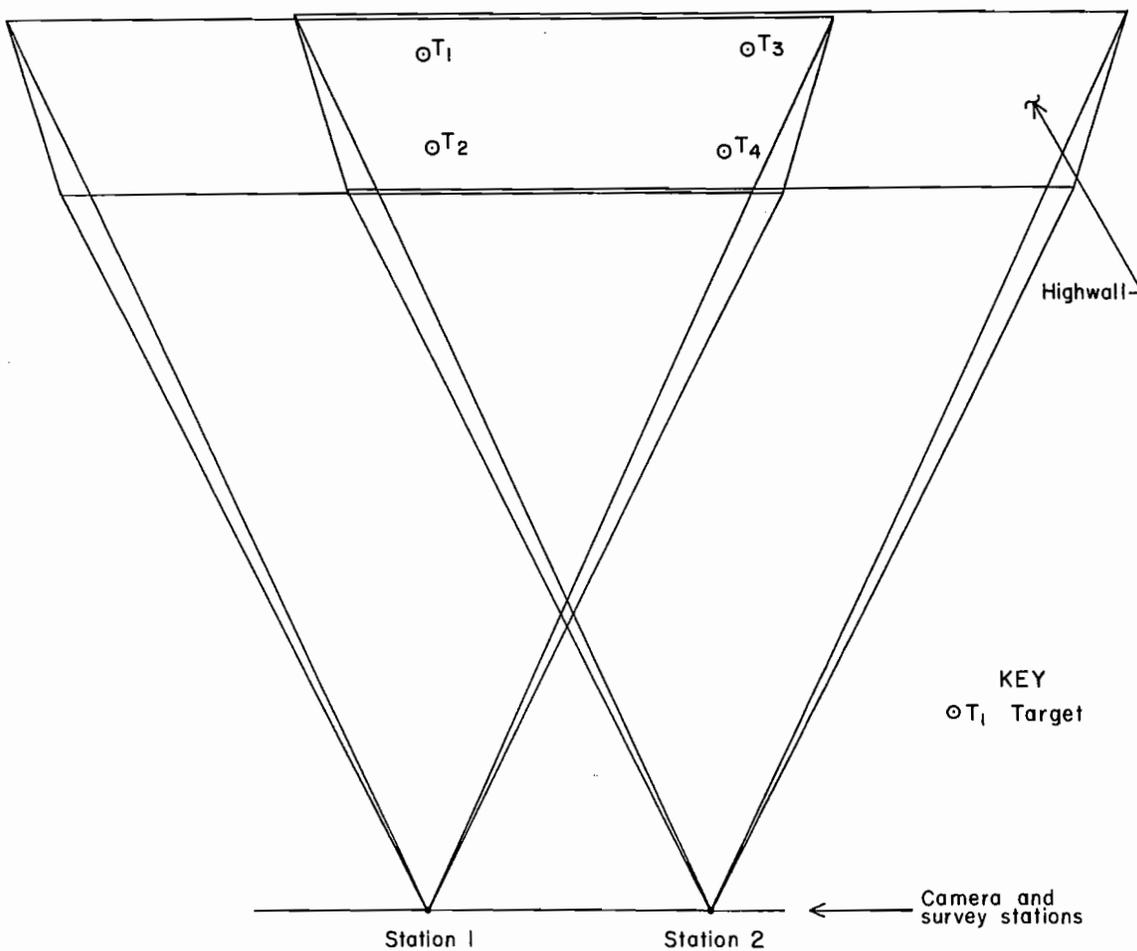
FIGURE 5. - Illustration of stereo photography technique with control targets.

1. Take two photographs (left and right stereo pair) with parallel camera axes, with separation one-fourth to one-fifth of the distance to the highwall.
2. Survey the location of the two camera stations and at least four targets on the highwall as controls such that their x, y, and z coordinates may be calculated. The four targets should be common to both the left and right pictures (fig. 5).

The photographs and coordinates were given to a photogrammetry firm so it could set up the pictures in a manner which duplicated the highwall geometry through a stereoscope. A photogrammetric operator then scanned a cursor over the surface seen in the stereoscope in vertical sections at regular intervals to read the x, y, and z coordinates of points on the highwall surface and feed them into a computer. The vertical sections were at 1-1/2- to 3-ft horizontal intervals, and the vertical increments between reading points were 1/3 ft or less. The vertical profiles of the highwalls were plotted from the coordinates by a Bureau computer

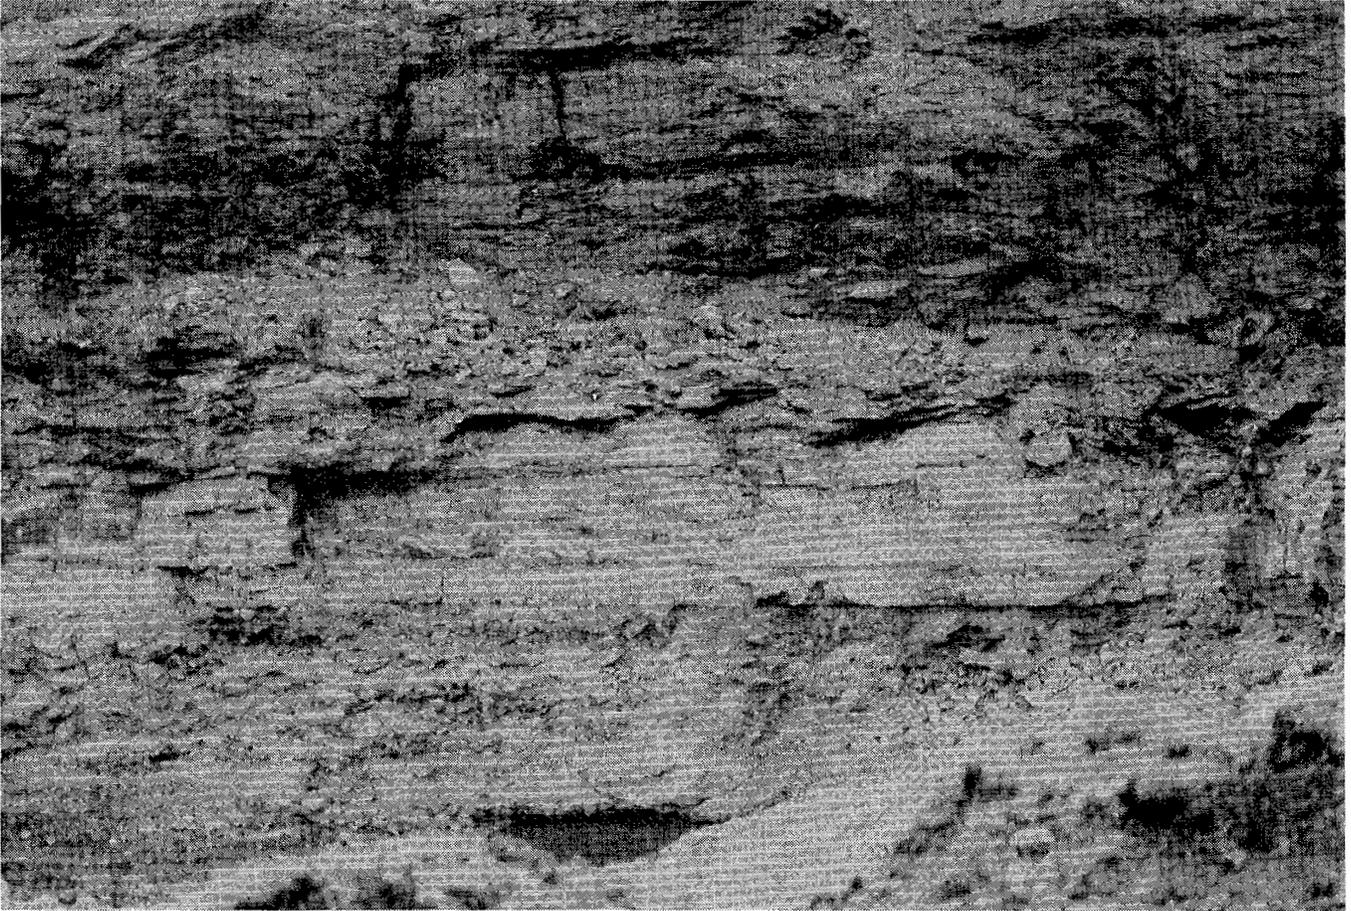
FIGURE 7. - Test highwall, no increase in delay time (blast design 1).

The highwalls of 59 test blasts were evaluated from stereo photographs, on-site observation, photographs taken by the blaster, and notes made by the blaster. Profiles and photographs of four typical highwalls are shown as figures 7-14. Figures 7 and 8 show a highwall formed by a shot that used 200-ms in-the-hole delays throughout. This highwall was dangerous because of the large (5-ft) overhang left of center. Overbreak had caused the lower material to fall away, leaving the overhanging portion as a hazard.

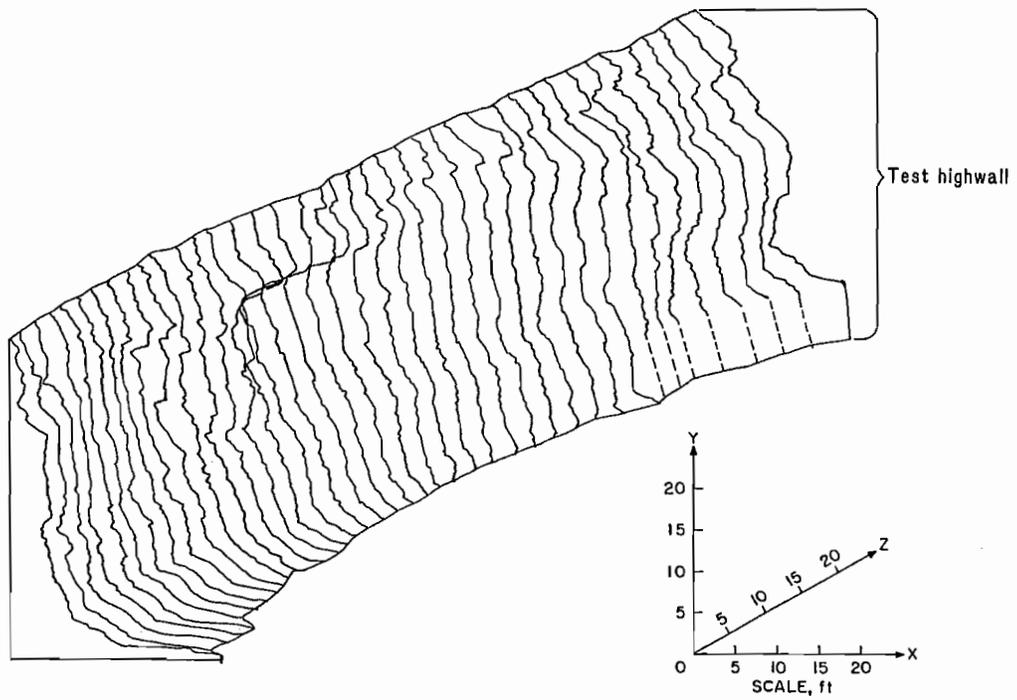
FIGURE 8. - Test highwall profiles, no increase in delay time.

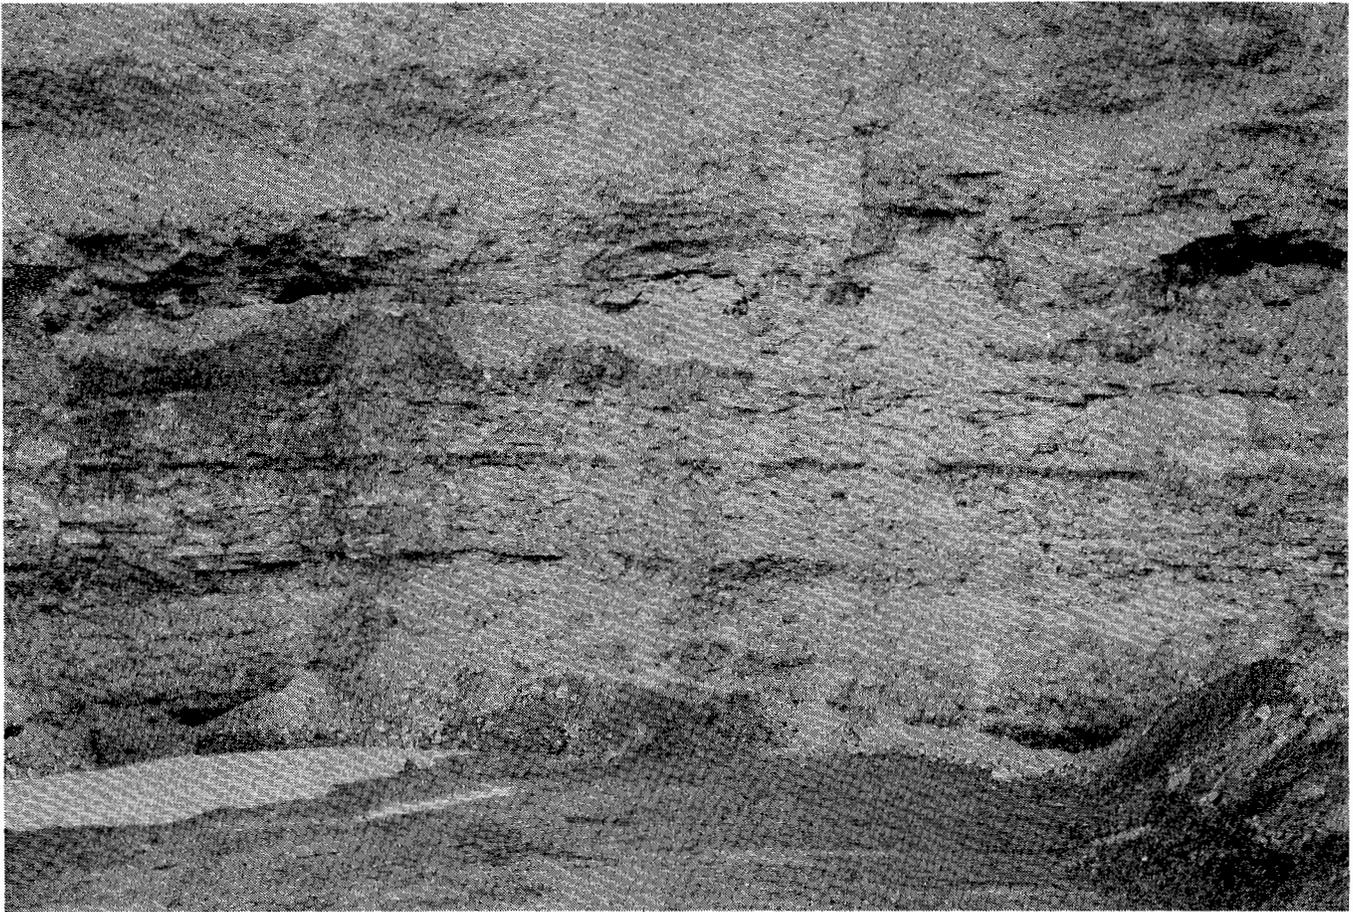
FIGURE 9. - Test highwall, 50-ms-longer delays in highwall holes (design 2).

The second highwall example (figs. 9-10) resulted from a shot that used 250-ms delays in the highwall holes and 200-ms delays in the rest of the shot. This highwall was smoother and showed well-interlocked material. There were some small ledges of about 1 ft, but they appeared to be locked in tightly.

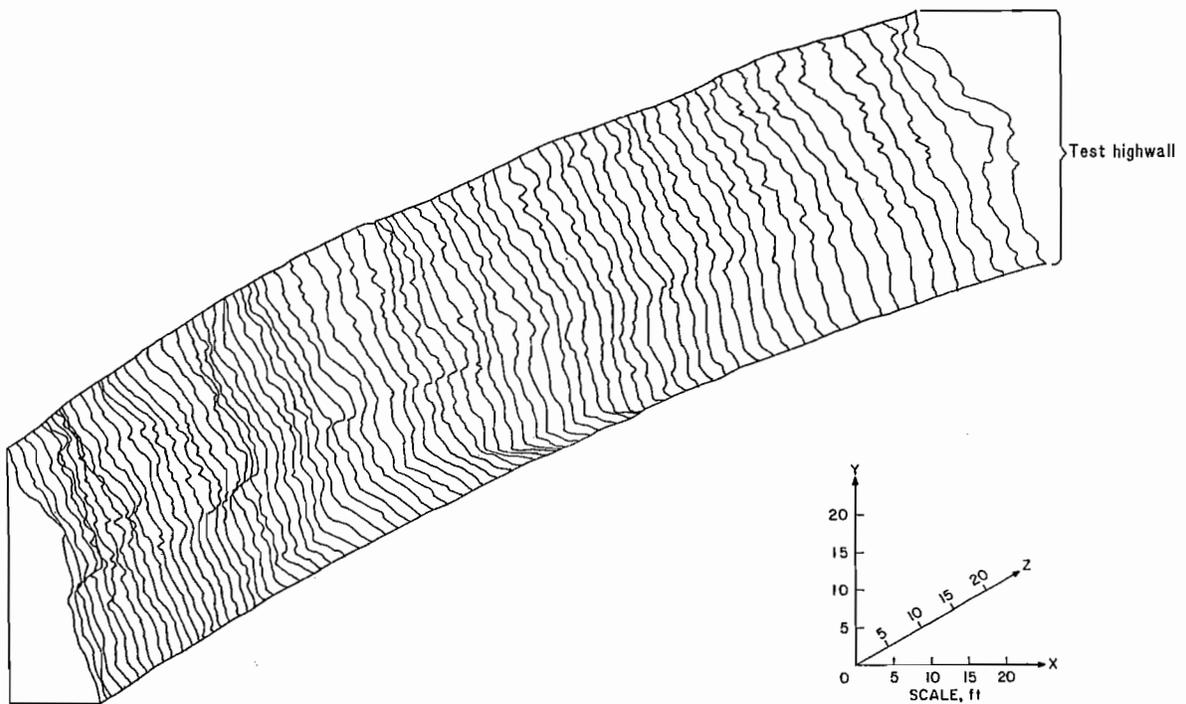
FIGURE 10. - Test highwall profiles, 50-ms-longer delays in highwall holes.

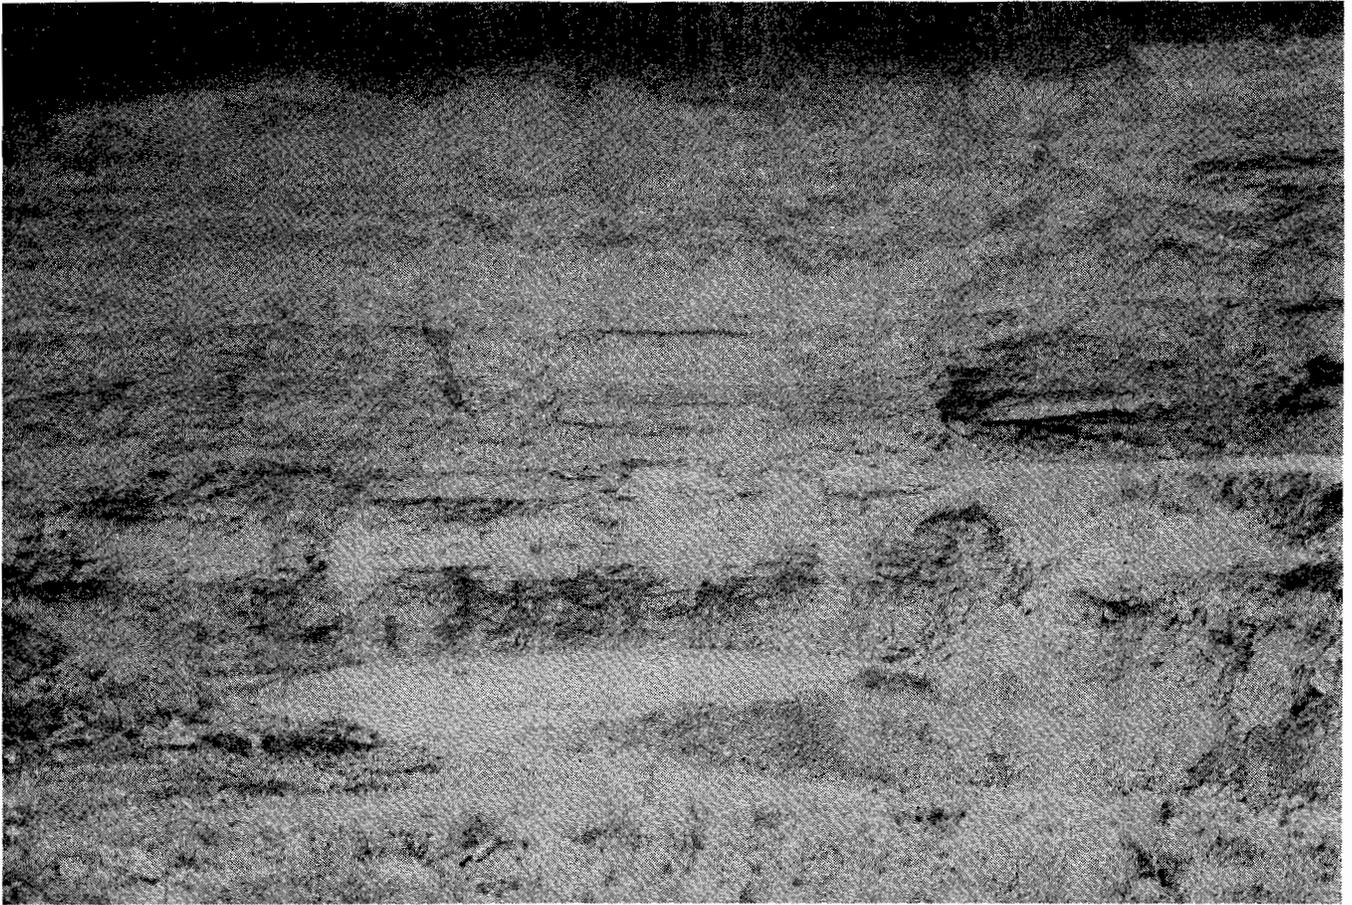
FIGURE 11. Test highwall, 100-ms-longer delays in highwall holes (design 3).

The third example (figs. 11-12) was formed by a shot that used 300-ms delays in the highwall holes and 200-ms delays in the rest of the shot. This highwall was sawtooth-shaped, although it did appear to be fairly solid. The shearing between holes was not as good as when 250-ms delays were used in the highwall holes (example 2). This was found to be true in many cases when 300-ms delays were used.

In spite of the variables found in the field, blast designs 2 and 4 produced the best results. Design 4 should be used in difficult geologies where designs 2 and 3 produce poor results, since it introduces a second row of relief. Design 3, used in the third example (figs. 11-12) tended to produce a sawtooth appearance; however, this appearance corresponded to the joints present and so would not necessarily occur at another site. The authors believe design 3 resulted in less overbreak than design 1 did (first example, figs. 7-8), but that the shearing action between holes was not as good--hence the sawtooth appearance.

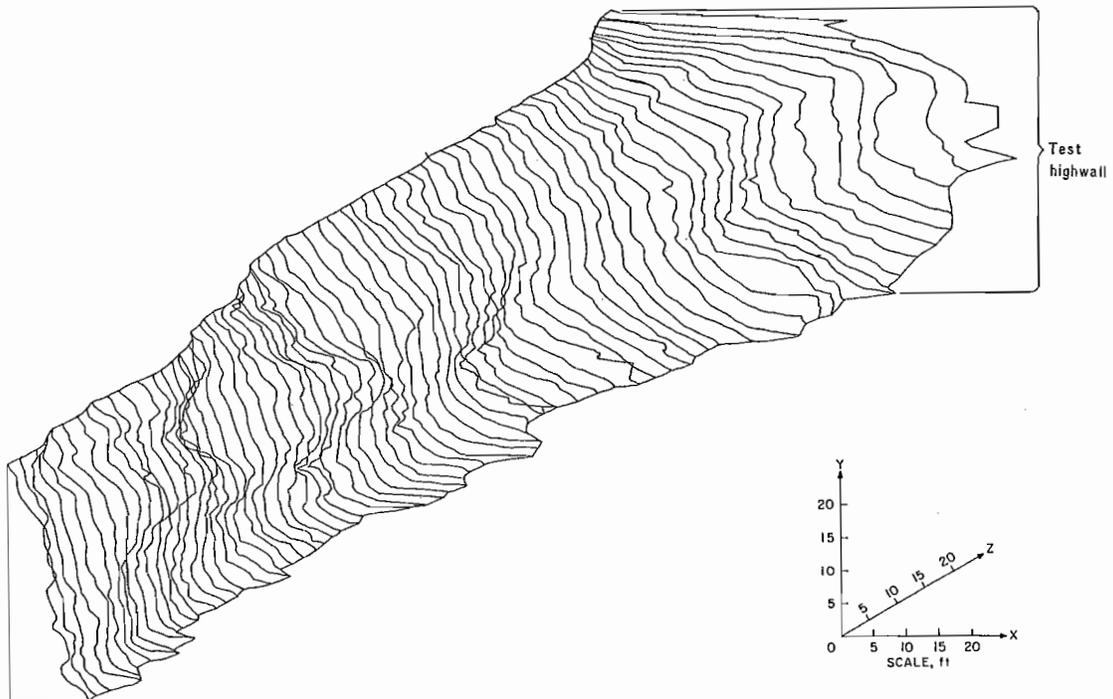
FIGURE 12. - Test highwall profiles, 100-ms-longer delays in highwall holes.

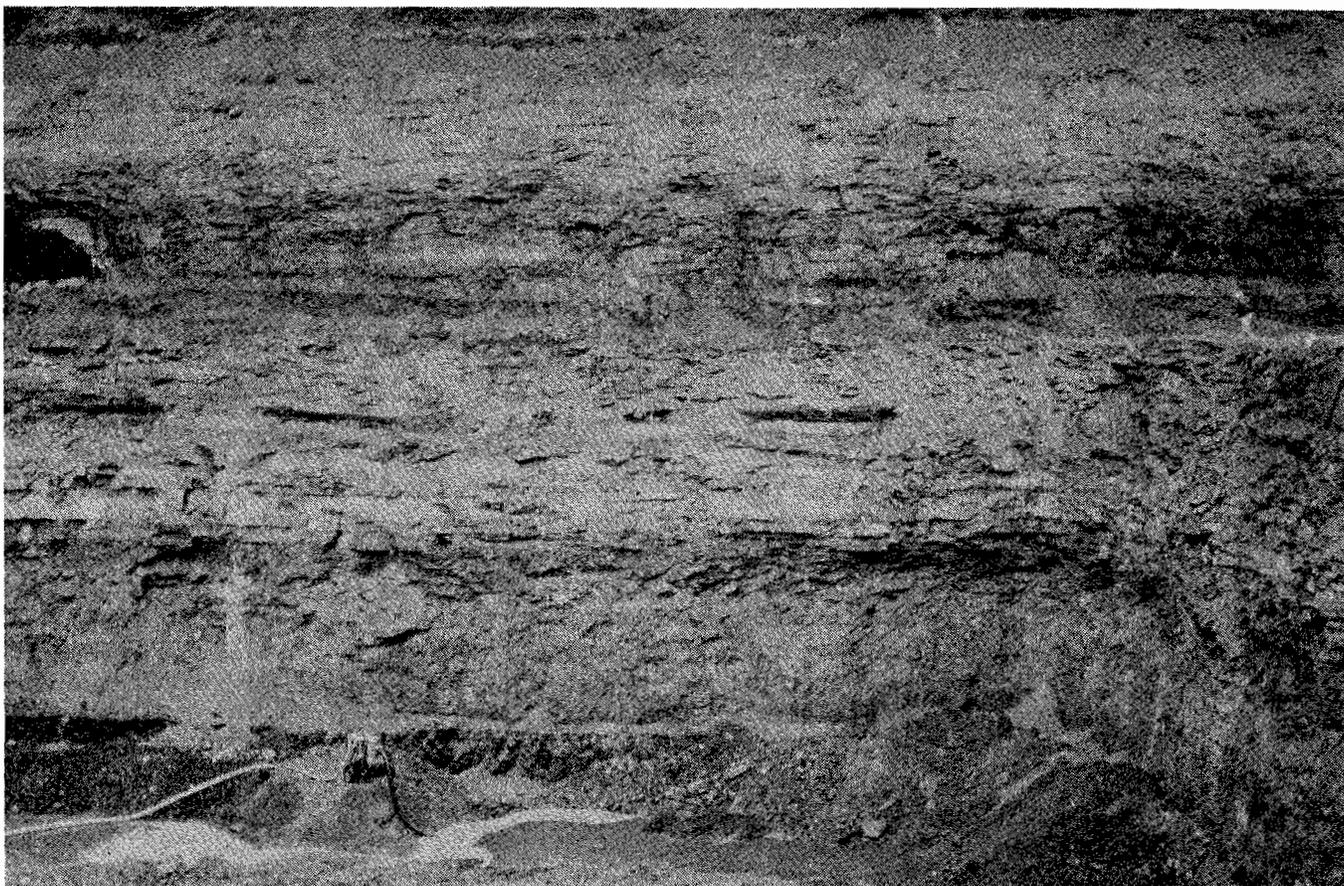
FIGURE 13. - Test highwall, 50- and 100-ms-longer delays in two rows of holes nearest to the highwall (design 4).

The fourth example (figs. 13-14) was formed by a shot that had 300-ms delays in the highwall holes, 250-ms delays in the second row of holes from the highwall, and 200-ms delays in the remainder

of the pattern. The highwall was smooth and showed well-interlocked material. This fourth shot design gave results comparable to those obtained using 250-ms delays in the highwall holes (example 2). The fourth shot design was tried because of reports of overbreak extending far beyond a distance of one burden (7-8). The additional row of longer delays (250 ms) provides a more uniform burden for the highwall holes (300-ms delays) because of the improved shearing action of the 250-ms delays. In addition to the uniform burden, less overbreak should occur up to a distance of two burdens because more time is allowed for burden movement. The evaluation system of stereo-generated profiles and photographic observation could not detect a reduction in fractures, although this probably occurred as a result of the additional row of delays.

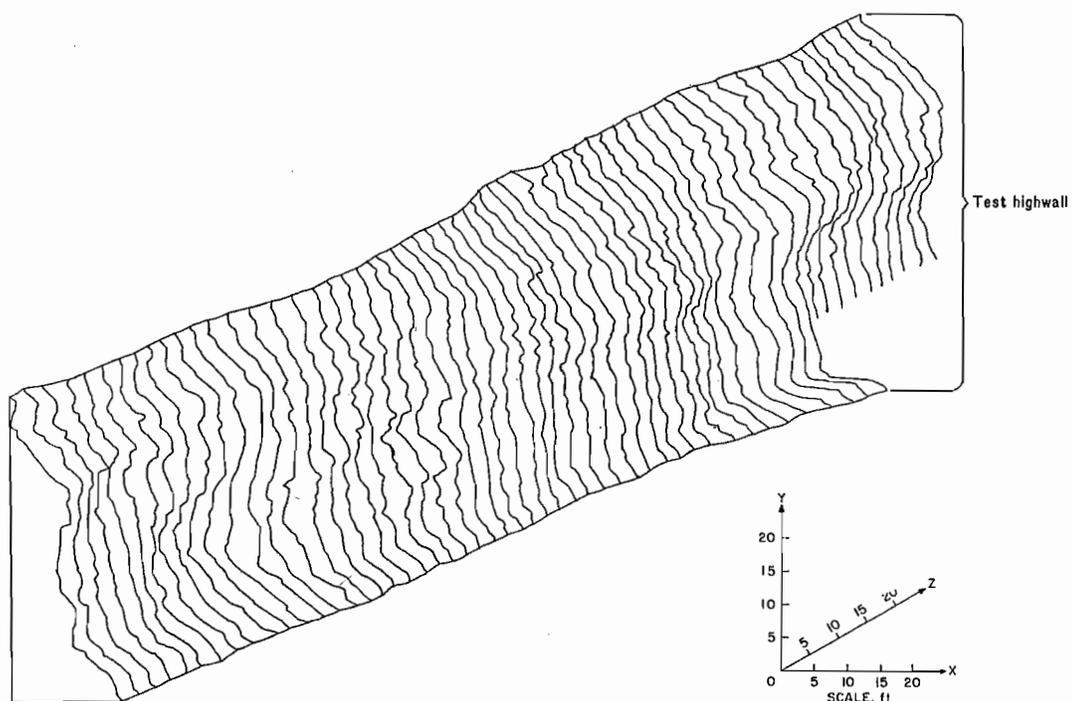
FIGURE 14. - Test highwall profiles, 50- and 100-ms-longer delays in the two rows of holes nearest to the highwall.
